PUBLISHED PROJECT REPORT PPR874

Innovative Geotechnical Repair Techniques

Effectiveness of Willow Poles

HAGDMS No. 30666

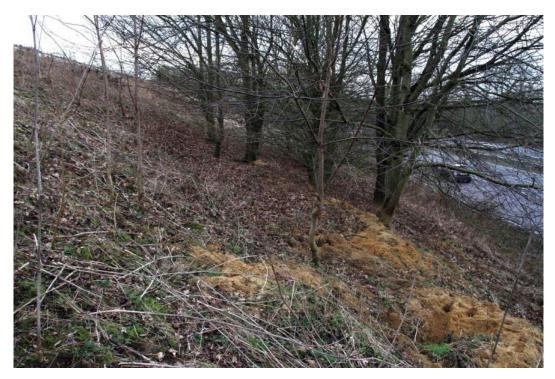
Signs of instability (rotational/sub-rotational movement) were observed in the area immediately to the south of the trial. The assessment of the stability of this area was complicated by extensive badger activity (Figure 3).

Figure 3: Area to the south of the trial at the A10 Hoddesdon showing signs of instability and badger activity (Site Photograph 7DW_4076)

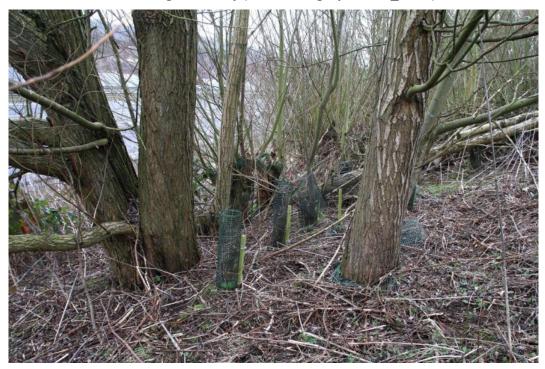
The trial comprised two distinct areas (see Figure 3); both areas were planted with alternating rows of *Salix alba* and *Salix dasyclados*. The smaller area, comprising five rows of willows, presented a distinct contrast between the condition and survival rate of the two species, with *Salix alba* apparently thriving (with the exception of the upper row) while for *Salix dasyclados* there was only one surviving specimen in each of the two rows. The *Salix alba* specimens towards the bottom of the slope appear to have thrived to an even greater degree with the most southerly specimen having several stems of around 350mm diameter and having reached an estimated height of around 12m (Figure 4).

Figure 4: Lower part of the smaller trial area at the A10 Hoddesdon. The photograph is taken from immediately to the south of the smaller trial area and shows the lower three rows with species Salix alba, Salix dasyclados and Salix alba from left to right (bottom to top of slope) (Site Photograph 7DW_4077)

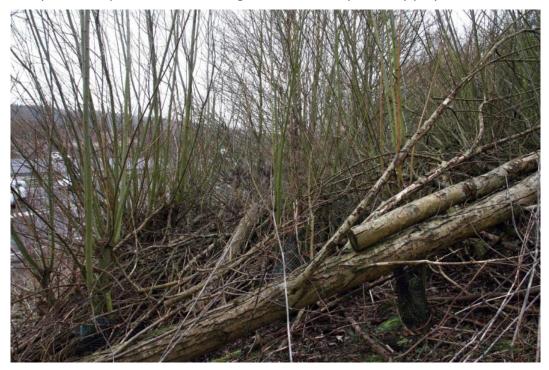
past. However, the deposition of this material within the larger trial area (Figure 5) meant that meaningful observations could not be made of the upper four rows of that area and that observations were difficult in the rest of that area.

Figure 5: The larger trial area at the A10 Hoddesdon showing larger specimens in the lower row and the disposal of coppiced material, viewed towards the north (Site Photograph 7DW 4078)

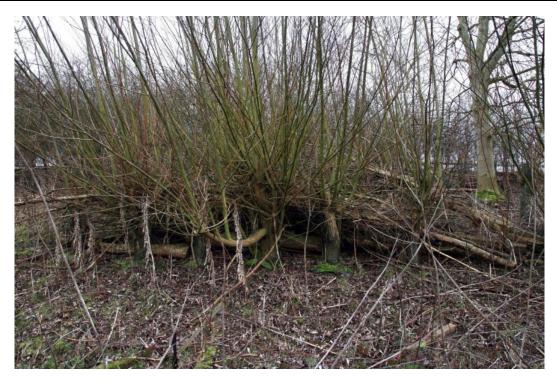
Figure 6: Lower part of the larger trial area at the A10 Hoddesdon showing larger specimens in the lower row and the disposal of coppiced material, viewed towards the east (Site Photograph 7DW_4080)

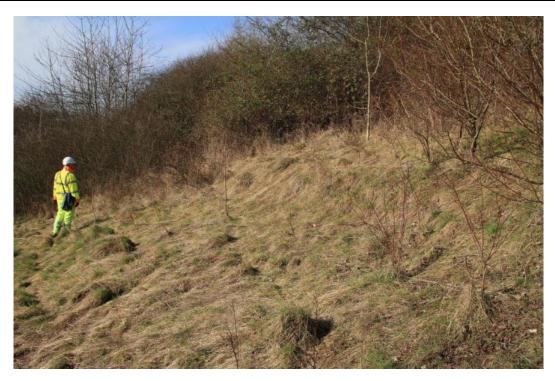
The signs of instability noted by Steel et al. (2004) were clearly visible during the site inspection although the toe bulge(s) observed during the site inspection were generally closer to the bottom of the slope than might be assumed from their description; this may mean that the movements observed by Steele et al. have developed and enlarged during the intervening 17 years or so. As with the A10 trial (see Section 2.1.3) the trial is located on the upper part of the area that shows instability and significant areas of instability were identifiable below the trial (Figure 10). Signs of surface soil and vegetation movement can be seen in Figure 10; these are typical of the slopes in and around the trial area and are potentially indicative of shrink-swell problems. Signs of instability were also noted to the east of the trial area. These were more significant than those in the trial area with a toe bulge of height around 0.5m to 0.75m and a significant back scarp. It was not possible to access the latter on site but information (unrelated to the willow poles works) in HAGDMS suggested a back scarp height of 1.5m.

Figure 10: A5 Milton Keynes showing the area immediately below the trial with significant signs of instability (Site Photograph 7DW_4057)

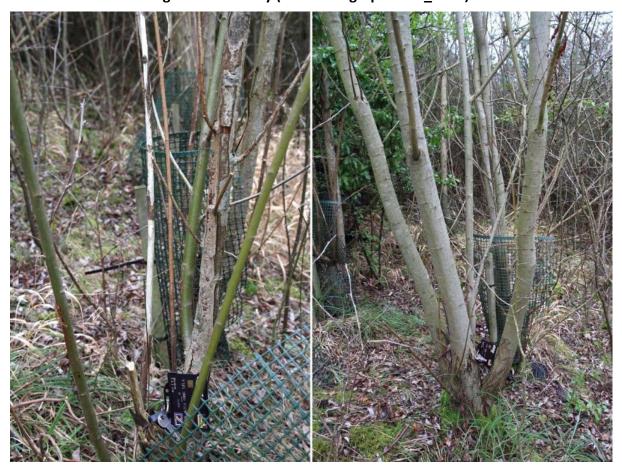
Figure 11: A5 Milton Keynes trial showing a row of *Salix alba* (left) and a row of *Salix spaethii* (right) (Site Photographs 7DW_4061 [left] and 7DW_4060 [right])

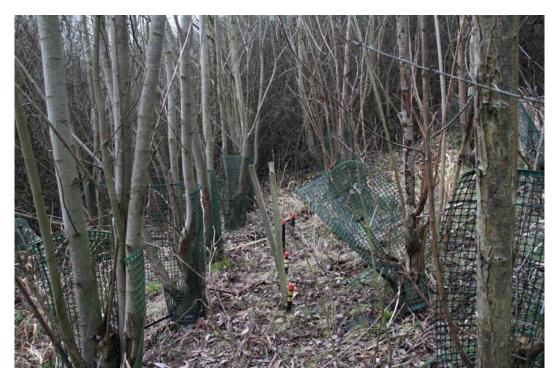
Figure 12: A5 Milton Keynes trial showing a row of *Salix spaethii* (left) and a row of *Salix alba* (right) (Site Photograph 7DW 4065)

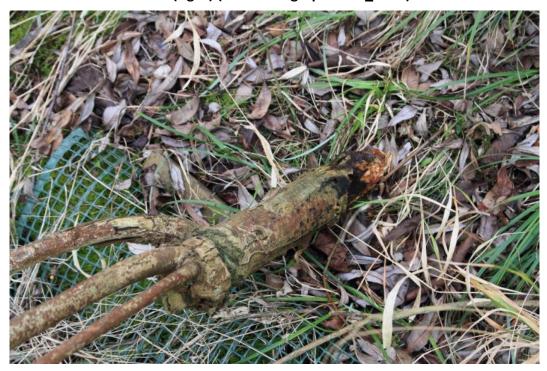
A small number of willow poles that had apparently established successfully seemed to have rotted at the base (Figure 13). It is understood, anecdotally, that this can happen after willows are coppiced but there were no indications that any of the willow at the A5 had been coppiced.

Figure 13: Specimen of *Salix alba* that has initially established but subsequently rotted at the base (Site Photograph 7DW_4069)

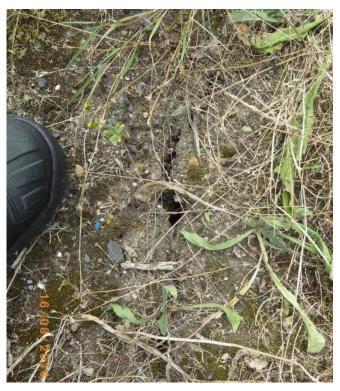
Minor signs of instability were observed on site and Figure 16 show signs of cracking at the crest of the embankment. From discussions with Aone+ and Highways England it seems clear that this movement is a direct result of the installation of a communications trench (allowing ingress of water) towards the upper part of the embankment (approximately in line with the upper edge of the variable message sign foundation and access block). During the installation of this trench the upper three rows of willow poles were removed (Figures 17 and 18).

Figure 16: M23 Gatwick trial showing crack at the crest of the embankment (Photograph courtesy and by permission of Martine Mildon, A-one+)

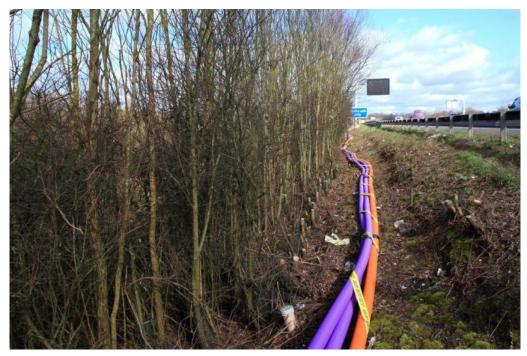
Figure 17: M23 Gatwick trial showing communications trench (to the right of the purple/orange conduits) and the remains of the willows that were removed during its installation. View to the north from the south end of the trial site (Site Photograph 7DW_4234)

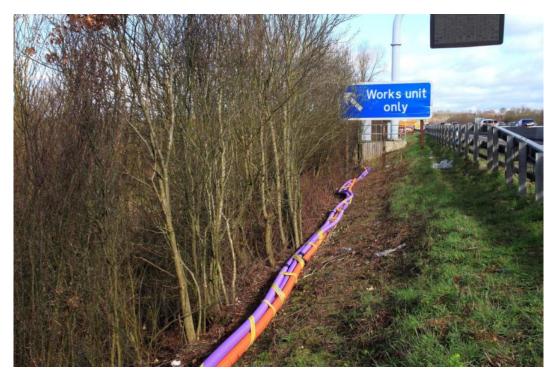
Figure 18: M23 Gatwick trial showing Panels 5 to 8 (left to right) view to north (see also Figure 15). Only Salix alba is visible after the alternating panels of Salix spaethii and Salix dasyclados in the upper rows where removed to allow the installation of a communications trench (Site Photograph 7DW_4225)

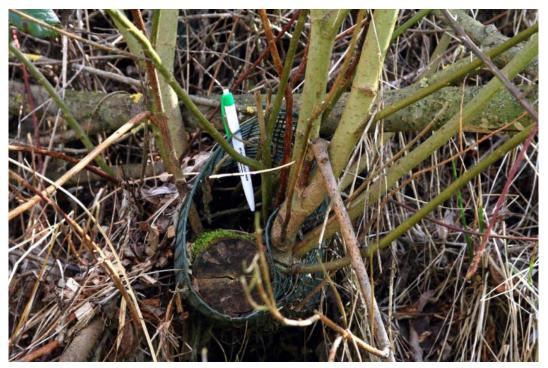
there was no evidence of coppicing having taken place (Figure 19). The diameter of the stems was typically between 60mm and 150mm.

Figure 19: M23 Gatwick trial. A *Salix alba* specimen at the base of the embankment showing the top of the original willow pole and subsequent shoots (Site Photograph 7DW_4238)

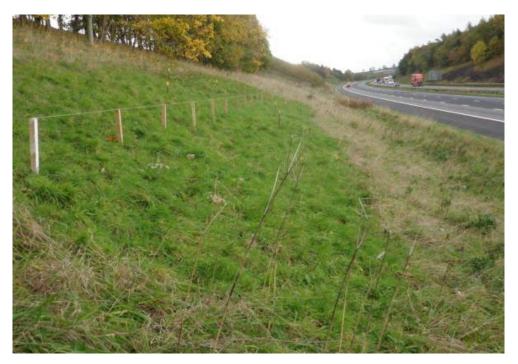
The laminated clay was considered the most likely cause of instability at this location and the cutting was considered to be over steep. Design seems to have focussed on the stability of the laminated clay, not least as a toe bulge broadly consistent with the location of the laminated clay was identified as part of the investigation (EM Highways 2014; 2015) (Figures 22 and 23).

Figure 23: View of the site looking southeast prior to the installation of the willow poles. The peg line defines the back scarp and the toe bulge is also visible (from EM Highways 2014)

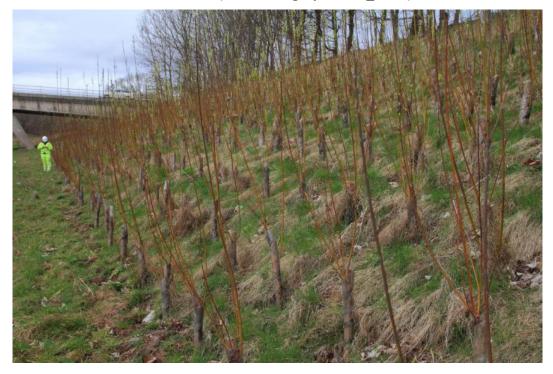
Figure 25: M6 south of J40, view of toe of slope looking approximately north-west towards the B5320 overbridge. The toe bulge is more discernible in this image (Site Photograph 7DW_4256)

Figure 25 also conveys an accurate impression of the relatively immature condition of the plants, albeit that establishment seems to be progressing well and new growth was readily visibly (Figure 26). This is broadly consistent with the reported planting dates between November 2015 and February 2016 (Keir 2016).

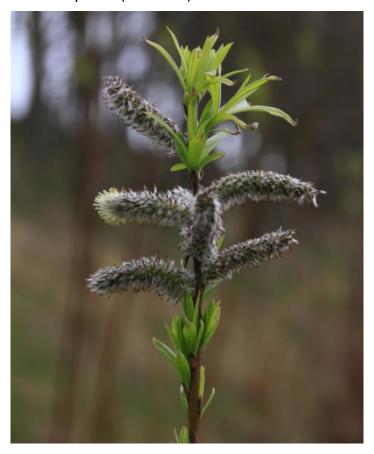
Figure 26: M6 south of J40, new growth on the willows in March 2017 (Site Photograph 7DW 4247)

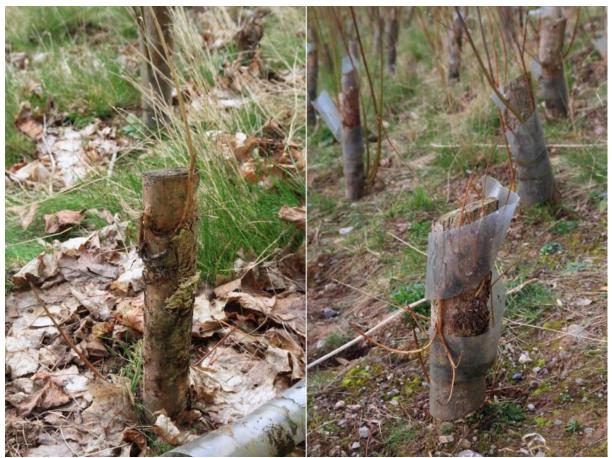
Relatively few poles that had failed to grow were encountered. However, where these were encountered significant mould/fungi growth was observed beneath the plastic spiral covers used to protect the exposed tops of the poles and shoots from animals (Figure 27). These covers seem to have inhibited shoot growth, in some cases, and it may be that they have also allowed the build-up of damp conditions so promoting the growth of the observed mould/fungi.

Mould/fungi of this nature was not observed at any of the other sites where small aperture geogrids were used to protect the poles (see Figures 4, 12 and 19 for example). This is confirmed by Steele et al. (2004) who note that at the A10, M1, A5 and M23 trials vented tree guards were used in preference to closed guards, such as those illustrated in Figure 27(R). When used at the Iwade trial site (Barker 1997) these had caused adverse desiccation

Figure 27: M6 south of J40. Growth of mould/fungi on willow poles (left) and the translucent plastic wraps used to protect the poles and shoots from animals (right) (Site Photographs 7DW_4260 [left] and 7DW_4258 [right])

and overheating to occur. It is understood that the specification for the works required the use of a grid rather than the enclosed plastic used.

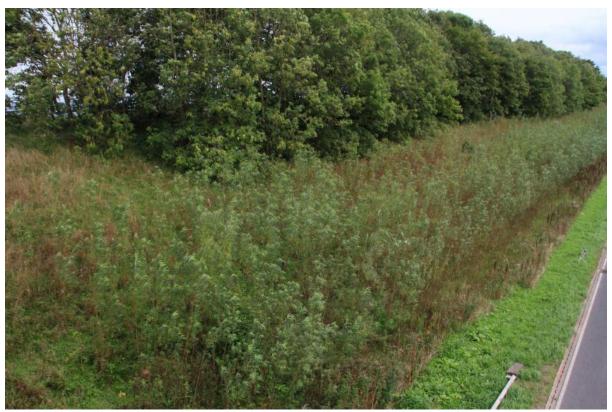
Figure 28: General view of the M6 south of J40 site from the B5320 overbridge looking south-east (Site Photograph 7DW_4827) taken on 28 August 2018 showing significant growth of the willows compared to Figure 24 (date 10 March 2017)

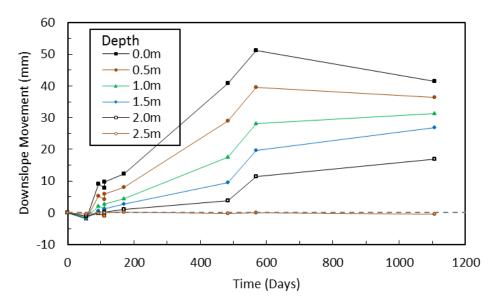
Although monitoring in the form of piezometers and inclinometers has been installed at the most recent site, M6 south of J40, at the time of writing data only to the end of the construction period was available. For the piezometer data there is no discernible trend while the inclinometer data showed downslope movements. The recorded downslope movements (Keir 2016) as of March 2016 varied from approximately 50mm at the surface to just over 10mm at 2.0m depth over around 570 days (Figures 29 and 30).

Figure 29: Downslope movement measured using an inclinometer at BH05A/13 at the M6 South of J40 site showing movement with time at different depths

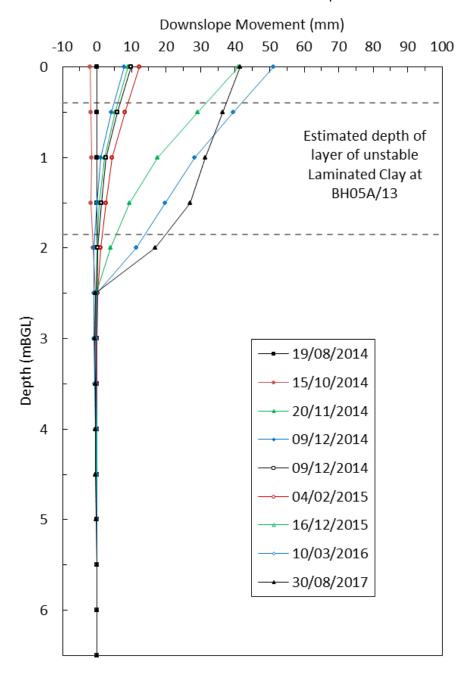
The movements observed showed reasonable coincidence with the estimated depth of the laminated clay layer that the work was intended to stabilise (Figure 30) and movement is clearly increasing with time (Figure 29) until after the completion of installation (readings dated 10 March 2016) with little to no movement recorded between that reading and the sole subsequent reading (dated 30 August 2017). The data strongly suggest that the use of willow poles has effectively stabilised the slope, at least in the short-term. Notwithstanding this the shape of the final set of readings relative to the previous readings may suggest that the movement is being forced deeper as a result of the willow poles, but this is considered relatively unlikely. Further monitoring is recommended at six monthly to annual intervals

Figure 30: Downslope movement measured using an inclinometer at BH05A/13 at the M6 South of J40 site showing movement with depth at different times

over a period of 20 years after the end of construction, a period that is meaningful in terms of slope instability, in order to evaluate the long-term effects of the willow pole stabilisation and to ensure that the movements do not continue at a deeper level.
