PUBLISHED PROJECT REPORT PPR045

TYRE BALES IN CONSTRUCTION: CASE STUDIES

by M G Winter, J M Reid and P I J Griffiths (TRL Limited)

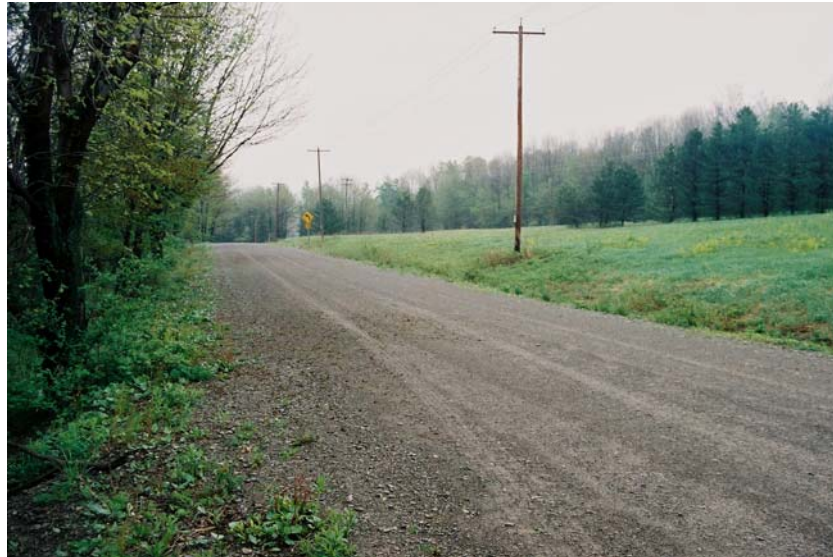
The road was completed in summer 1999 and involved 2,000 bales (200,000 tyres) in a 928' (278m) section of the CR647 road. As of May 2004 the road is showing no signs of distress (Figure 1.2).

Figure 1.2 – CR647 in May 2004.

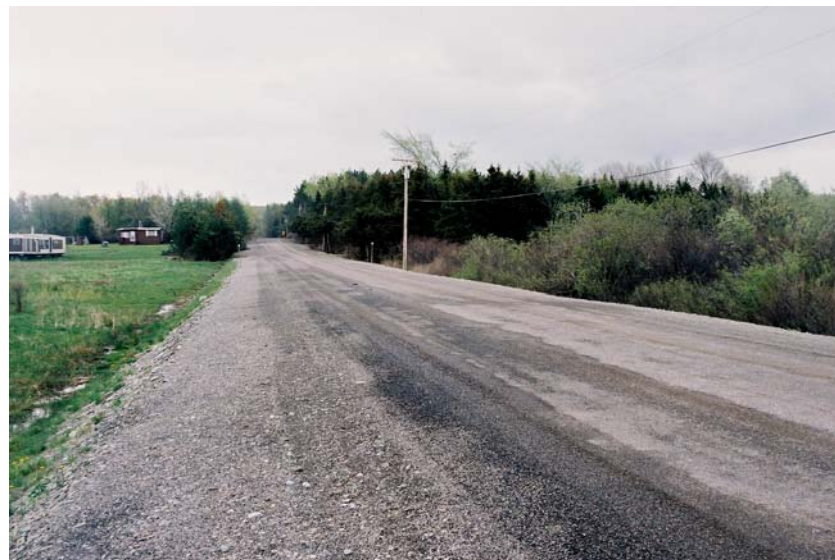
Construction was broadly as described for the Kabob Road but without the blacktop layers or the side drain. The road is not controlled by the County Authorities and some damage has been observed due to the provision of shallower than normal cross falls, and associated ponding (Figure 1.7).

Figure 1.7 – East Road in May 2004.

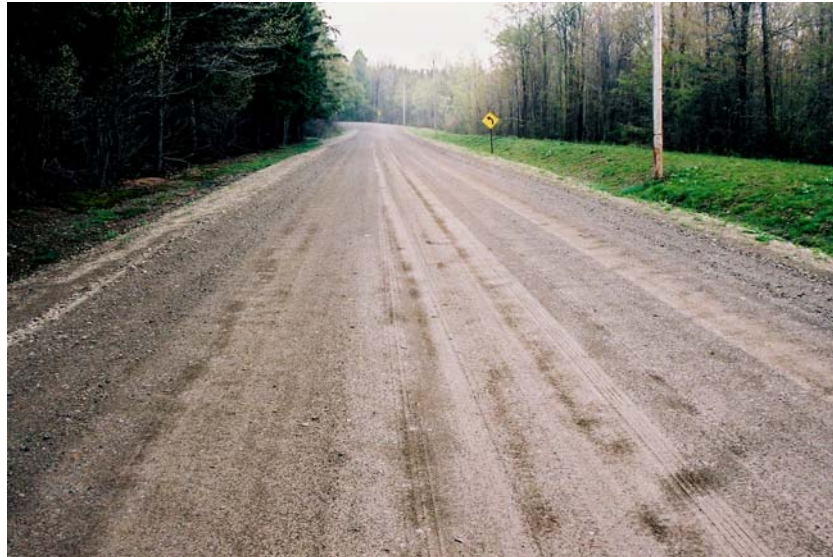
Approximately 1000' (300m) of Sandford Road was reconstructed in the same manner as East Road in summer 2002 over very marginal soils. Traffic counts indicate around 100 vehicles per day per direction which includes very few heavy goods vehicles. However, one significant difference is that the road was constructed five bales rather than six bales wide. This combined with the shallower than normal cross fall leads to a road that is perceived as narrow and difficult for vehicles to pass each other (Figure 1.8).

Figure 1.8 – Sandford Road in May 2004.

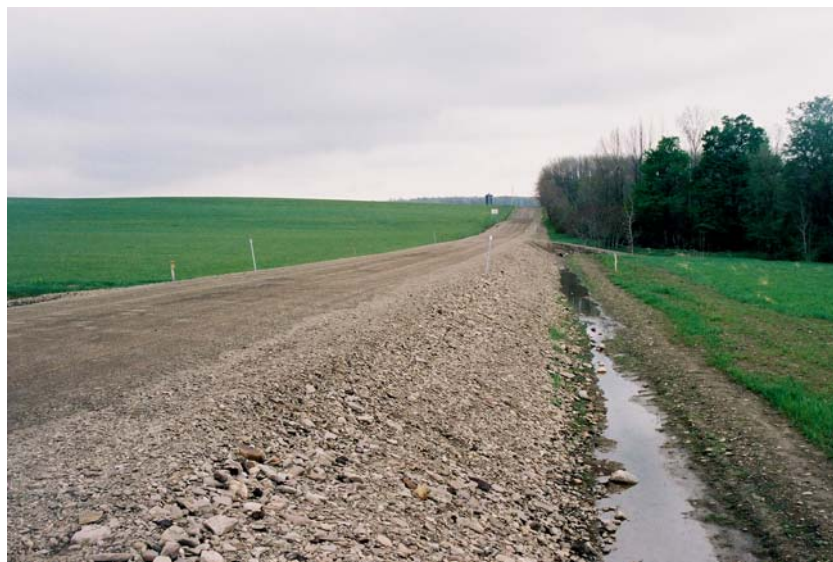
Approximately 1000' (300m) of C. Johnson Road was reconstructed in broadly the same manner as East Road in summer 2003 over very marginal soils. Two layers of bales and an additional depth of gravel were used to help to level a dip in the landscape. However, like Sandford Road, the road was constructed five bales rather than six bales wide. This combined with the shallower than normal cross falls led to a road that is perceived as narrow and difficult for vehicles to pass each other (Figure 1.9).

Figure 1.9 – C. Johnson Road in May 2004.

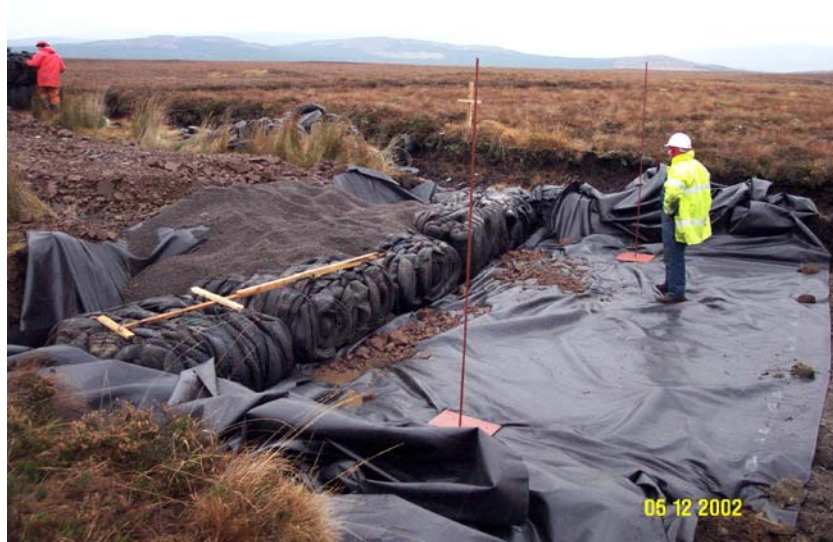
Monitoring of the settlement rods indicated that maximum settlements were 0.2m and 0.45m either side of the road during the first ten months of opening. However, most (in excess of 75%) of this settlement occurred in the first four months after opening to traffic. The rates of settlement are now such that cumulative settlements over the next year are anticipated to be a maximum of 0.15m. In reality these are likely to be considerably less due to further decreases in the rate of settlement. Of the gross settlements between 0mm and 10mm is attributed to compression of the lower tyre bale layer.

Figure 2.3 – Tyre bale construction on the B871 showing the settlement rods. (Photograph © Highland Council.)

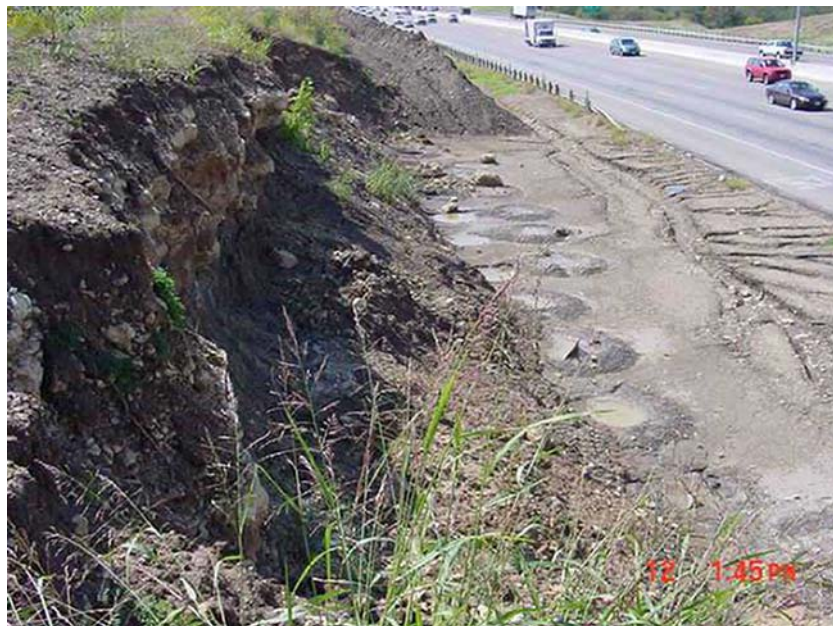
Interstate Highway 30 (IH30) runs between Dallas and Fort Worth and it was a portion of the cut slope adjacent to the east bound lanes of IH30 west of Oakland Boulevard that failed. The length of the failed slope area was approximately 150' (46m) and the original slope height reached 20' (6.1m) at a constant 1 in 3 (approximately 18°).

Figure 5.1 – The IH30 slope failure after excavation of the failed material. (Photograph © Texas Department of Transportation.)

The failed area was subsequently repaired by first removing the failed material as shown in Figure 5.1. (The pilot holes for an 'H'-beam wall can be seen in the base of the excavation. This was initially planned to be constructed but was abandoned in favour of the tyre bale option.) The excavation was taken back to around 35' (10.7m) from the original toe of the slope. This case study is developed further by Prikryl *et al.* (2005) and is also discussed by Winter (2005).

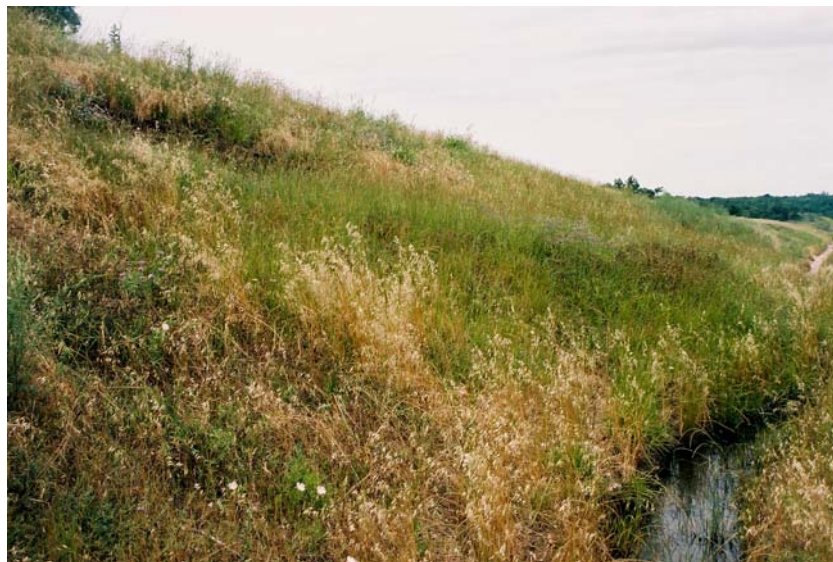
Figure 5.8 – Water drained to the front face of the slope by layers one and two of the tyre bales, May 2004.

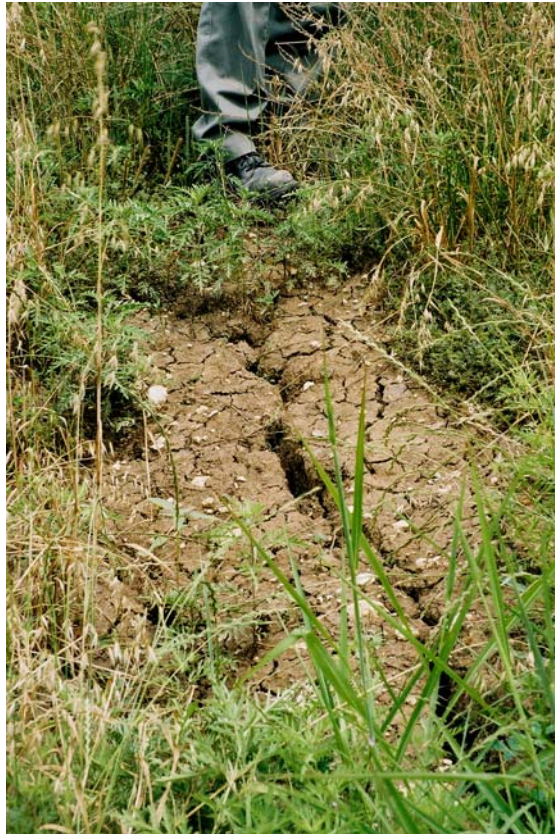
conventional fill derived from in-situ materials, was showing signs of distress. Cracks were discovered at the crest (Figure 5.9) and a small surface failure was observed on the upper part of the slope. The Texas Department of Transportation plans to continue observations of the slope and, if necessary, reconstruct the upper part of the slope using tyre bales in the same manner as the lower portion.

Figure 5.9 – Cracks at the crest of the slope in May 2004, demonstrating potential for further failure in the upper part of the slope which was backfilled with in-situ soil rather than tyre bales.

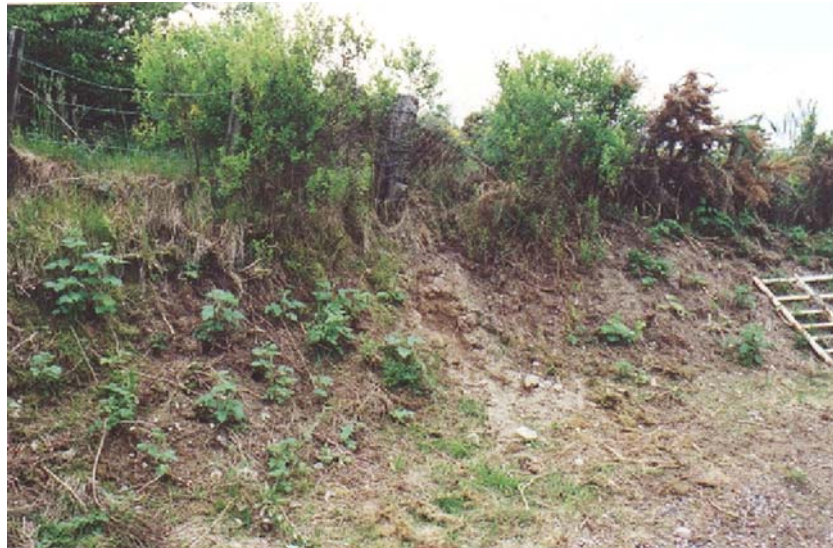
The slope had existed for many years without problems until water erosion became prevalent in 2002 (Figure 7.1). This coincided with the deposit of a large amount of material on the land upslope of the site as part of a railway repair, although a causal link has not been established.

Figure 7.1 – The effects of erosion on the slope. (Photograph © Northern Tyre Recycling.)

A construction solution involving the use of tyre bales to capture and drain the water away from the slope was devised (Figures 7.2 and 7.3).

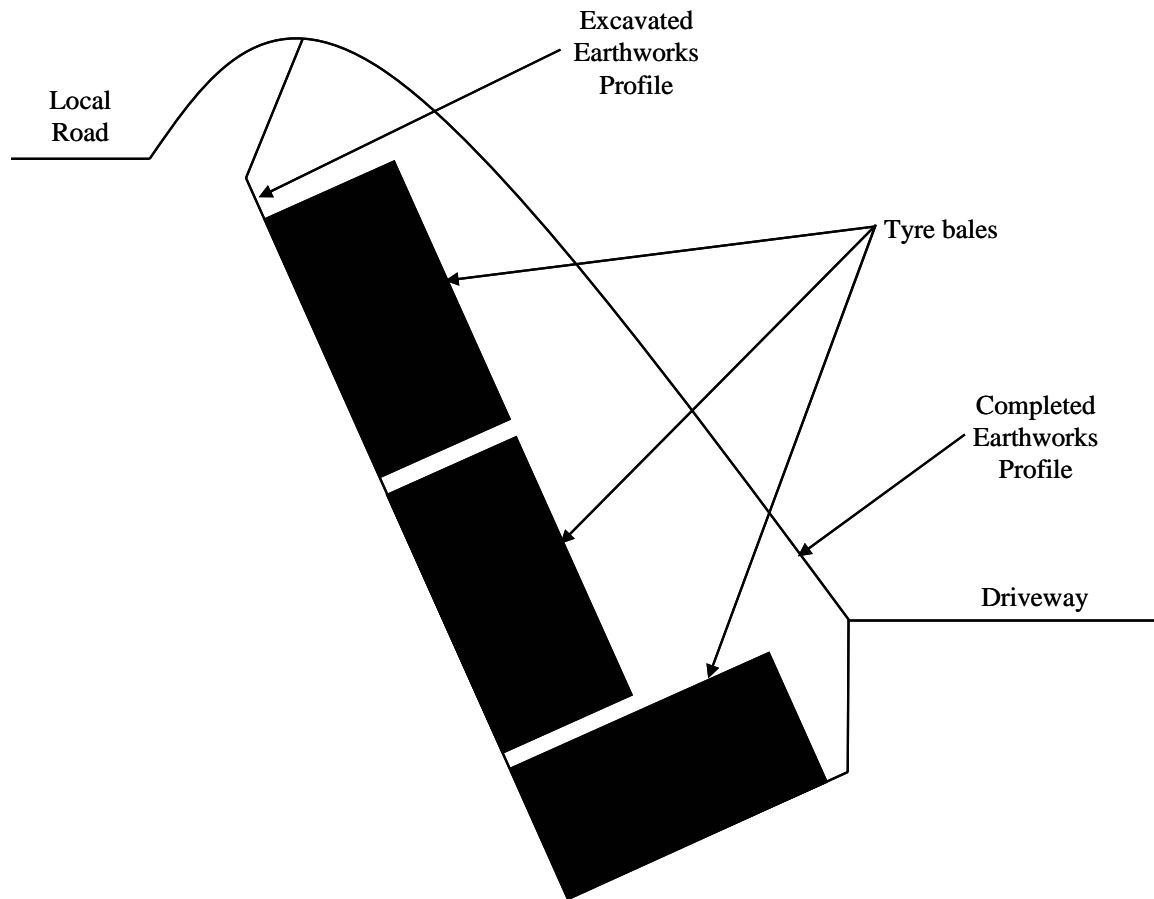
Figure 7.3 – Schematic of the slope repair (Not To Scale).

The slope face was excavated and tyre bales were placed in the void created. This allowed the water coming from both above and behind the slope to be captured in the bales voids and drained to tyre bales forming a drain between the base of the slope and the driveway. The drain was carefully profiled so as to allow flow out to the mains drainage. The completed slope is shown in Figure 7.4.

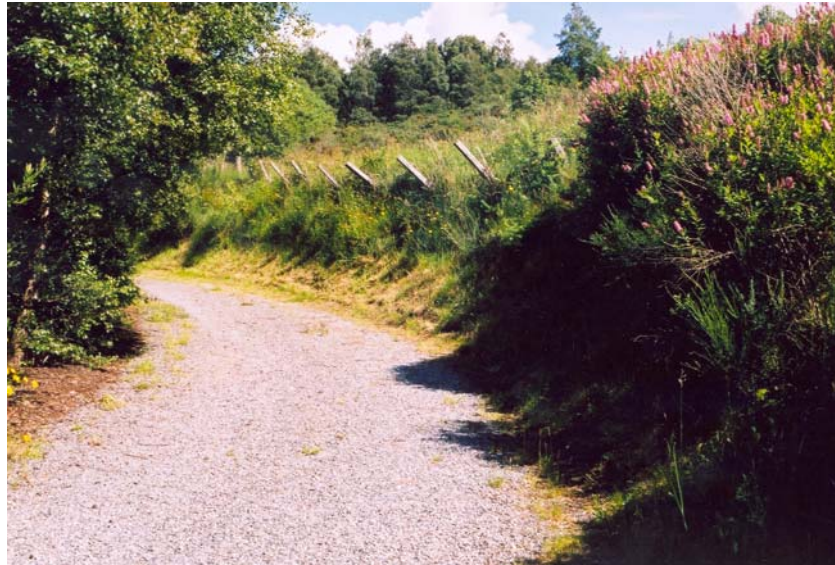
The slope has since shown no signs of further erosion or movement and as of June 2004 (some 2 years after construction) appears to be operating successfully (Figure 7.5).

Figure 7.5 – The completed slope in June 2004.
