PUBLISHED PROJECT REPORT PPR1033

Forensic Examination of Critical Special Geotechnical Measures: Soil Nails Information Note

M Duffy-Turner (Coffey Geotechnics Ltd), I M Nettleton (Coffey Geotechnics Ltd), M G Winter (Winter Associates Limited) and I Webber (Coffey Geotechnics Ltd)

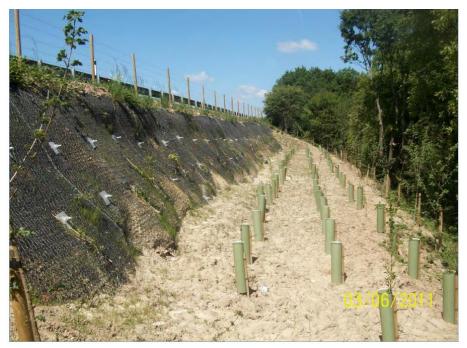
A problem with the ground conditions was encountered on the A21 at Lower Haysden where a failure of the soil nail slope occurred following construction (see Figure 1).

Figure 1: Failure of a soil nail slope after construction with bulging between the nails, A21 Lower Haysden (from Balfour Beatty Mott MacDonald, 2013)

The embankment fill had a higher sand content than at other locations on the A21 and as such the spacing of the nails was increased due to the higher soil shear strength. However, the final trimmed surface of the embankment was more irregular than at the other A21 sites due to

the more granular nature of the soil which meant the facing did not have intimate contact with the surface as required by the design and was unable to be adequately tensioned. Therefore slumping between the nails occurred as the face was unsupported and the cohesion in the soils was lower than had been assumed elsewhere (Balfour Beatty Mott MacDonald, 2013). A hard facing i.e. a steel mesh with separator and gabion style finish or sprayed concrete, would have been more appropriate for these ground conditions.

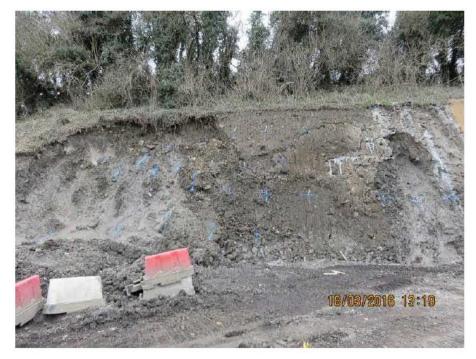
In some instances, soil nail slopes on the network have been over-excavated which has led to failure of the slope prior to the installation of the nails (Figure 2).

Figure 2: Failure of a full height slope excavation prior to installation of the soil nails, A1 Dishforth to Barton Improvement (from Carillion/Morgan Sindall JV, 2018)

This happened on the A1 Dishforth to Barton Improvement Scheme where full height, rather than benched excavation was undertaken due to run off issues from the upper slope (Carillion/Morgan Sindall JV, 2018). The installation of the nails was out of sequence with the excavation of the slope and the excavations were left unsupported (un-nailed/faced) for significant periods of time with one particular slope left only partially nailed and faced over the Christmas break which ultimately failed (Figure 3). The failures were characterised by a series of shallow slips and flow slides and along with the excavation issues identified above

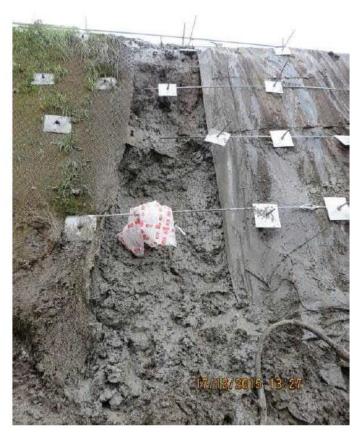
Figure 3: Failure of a slope which was left partially nailed and partially faced over an extended period, A1 Dishforth to Barton Improvement (from Carillion/Morgan Sindall JV, 2018)

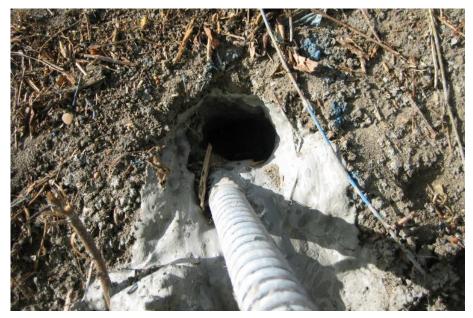
Figure 4: Self-drilled soil nail lying on the base of the borehole due to failure to use centralisers. This reduces the grout cover for corrosion protection and potentially reduces the bond strength (image the authors)

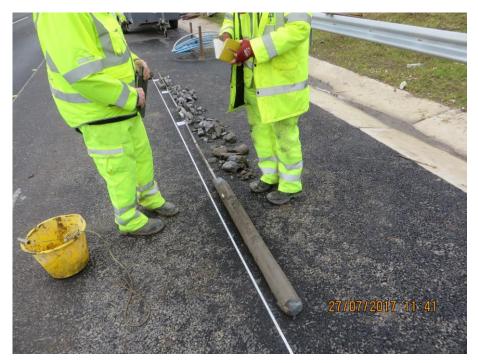
Another issue identified on the A1 Dishforth to Barton Scheme was that no tremie pipe was inserted to the back of the soil nail bore. It is not known if this was just on specific boreholes or if a tremie was not used on any of them; this may account for the lack of grout on the tendons when they were extracted.

Figure 5: Extraction of soil nail as part of the forensic investigation. The nail was pulled out of the slope with a load greater than required by the acceptance tests (image provided to Coffey by AECOM in 2017)

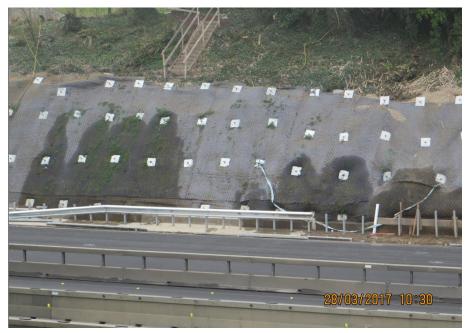
- Low volume water flow/seepage through the slope face, softening exposed materials (see Figure 6).
- Persistent seepage of groundwater through and over the upper slopes and discharging over the crest.
- Run off from the upper slope was not accounted for in the design.
- The unexpected presence of historic coarse stone drainage grips which channelled water into the slopes.
- Presence of a perched water table.
- Severing of original stone filled counterfort trenches.
- Incised ditches and channels present at the base of archaeological remains which channelled water into the slopes.

Figure 6: Seepages present on the cutting face at Cataractonium Cutting (image provided by National Highways)

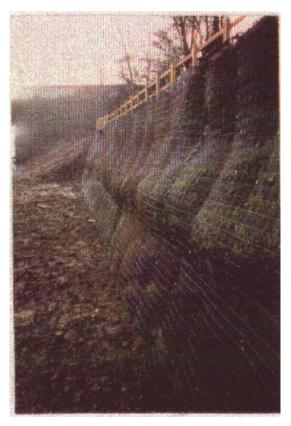
In 1995 on the M1 Widening Scheme at Junction 21/21a an 80m section of soil nailed slope became waterlogged causing the facing panels to bulge which ultimately led to failure of the panels over a length of approximately 30m (Figure 7). The facing comprised a 300mm thick cage with topsoil located between the front and back mesh. It had been assumed that the topsoil between the meshes would have sufficient stiffness to ensure a degree of composite action between back mesh, soil and front mesh. When the panels were removed it was evident that water was seeping from the cutting face above the top row of nails. This was concluded to have been from a high perched water table established after a high intensity rainfall event and led to saturation of the topsoil in the facing. Rather than transferring shear between the meshes as designed for, the topsoil acted as a dense fluid (which cannot carry or transfer shear), and the mesh which was clipped together as a series of panels was not capable of withstanding the significant deformations (GIBB, 1996). The failure at this location was related only to the facing panels; the soil nails and head plates were found to be intact during subsequent investigations.

Figure 7: Failure of facing panels on a soil nailed slope, M1 Rapid Widening Scheme (from GIBB, 1996)

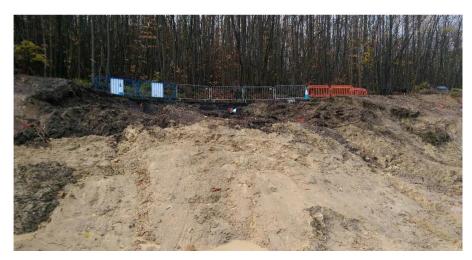
In 2016 on the A21 Tonbridge to Pembury Scheme a 20m section of a partially soil nailed slope at Castle Hill failed following a period of heavy rainfall (Figure 8). Following investigations, it was concluded that water was flowing down the access track into a manhole and then entering the slope via a BT duct along the crest. This led to softening and collapse of the slope.

Figure 8: Failure of a partially soil nailed slope during construction, A21 Tonbridge to Penbury (from WSP, 2019)

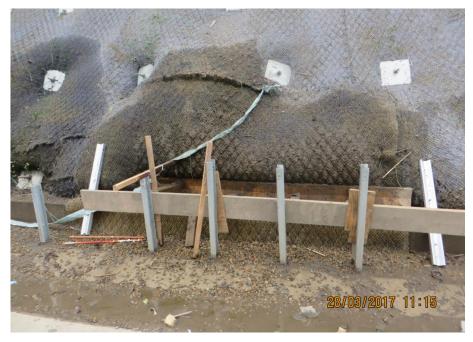
The failures seen on the A1 at Cataractonium Cutting (described in previous sections) also had problems with the installation of the facings with the three slopes (SNS1, SNS2 and SNS3) originally constructed using a Geobrugg Greenax steel wire mesh facing. The slopes were subject to slumping failures (Figure 9) and localised crest slope regression.

- Lack of tension in the mesh when applied to the slope.
- Lack of crest and toe facing-mesh tie-in for significant periods of time.
- Damage to the mesh at the toe of the slope.
- Nuts left loose and not fully engaged to tie the nail head and mesh together.

A discussion with the Geotechnical design lead who undertook the forensic investigation of the Cataractonium cutting failures (Roberts. P, personal communication, 25 February 2022), suggests that the flexible facing used on these slopes was unable to be adequately tensioned as per the manufacturer's specification, due to the presence of the soil nails already installed on the slope i.e. once the facing was draped over and the nail threaded through the mesh aperture: that is, it is not possible to adequately tension the mesh with the nail head in place. As the performance of the facing is dependent upon the facing system being in tension the selected facing type was possibly not appropriate; however, the sequencing of construction at the Cataractonium cutting was not as recommended by Phear et al (2005) and did not allow for the facing to be installed and tensioned incrementally (Figure 28) between subsequent rows of nails. Following the failures of the facing, the manufacturer Geobrugg were consulted regarding use of the Greenax steel wire mesh. At this time Geobrugg raised concerns that the

Greenax steel wire mesh would not be able to withstand the forces it was being put under and that normally it is only recommended for slopes with gradients up to between 40° and 45° (personal communication – email from S. O. Rourke to A. Scholefield, 11 April 2017, 15:56pm), where it is understood that cut slopes in the Cataractonium Cutting were cut to 55° (Carillion/Morgan Sindall JV, 2014).

Figure 9: Slumping of the soil nail slope (SNS2) causing deformation of the facing at Cataractonium Cutting (image provided by National Highways)

The original facing systems were condemned during the works and replaced by a 450mm thick stone-filled mattress facing system with double layer structural mesh backing for SNS1 and SNS2 and a PVC-coated steel wire mesh with incorporated 3D erosion control mat facing system for SNS3 (Carillion/Morgan Sindall JV, 2018).

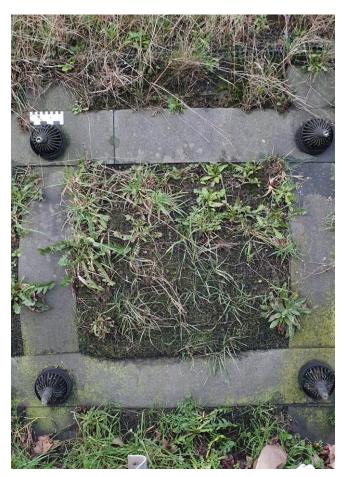
On the A42 to the northeast of Ashby-de-la-Zouch the slope adjacent to an emergency layby has been soil nailed and faced with concrete cloth straps/planks on a 1m grid and infilled with a black geogrid (Figure 10). This soil nail slope is believed to be around 30 years old which is one of the oldest on the SRN. The face was observed to be bulging with the concrete straps heavily bowed, especially the ones in vertical alignment. The geogrid located behind the concrete cloth straps was brittle and broke apart with light pressure suggesting this may be suffering from UV deterioration.

Figure 10: Facing of a soil nail slope comprising concrete cloth straps/planks with a small aperture black geogrid, A42 northeast of Ashby-de-la-Zouch (image the authors)

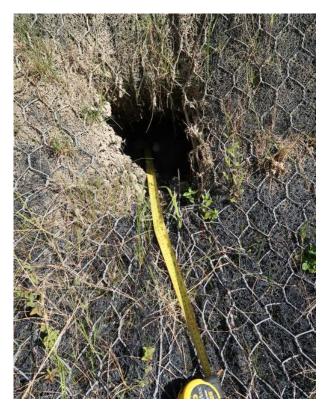
The nail head plate should be designed and specified in conjunction with the soil nails and slope facing to act as a complete soil nail system to adequately resist any driving forces and loads upon it. The nail head plate should be correctly sized to prevent bearing failure and to promote soil arching thereby reducing local instability in between soil nails (Phear et al., 2005). Inadequate design or construction can lead to punching failure of the facing (Figure 11).

Figure 11: Mesh soil nail slope facing where slope movement forces have caused punching failure of the soil nail mesh facing. After failure the face plate is approximately 600mm behind the facing (image the authors)

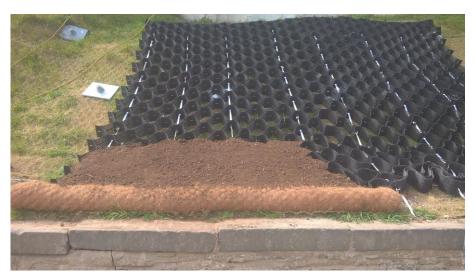
Figure 12: Geocell installed on a soil nailed slope and infilled with topsoil to prevent a trip and spike hazard in a publicly accessible area (image the authors)

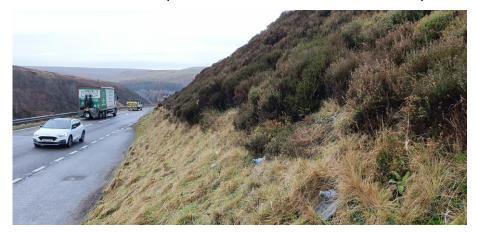
On a slope along the A628, the lower row of nails, immediately adjacent to the layby, presented trip and fall hazard. Vehicle impact with the protruding nail heads was also a possibility (see tyre tracks in Figure 13). Nails on the first row were uncapped (Figure 14), while some of the nails on the second row were capped (Figure 15). Historic Google Maps imagery showed that caps were present on the lower two rows and on the netting dowels

following construction in 2012, with the majority having been lost in the interim; presumably either intentionally (whether by the operator or vandalism) or possibly through weather-related issues (i.e. high winds). The head plates and locking nuts at this location were observed to be loose and both the plate and nut were able to be moved by hand.

Figure 13: Soil nails installed in cutting adjacent to layby on the A628 to the East of Manchester (image the authors)

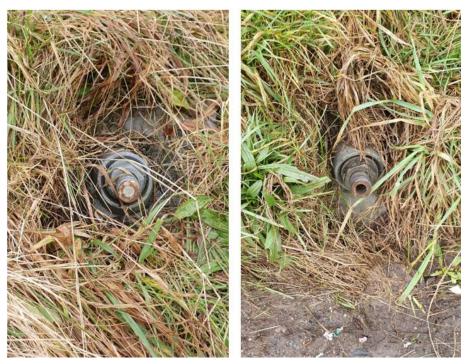
During the site investigations no soil nail tendons were exposed apart from at the nail head. The different sites all had nail heads which showed signs of corrosion where the bar had been cut and these were accompanied by varying degrees of grout loss from within the soil nail annulus, typically ranging from no/slight loss through to full loss (Figure 14).

Figure 14: Soil nail heads on the A628 east of Manchester showing varying amounts of grout loss from within the nail head (image the authors)

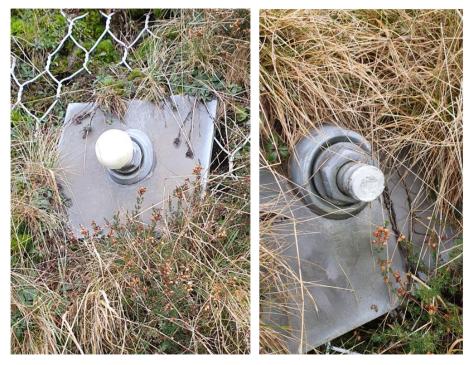
One site, the A628 east of Manchester (SGM ID 6312), had caps present on some of the soil nail heads (see Section 2.6). Where the cap was present, the nail beneath it appeared to have been covered by a galvanizing paint and in these instances no corrosion or grout loss was observed on the nail head.

Figure 15: Soil nail heads on the A628 east of Manchester with rare caps present. The image on the right shows the condition of the nail head beneath a cap indicating no corrosion or grout loss (image the authors)

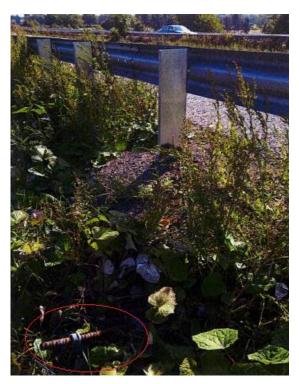
Following an inspection in 2011 of a soil nail embankment on the M23 Gatwick Spur Junction 9 to 9a, it was observed that one soil nail was missing, two were damaged (Figure 16) and a further one needed the head plate and nut to be tightened (Balfour Beaty Mott MacDonald, 2011). In addition to the damage to the soil nails, the galvanized mesh was disturbed around the damaged nails. Earlier in 2011 a scheme had been completed to install a safety barrier for the full length of the M23 Gatwick Spur. It is understood that a Geotechnical Report was not prepared for the safety barrier works as it was assumed by the consultant that it was not required based on the guidance in HD 22/08 Management Geotechnical Risk (HE, 2008). National Highways understood this to be a non-compliance and requested a Non-Conformance Report to be raised. Discussions with National Highways Area 4 team indicate that the installation of the safety barrier damaged the soil nails although nothing was reported at the time of the barrier installation.

Figure 16: Soil nail protruding from the face directly below a safety barrier post which was installed at a later date, M23 Gatwick Spur (from Balfour Beaty Mott MacDonald, 2011)

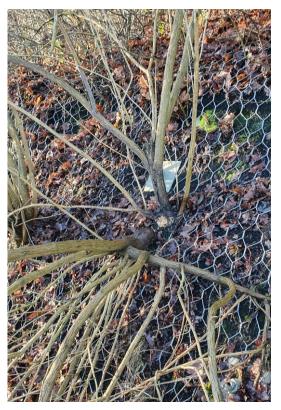
During the site inspections in 2022 the soil nail cutting at M6 Junction 10 (Northern carriageway) was observed to have vegetation growing out of the slope and causing damage to the mesh facing (Figure 17). Currently this is not causing too many concerns but as the trees grow this will put more stress upon the mesh and subsequently the head plates and nails.

Figure 17: Vegetation growing through the mesh on the soil nail slope at M6 Junction 10 (image the authors)

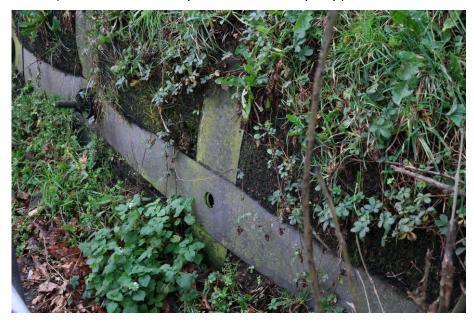
On the A42 to the northeast of Ashby-de-la-Zouch the soil nail slope inspected in 2022 was observed to have infrequent soil nails missing from the bottom row (Figure 18). There were no signs of the missing nails in the hole or any indication of what may have happened to them (there are no design or construction details relating to this slope, but it is assumed they were originally installed). All the other nails present on the slope appeared to be secure.

Figure 18: Missing soil nail from a slope adjacent to an emergency layby along the eastbound carriageway of the A42 (image the authors).

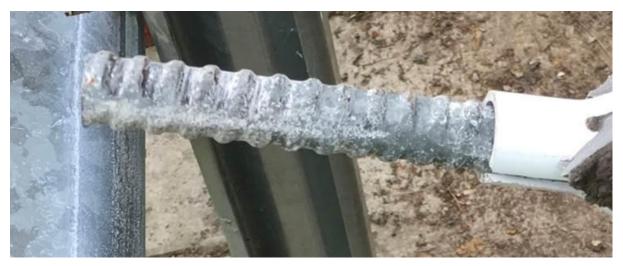
During the initial phase of the SGM project it was highlighted that there may be an issue between the nail/grout interface relating to the presence of calcium zincate forming. This issue was brought to the forefront following loss of bond between the grout and the nail at the Cataractonium Cutting and the development of a white substance on the tendon which was observed following an extraction test during the works. The tendon was later sent to Newcastle University where it was subject to testing as part of a Masters dissertation project (Otchere, 2018) using X-ray powder diffraction (XRD) (Roberts. P, personal communication, 25 February 2022). Otchere (2018) identified that the calcium hydroxy zincate was found on all the samples of bar tested and this was the anticipated corrosion product formed during the initial reaction between the hydroxides in the cement grout and the zinc passivation layer with a by-product of hydrogen gas released during this process.

Also identified by the XRD on all the samples was the presence of calcium carbonate which was determined to be the source of the white stains on the bar.

Figure 19: Presence of white substance on the soil nail tendon following pull out of the soil nail at the Cataractonium Cutting (image provided by AECOM).
