A study of front-mounted bicycle racks on buses

**Prepared for Charging and Local Transport Division,
Department for Transport**

G J L Lawrence and N M Brook-Carter

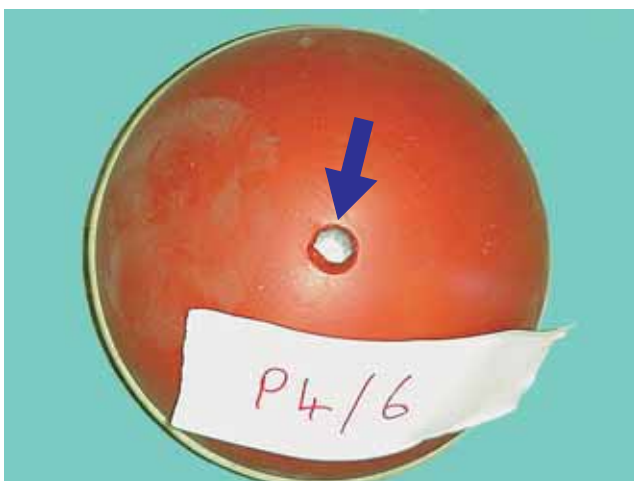
The authors have noted that the part of the handlebar grip that covers the end of the handlebar tube is frequently damaged in use, leaving the end of the tube relatively unprotected. The small cross-sectional area of a tube such as this would be very likely to cause penetration injuries when striking a pedestrian. For a head to handlebar impact, even if the impact speed is so low that it does not cause a skull fracture, the handlebar end is still likely to cause serious injuries to the flesh if the handlebar grip fails to protect the end of the tube. This is because the area of the end of the handlebar tube is only about 1 cm² and the inertia of the mass of the bicycle means that the contact force will be high. The handlebar grips on the new bicycles tested successfully protected the end of the handlebar tube in the headform tests. However, it is very likely that damaged or less tough handlebar grips might fail in real life. The end of a tube, forming part of the bike rack, was tested with the child headform. This tube was very similar in presentation and dimensions to a handlebar end and was fitted with a tough plastic plug, which failed during the headform test. The consequences of this failure can be seen in Figure 10.1.1. It is anticipated that similar flesh injuries to a pedestrian would often occur in real life if the metal tube of the handlebar end makes contact with the head, even in low speed impacts.

Figure 10.1.1 Headform impactor flesh damage from impact to the end of a tube forming part of the bike rack due to failure of plastic plug

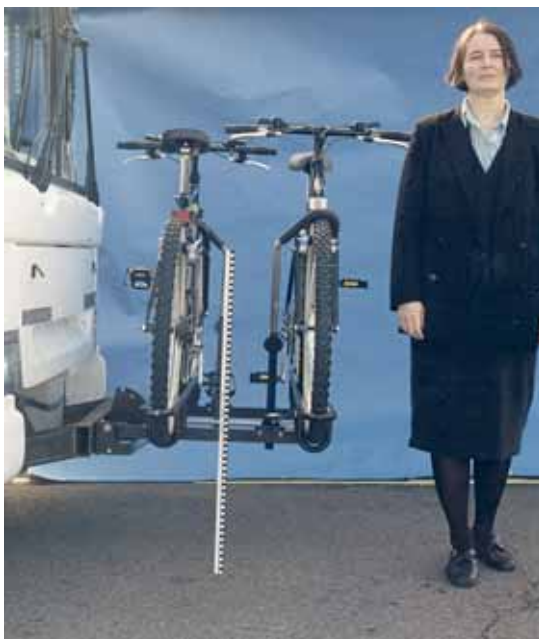
Plate A.6 Female pedestrian alongside the handlebar of the outermost bicycle.

(N.B. When the bus was in motion, the bicycles tended to sway, sometimes bringing the innermost handlebar closer to the bus windscreen).
