PUBLISHED PROJECT REPORT PPR730

Off Street Trials of a Bus Stop Bypass

Appendices

Prepared for: Transport for London
Project Ref: 11112436 WS9 Bus Stop Bypass Appendices

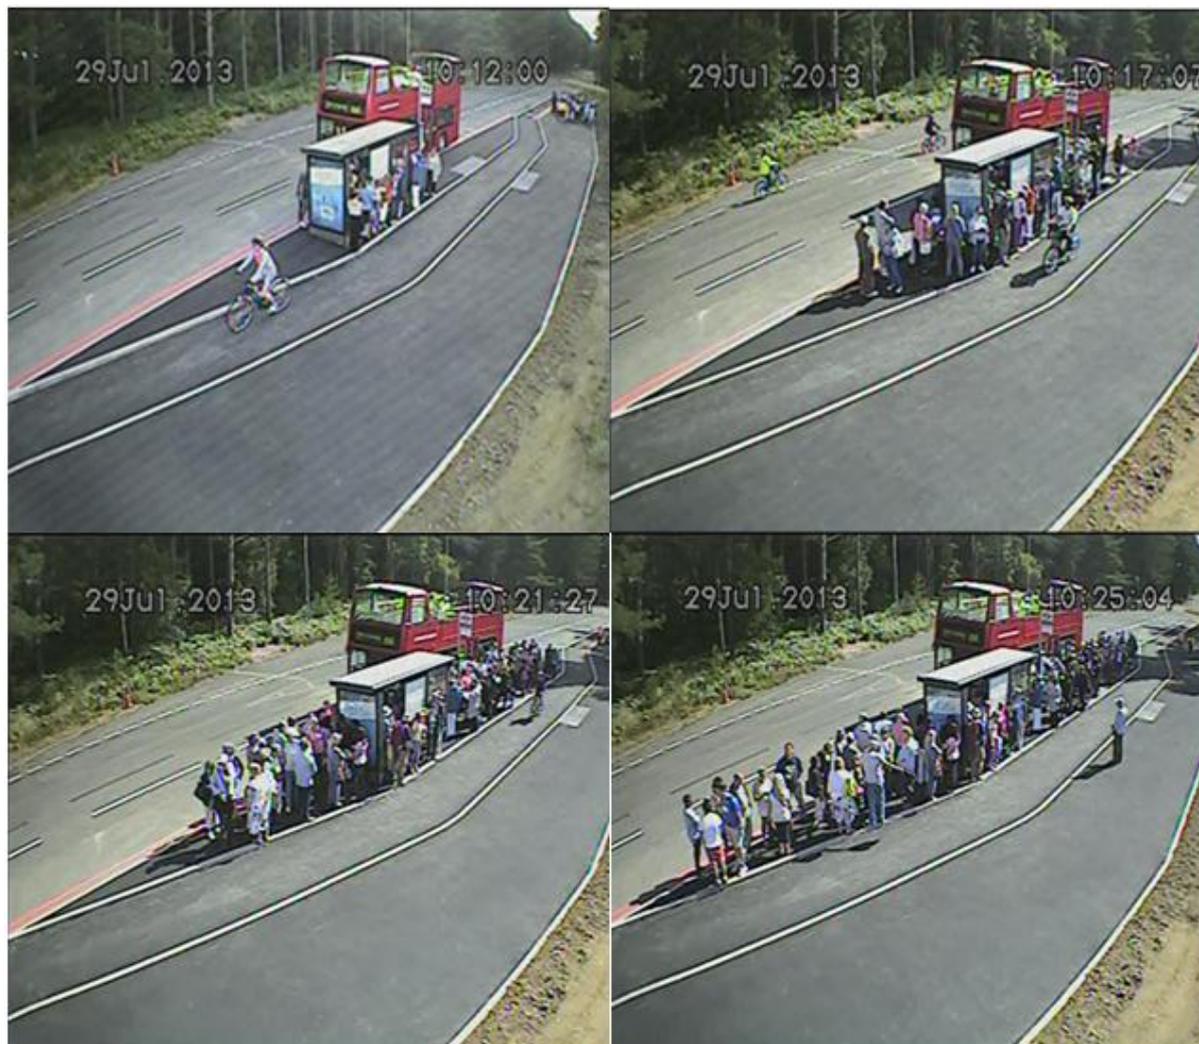
An example of the number of pedestrians using the bus stop island is illustrated in Figure 25

Figure 25 Bus Stop Island with 25, 50, 75 and 97 pedestrians
