# **The evaluation of tests for repair materials used on concrete pavements**

**Prepared for Quality Services (Civil Engineering) Division,  
Highways Agency**

J W E Chandler (TRL) and G C Mays (Cranfield University) – RMCS)

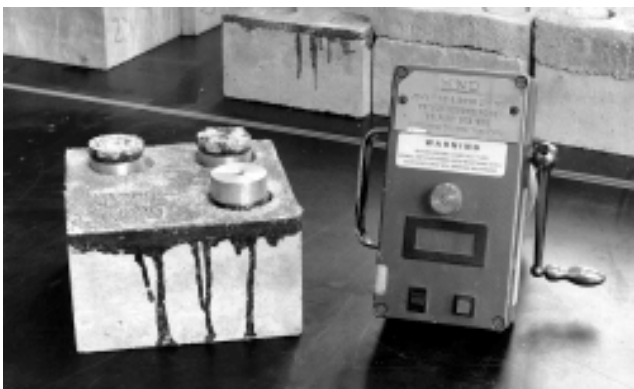
**Figure 2** Pull-off test

- With the composite specimen securely clamped, a core was drilled through the repair material and into the substrate concrete for 5 - 10mm. A pillar drill was used with a 50mm diameter coring bit.
- The coring bit was lubricated with water during the drilling process. The surface of the specimen was wiped clean prior to bonding the dolly.

- The surface of the aluminium dolly was grit blasted and degreased with acetone. Care was taken to ensure that the surfaces of the repair material and dolly were not contaminated by handling prior to bonding.
- The epoxy resin adhesive was mixed and an even layer applied to the surface of the repair material and the four dollies bonded in place. Care was taken to ensure that the cored groove was cleared of any excess adhesive.
- The adhesive was allowed to cure for 24 hours, where the time of testing permitted, at 20°C.
- The pull-off test was performed as per the manufacturer's instructions, the equipment used is shown in Figure 2.
- The pull-off load was recorded and the mode and location of the failure plane was noted.

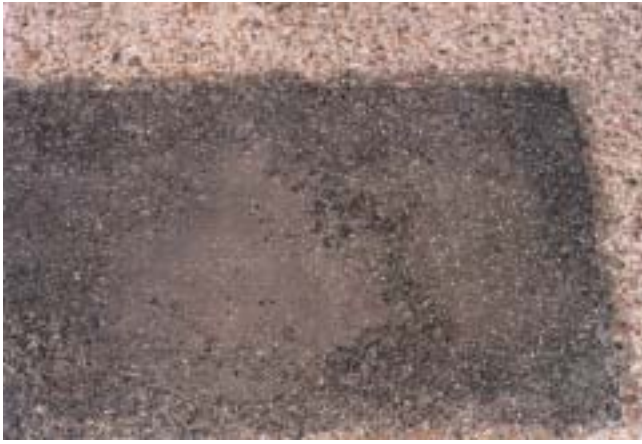
**Plate 1** Rapid hardening modified cementitious (M11)

Rapid hardening Showed no signs of deterioration which is consistent with its top ranking in the laboratory trials. However, it had a coarse surface texture, Plate 1 (see page 36), which is consistent with the relatively short workable life referred to above.

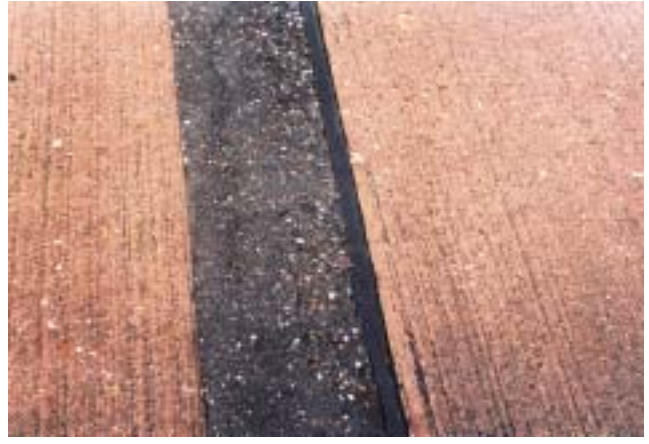
**Plate 4** Magnesium phosphate (A5)

**Magnesium phosphate** The contractor experienced some difficulty in placing and finishing the magnesium phosphate material in full lane width arris repairs before the product started to harden. One repair had to be replaced immediately after placing and the remaining arris repairs showed some evidence of surface aggregate loss on the later placed material (see Plate 4). Plate 5 shows a surface patch repair, of area approximately

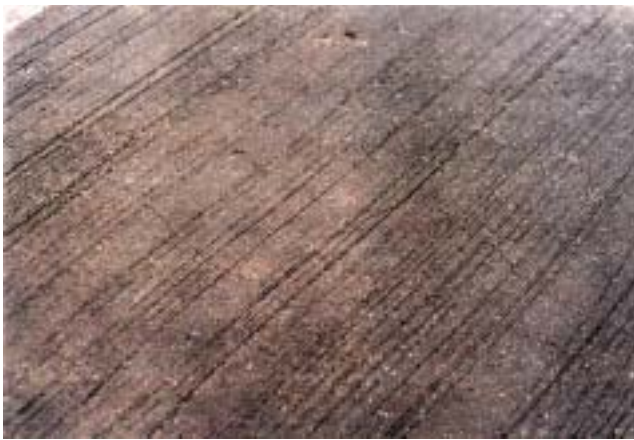
**Plate 2** Acrylic mortar (M11)

Acrylic Suffered fine map cracking at approximately 150mm centres in those patches located under the nearside wheel tracks as shown in Plate 2 (see page 36). Patches under the offside wheel track and between the wheel tracks had performed well. This material was ranked fifth overall in the laboratory tests, the movement relative to substrate concrete results being particularly poor and perhaps a pointer to the observed cracking.

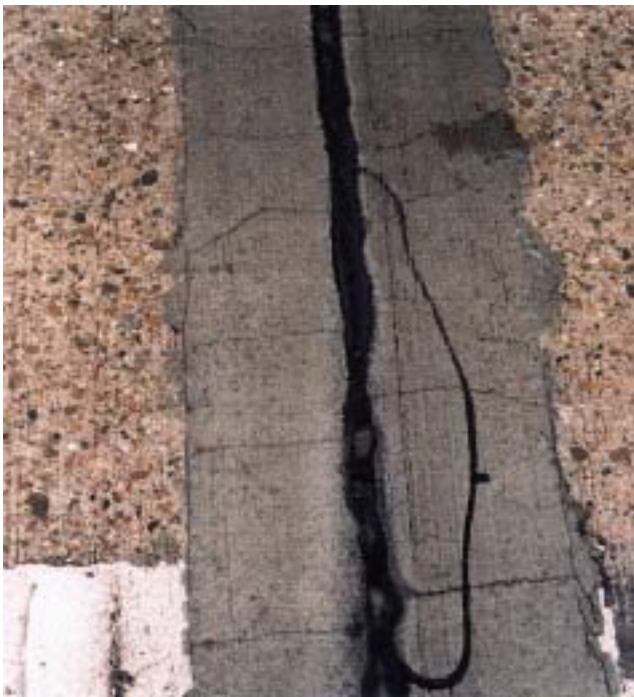
**Plate 3** SBR mortar (M11)

SBR All of the arris repairs had fine longitudinal cracks at spacings varying between 100mm and 200mm, accompanied by debonding from the substrate concrete as shown in Plate 3 (see page 36). The failure to reach the acceptance criteria in the thermal cycling test may be a pointer to its performance in service.

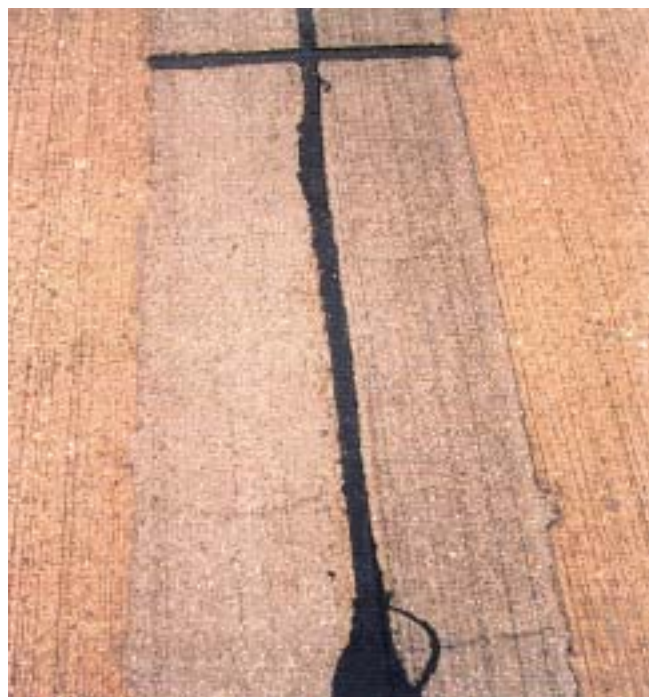
**Plate 6** High alumina cement (A5)

All of the arris repairs with this material had fine longitudinal cracks at spacings varying between 100mm and 400mm as shown in Plate 6. This performance was consistent with the poor performance of this material in all but the compressive modulus and time to opening tests.

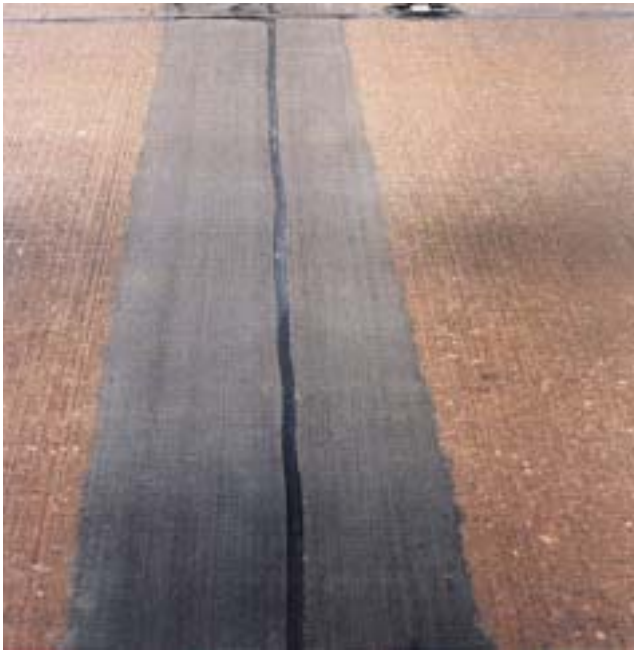
**Plate 7** Microsilica concrete (A5)

The microsilica concrete showed no signs of deterioration other than an occasional fine longitudinal crack. The material appears to be capable of achieving good quality repairs as shown in Plate 7 (see page 37). The performance is consistent with the results of the laboratory tests, the one anomaly being the low score achieved on account of its relatively high static compressive modulus.

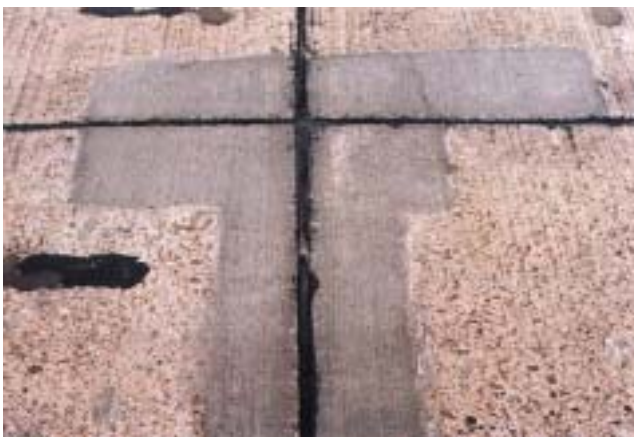
**Plate 8** Air entrained concrete (M11)

Air entrained concrete Showed few signs of deterioration other than where there were associated structural problems as shown in Plate 8. The performance is consistent with the results of the laboratory tests, the two anomalies being the low scores achieved for compressive modulus and tensile strength.
