# **Impact of road humps on vehicles and their occupants**

**Prepared for Charging and Local Transport Division,  
Department for Transport**

J Kennedy, C Oakley, S Sumon, I Parry (TRL Limited)  
and E Wilkinson, J Brown (Millbrook Proving Ground Ltd)

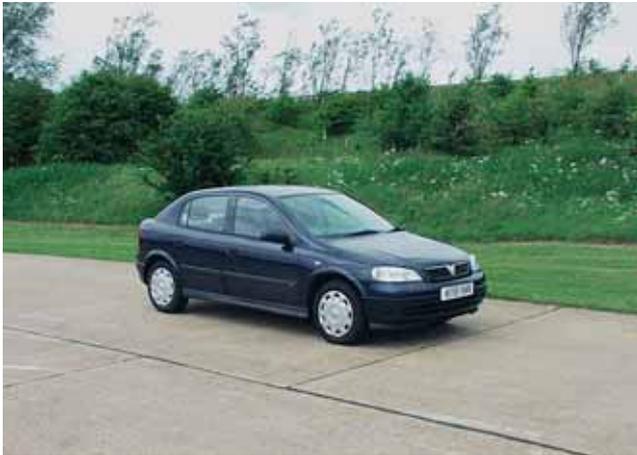
**Figure 1** Medium-sized car (Vauxhall Astra)

Five different vehicles were tested, as shown in Figures 1 to 5, a medium sized car (Vauxhall Astra), a London taxi (LTI TX1), an ambulance, a single deck bus and a minibus. Their characteristics are summarised in Table 1.

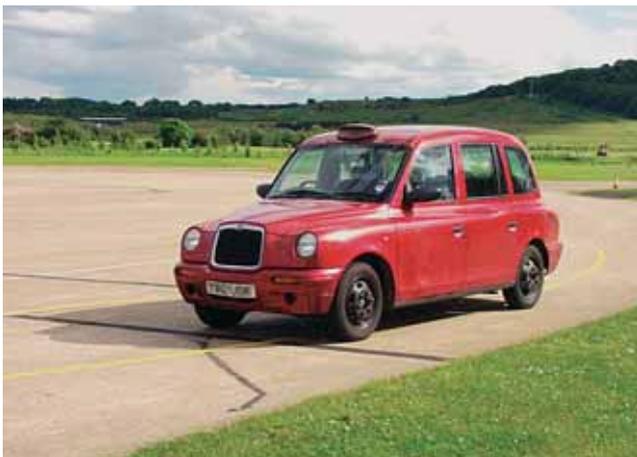
**Figure 2** London taxi

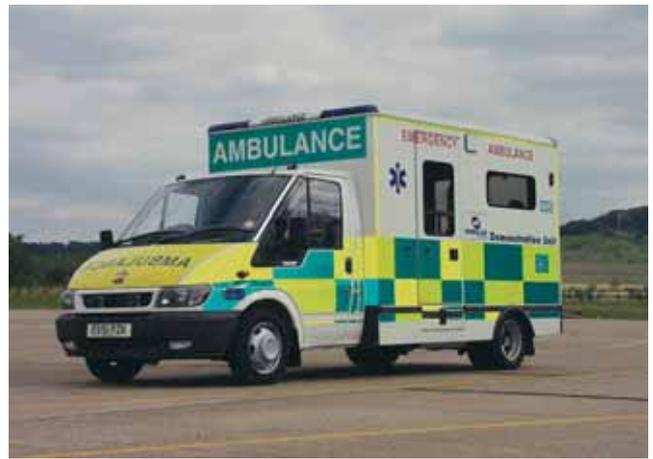
**Figure 3** Ambulance

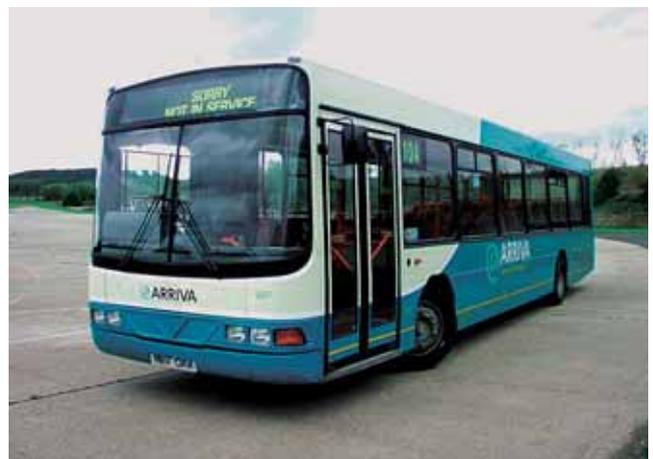
**Figure 4** Single deck bus

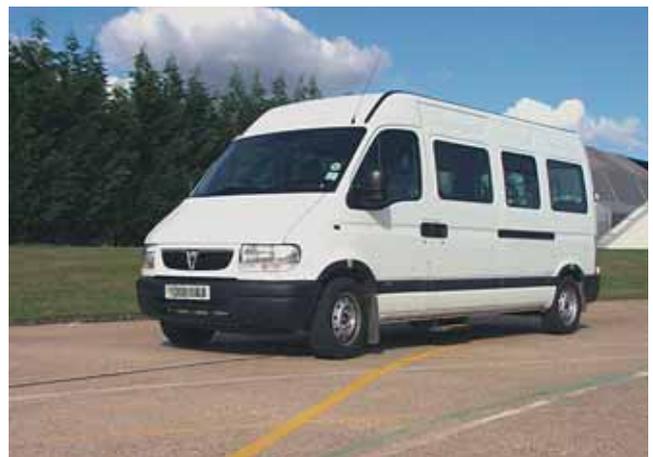
**Figure 5** Minibus

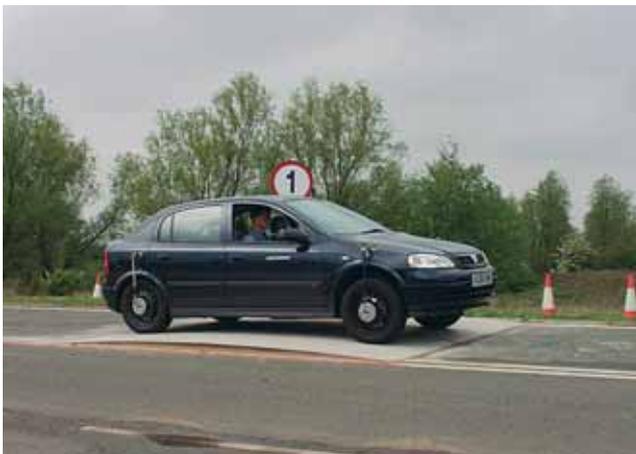
**Figure 6 Round-top hump**

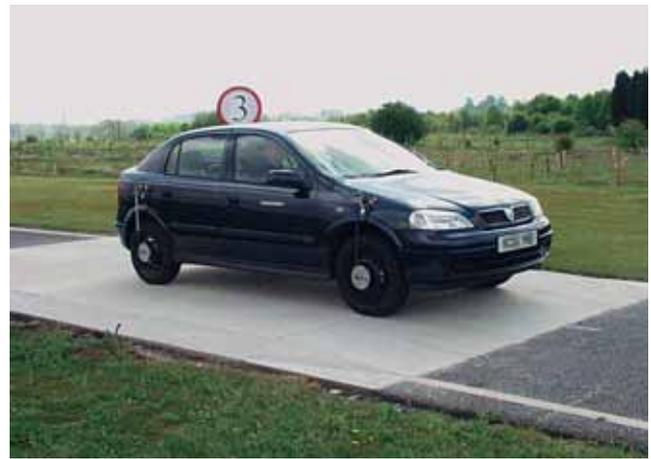
**Figure 7 Flat-top (platform) hump**

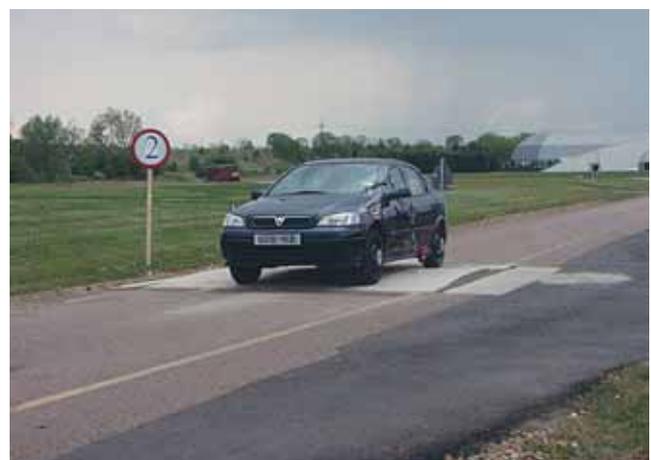
**Figure 8 Sinusoidal hump**

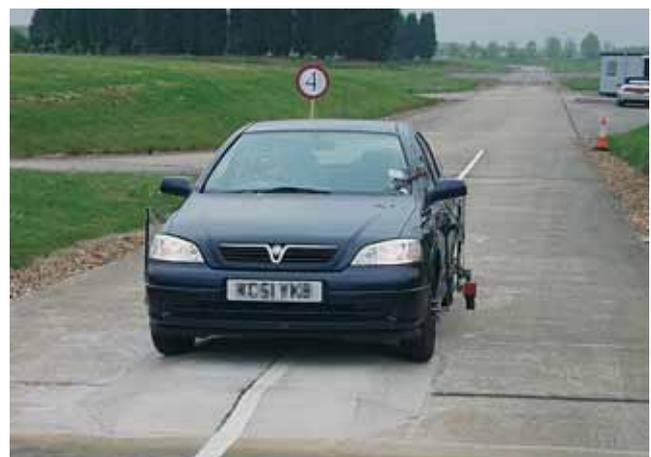
**Figure 9 Speed cushion**

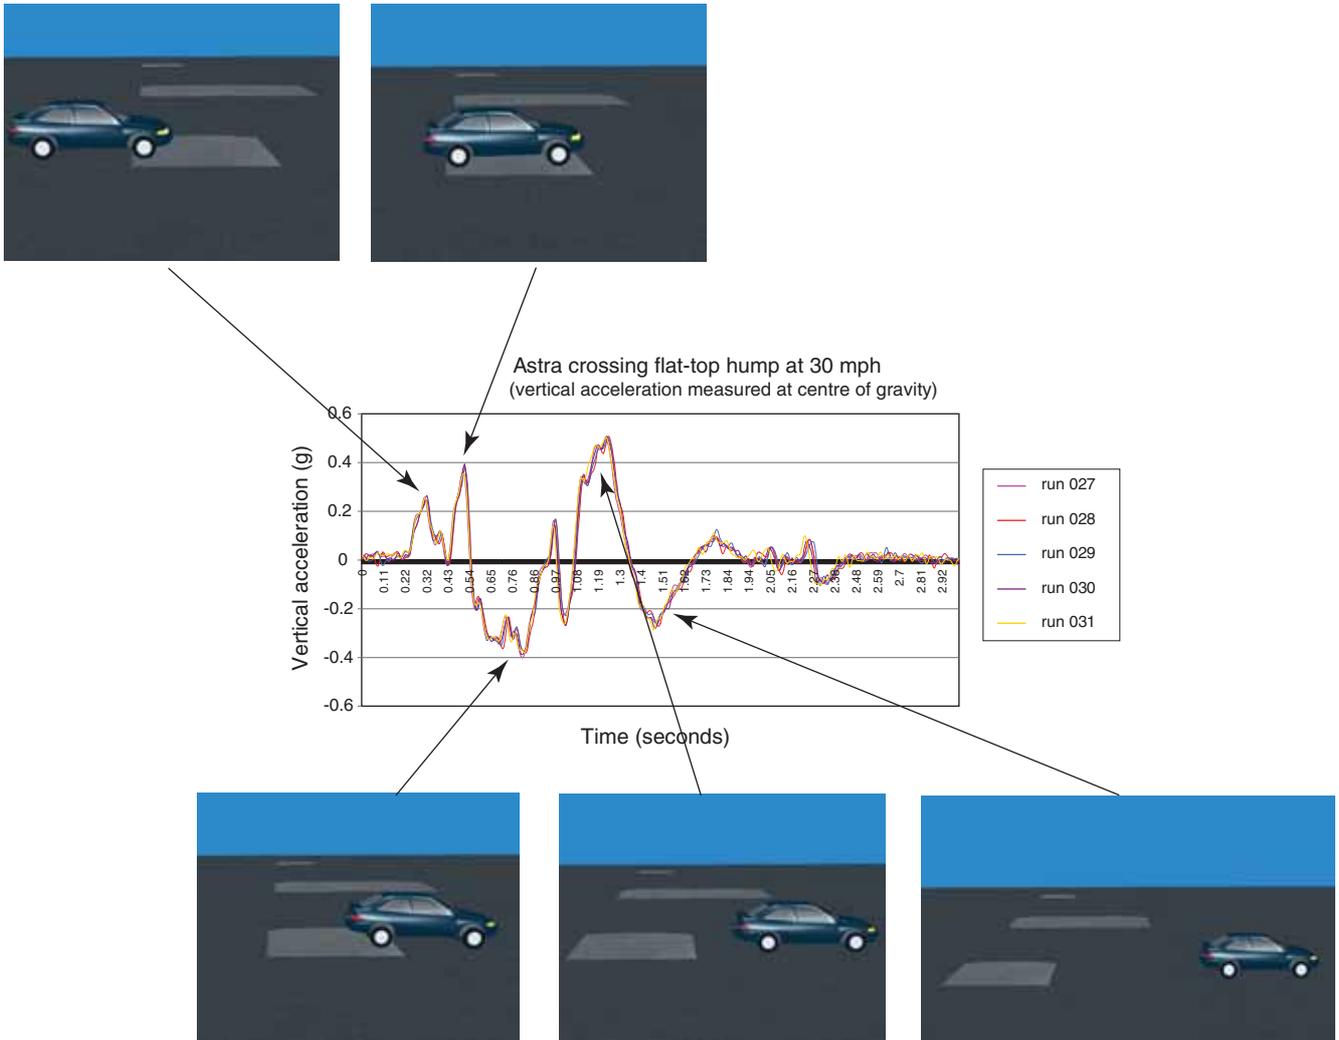
**Figure 10** Traces produced at centre of gravity of car passing over the flat top hump

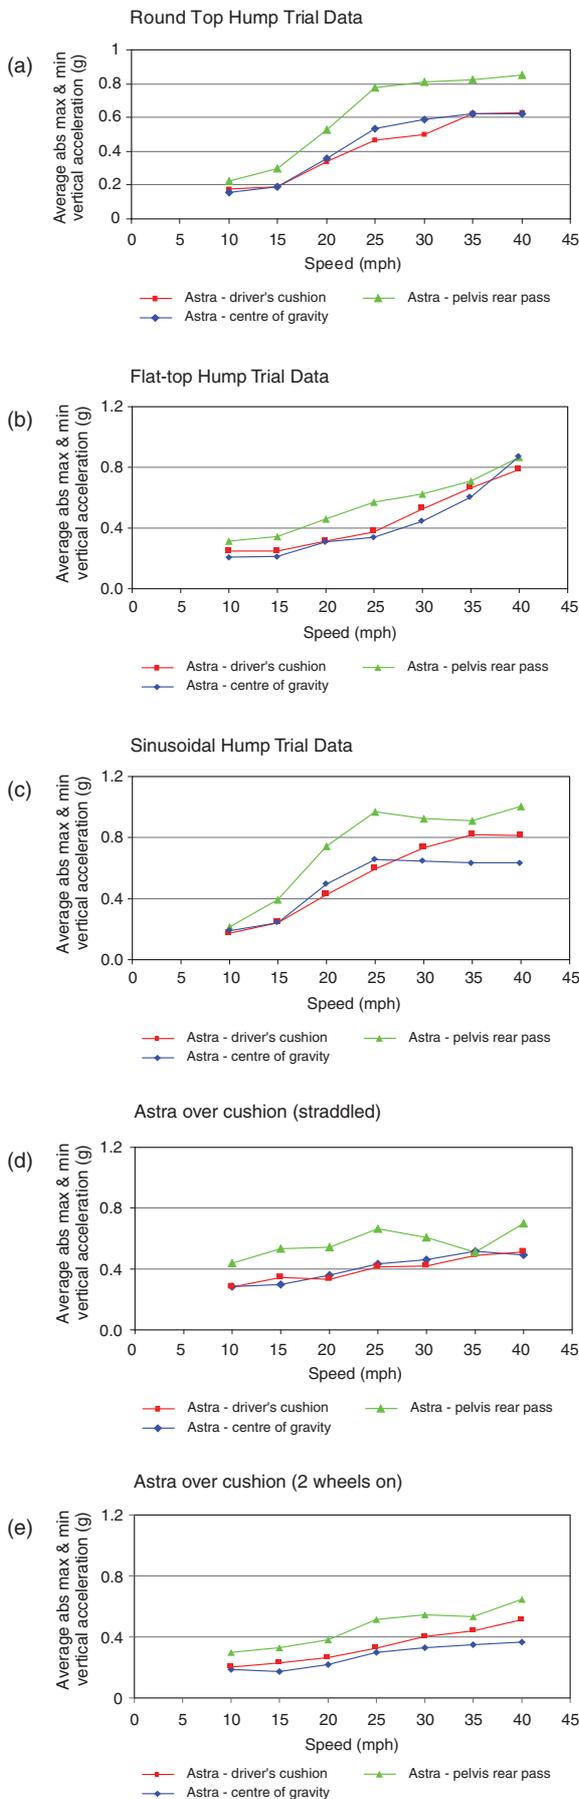
**Figure 11** Average of absolute values of maximum and minimum acceleration against speed for the car

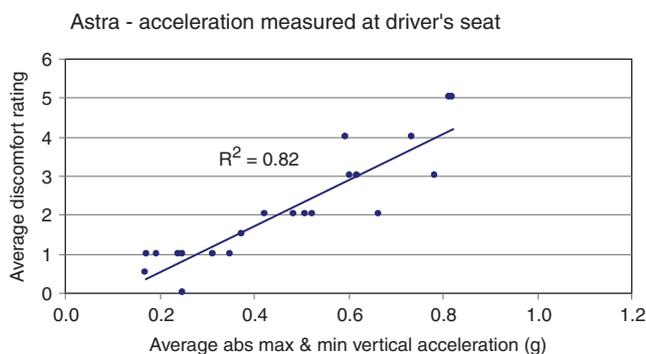
**Figure 12** Average discomfort rating for car driver and passenger plotted against average of absolute values of maximum and minimum acceleration

- Reported discomfort ratings were found to be strongly correlated with measured peak vertical accelerations. These subjective ratings were based on one driver and one or more passengers. Although this is clearly too small a sample to provide robust results, their correlation with the accelerations suggests they are indicative of the likely effects on vehicle occupants.

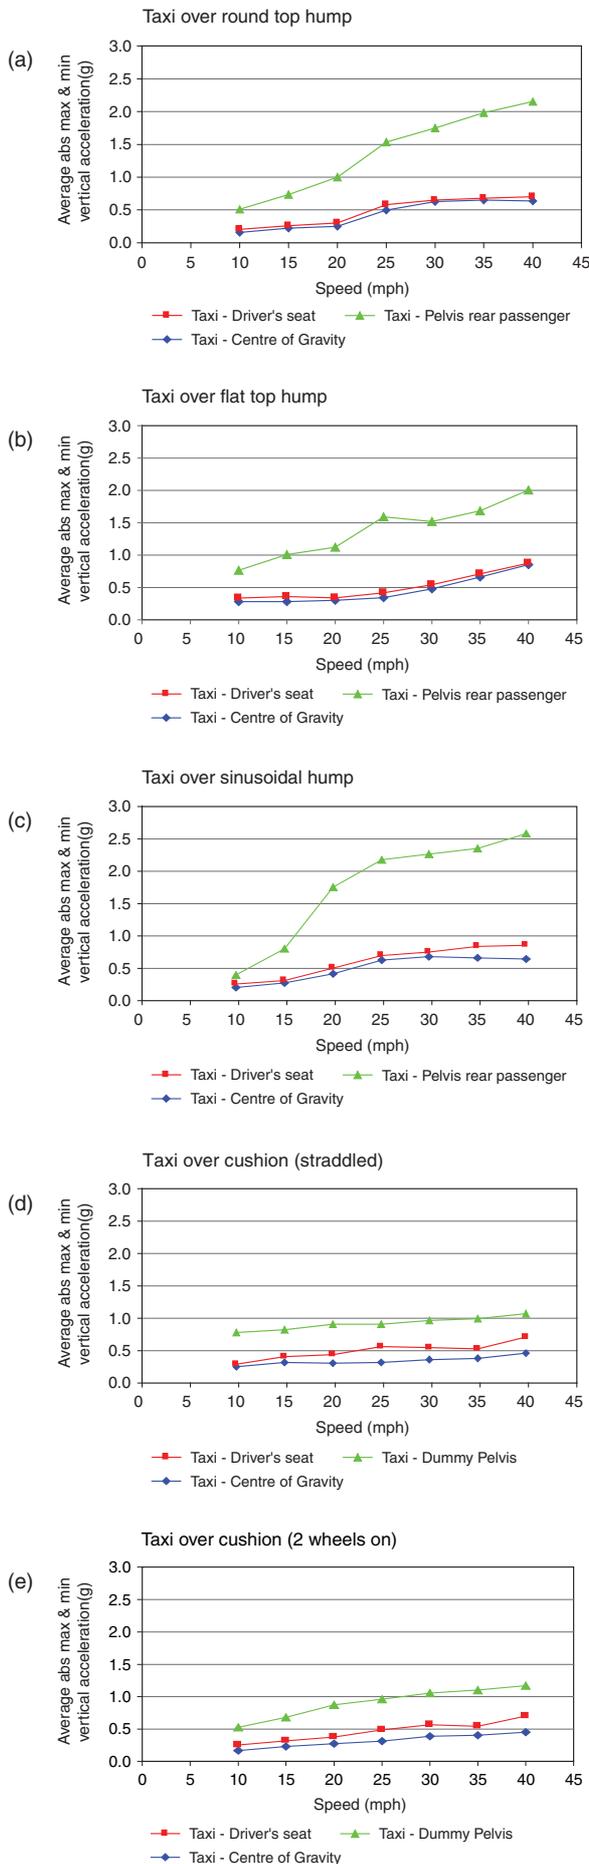
**Figure 13** Average of absolute values of maximum and minimum acceleration against speed for the taxi

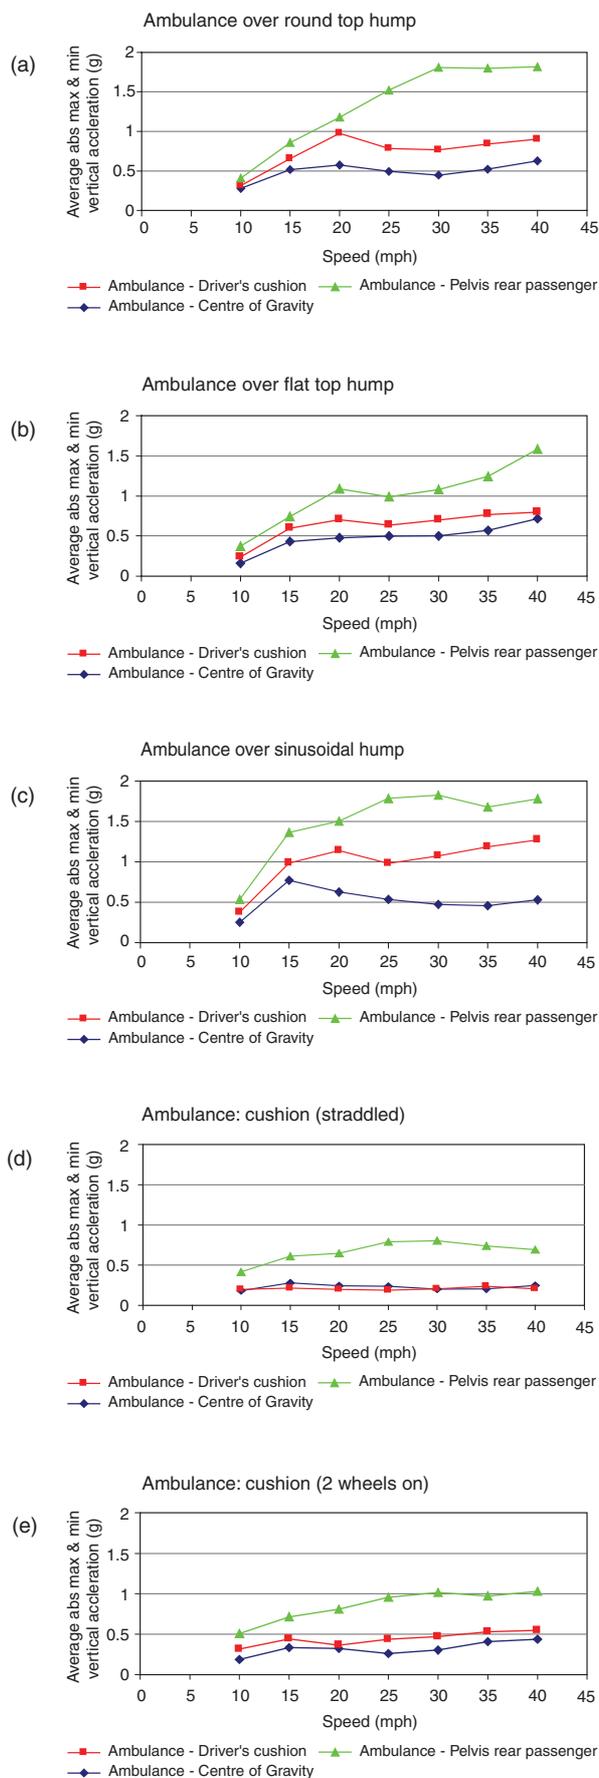
**Figure 14** Average of absolute values of maximum and minimum acceleration against speed for the ambulance

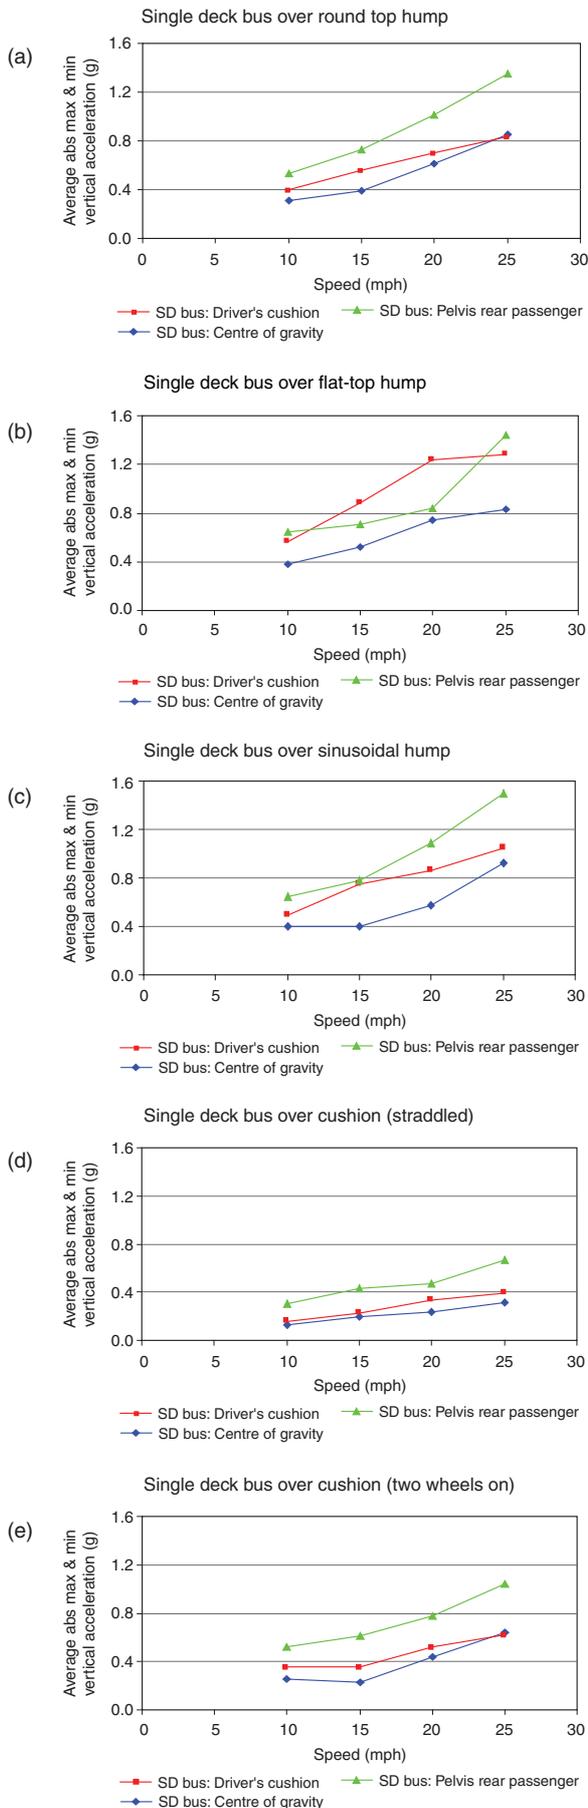
**Figure 15** Average of absolute values of maximum and minimum acceleration against speed for the single deck bus

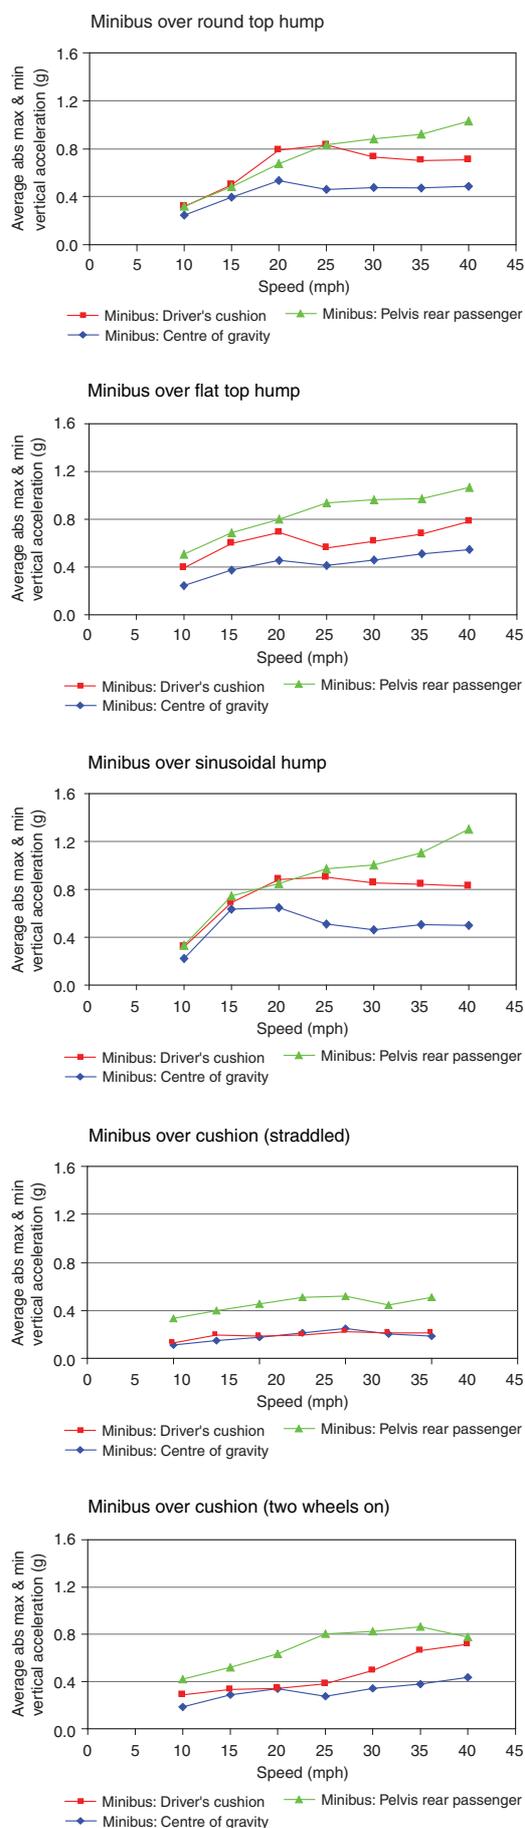
**Figure 16** Average of absolute values of maximum and minimum acceleration against speed for the minibus

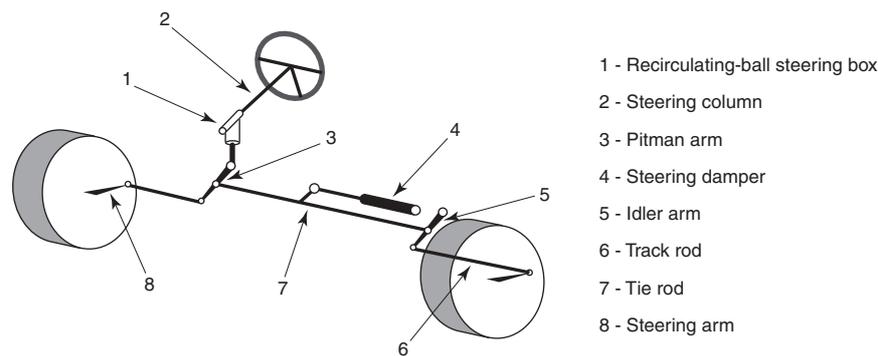
Figure 17 Steering assembly on taxi

The testing of the effect of repeated driving over the speed cushion was undertaken on a test rig in the laboratory. The maximum forces generated in the tie rod from straddling the cushion were replicated using servo-hydraulic actuators at the same rate of application. The simulation tests were equivalent to 3000 passes over the cushion. Suspension geometry checks were undertaken after every 600 passes, without re-setting the toe. The changes in front axle toe during these tests are shown in Figure 18. The toe

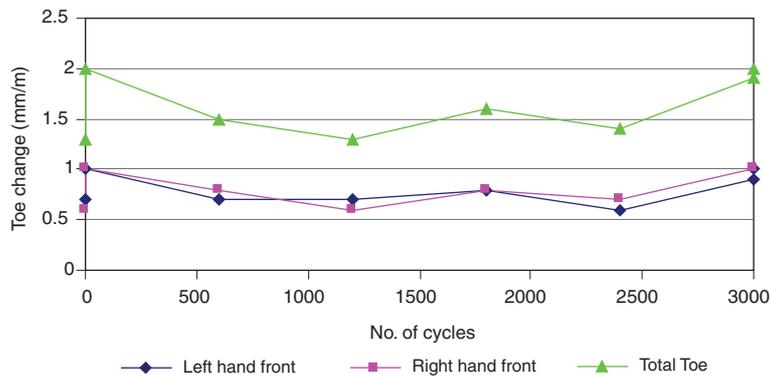
**Figure 18** Toe change (mm/m) on taxi during hydraulic rig simulation

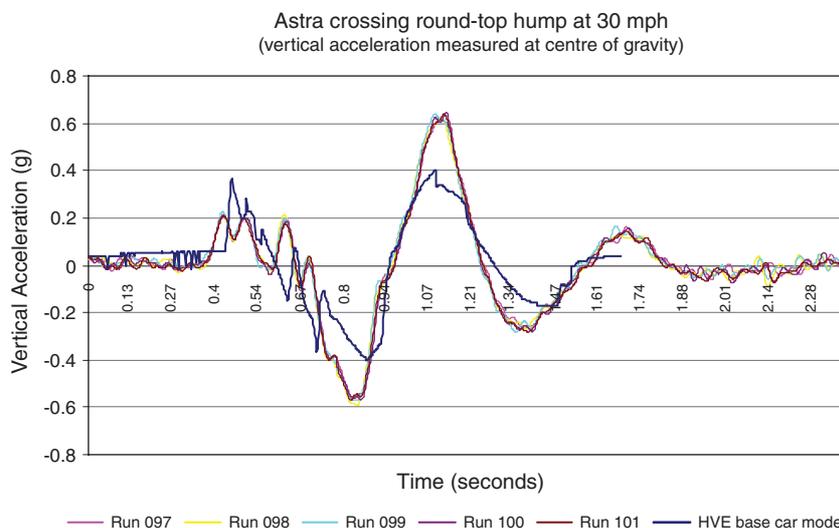
**Figure 19** Comparison of physical and initial simulation test results for the CoG vertical acceleration of the car

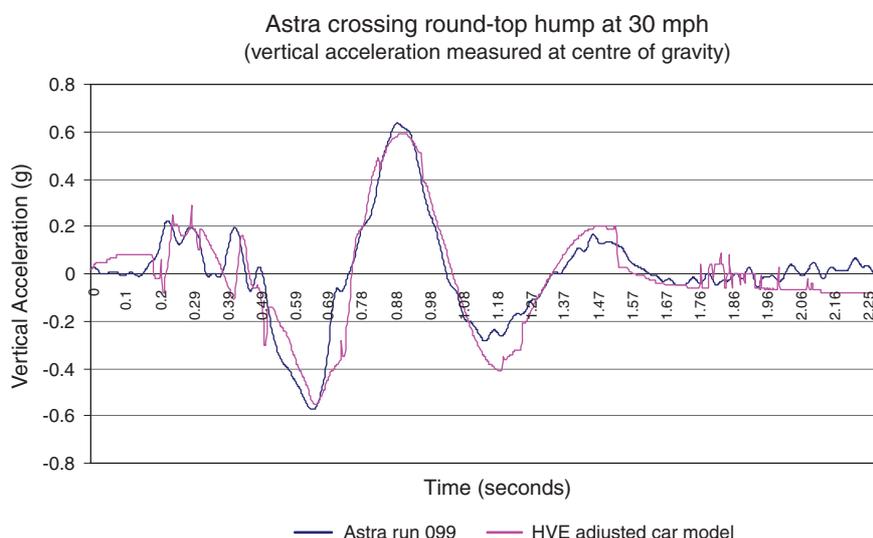
**Figure 20** Comparison of physical and 'best fit' simulation test results for the CoG vertical acceleration of the car

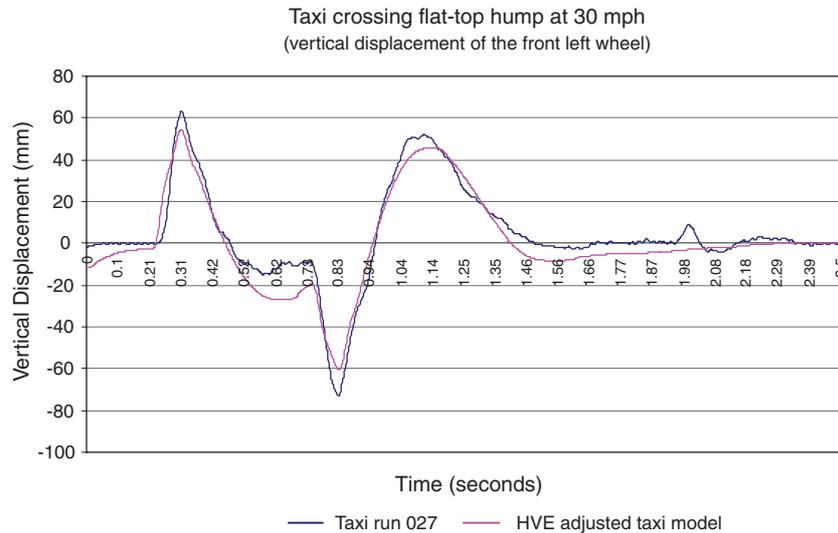
**Figure 21** Comparison of physical and ‘best fit’ simulation test data for the vertical displacement of front left wheel of the taxi

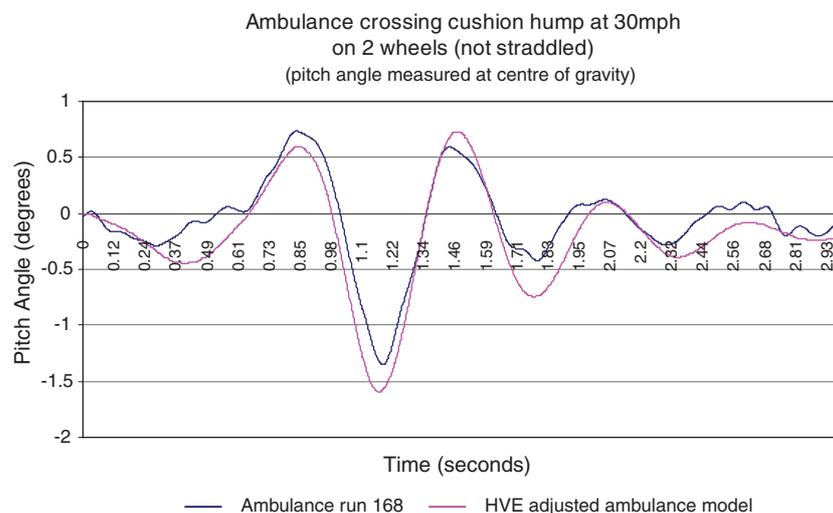
**Figure 22** Comparison of physical and ‘best fit’ simulation test data for the pitch angle of the ambulance

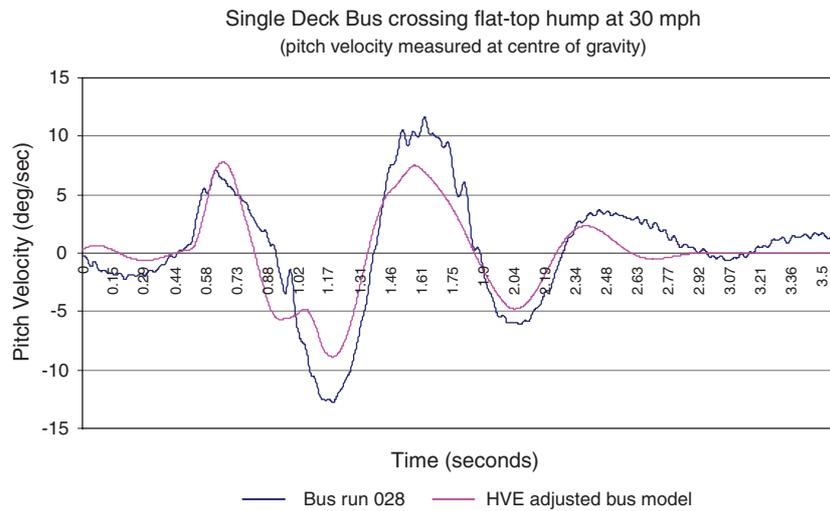
**Figure 23** Comparison of physical with ‘best fit’ simulation and test data for the pitch velocity of the single deck bus

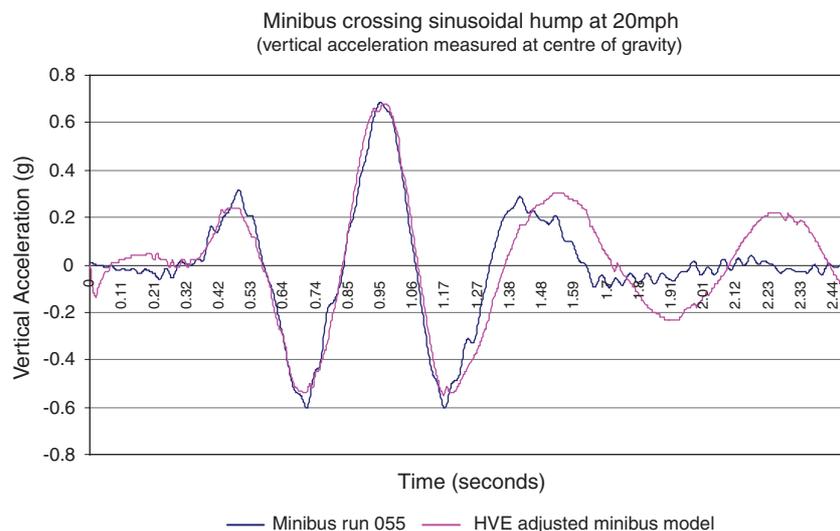
**Figure 24** Comparison of physical and ‘best fit’ simulation test data for the CoG vertical acceleration of the minibus

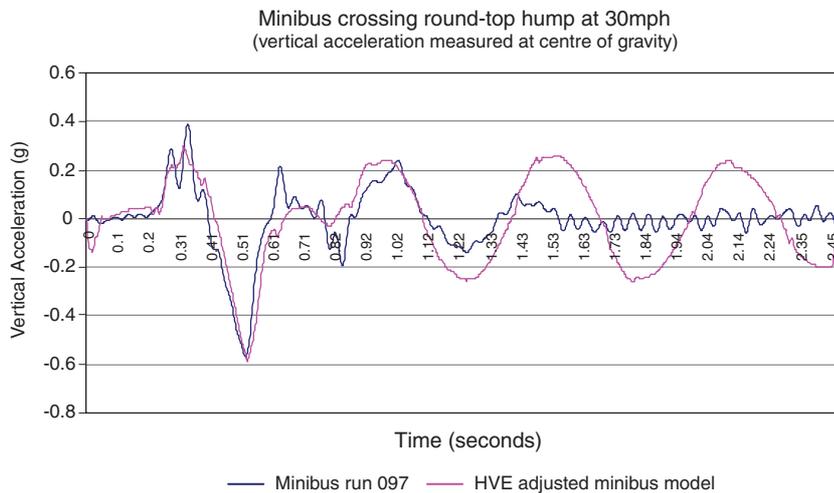
**Figure 25** Comparison of physical and ‘best fit’ simulation test data for the CoG vertical acceleration of the minibus

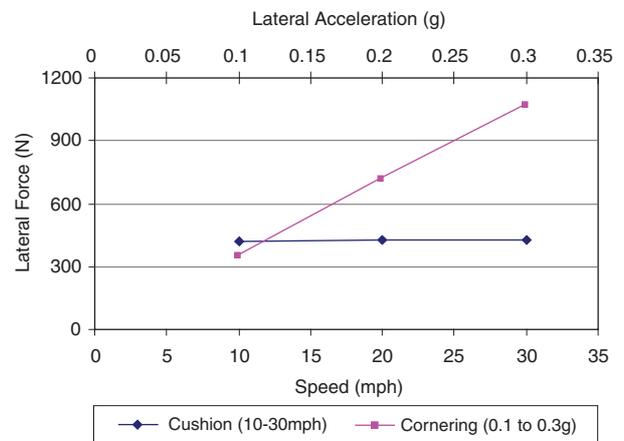
**Figure 26** Comparison of lateral force at front tyres during travel over a speed cushion and cornering

cushion, the lateral forces experienced by a vehicle during cornering are typically greater during heavy and moderate steering, and similar under light steering. The above results are summarised in Figure 26.

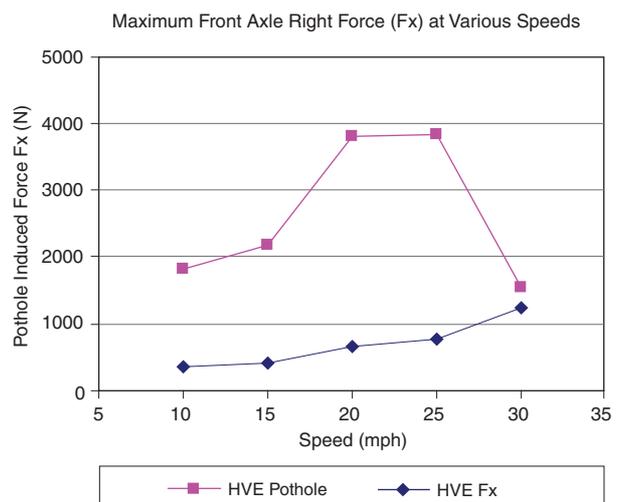
**Figure 27** Comparison of longitudinal force at front tyre during travel over a flat top hump and a representative pothole

Finally, a series of simulation tests was conducted to demonstrate the levels of longitudinal force that can be generated during the travel of a vehicle over a representative pothole feature. For these tests a representative pothole of one metre long and 10 centimetres deep was constructed within the simulation environment. Figure 27 presents the relationship between longitudinal force at the tyre during travel over a road hump, and travel over the virtual pot hole.

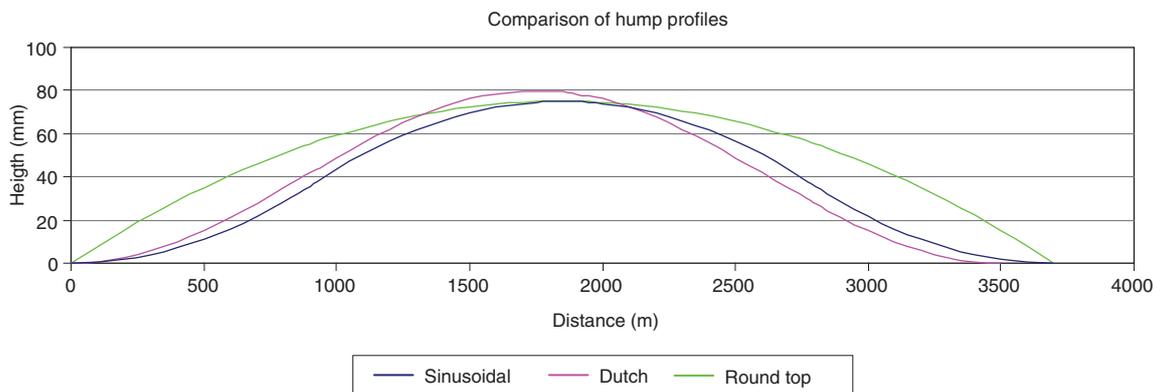
Figure 28 Comparison of round top, UK sinusoidal and Dutch sinusoidal hump profiles (vertical scale exaggerated)

Humps with a sinusoidal profile are similar to round top humps but have a shallower initial rise. They were developed in the Netherlands and Denmark to provide a more comfortable ride for cyclists in traffic calmed areas. The Dutch sinusoidal hump differs slightly from the UK version (see Figure 28), being 80mm in height rather than 75mm. Its effect on the car was found to be little different to the UK sinusoidal hump.

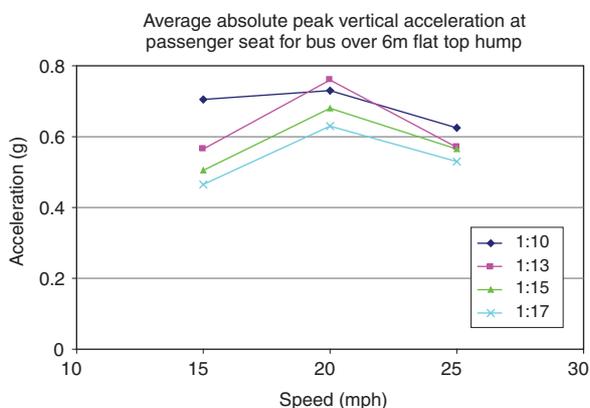
**Figure 29** Average absolute maximum and minimum vertical acceleration at the passenger seat for the bus over flat top humps with different on/off ramp gradients

The flat top hump used in the physical testing had a 6m long plateau with an on/off ramp gradient of 1:15. Alternative on/off ramp gradients of 1:10, 1:13, (1:15) and 1:17 were tested for the car, taxi, ambulance and bus. In terms of the above criteria, for the car, the acceleration at the driver's seat was too severe with a 1:10 ramp gradient and the 1:17 ramp gradient had the effect that lower accelerations were predicted at higher speeds. For the bus at 15mph, 1:10 was more severe than the other gradients; 1:17 was slightly better for both passenger (Figure 29) and driver, but accelerations were still too high. In the taxi and the ambulance, 1:17 minimised the effect on both driver and passenger, but the differences were not very great and accelerations were still too high for the passenger. Overall, ramp gradients different from 1:15 were not predicted to give any improvement in performance.

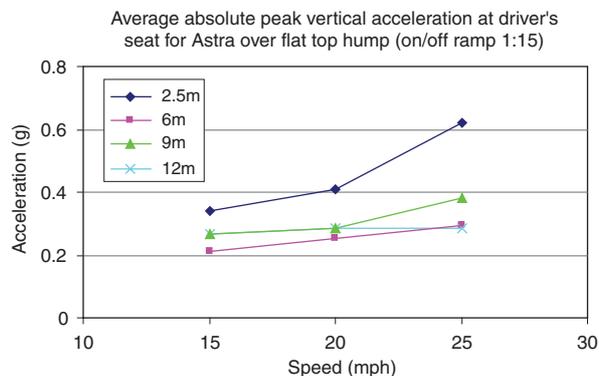
**Figure 30** Average absolute maximum and minimum vertical acceleration at the driver's seat for the car over flat top humps with different plateau lengths

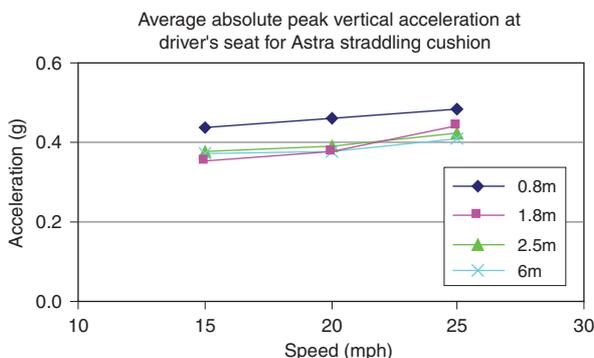
**Figure 31** Average absolute maximum and minimum vertical acceleration at driver's seat for car straddling speed cushions with different plateau lengths

With the other dimensions kept fixed, various alternative plateau lengths were tested - 0.8m, (1.8m), 2.5m and 6m. When the cushion was straddled, there was little variation with plateau length for any of the vehicles, although for the car at the driver's seat, a length of 0.8m was the most severe (Figure 31), with 1.8m giving a better increase with speed. A length of 2.5m was better for the taxi driver and passenger. There was little effect on bus or ambulance passengers.

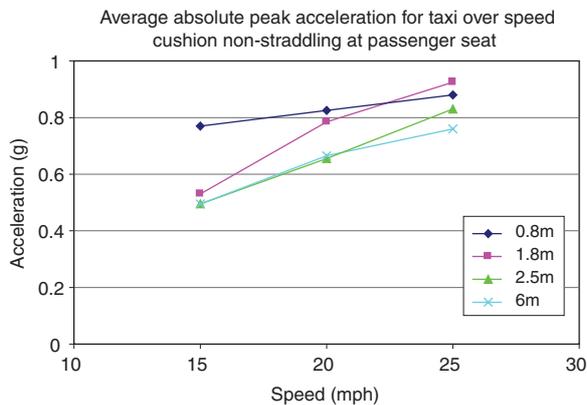
**Figure 32** Average absolute maximum and minimum vertical acceleration at rear passenger seat for taxi with 2 wheels on speed cushions with different plateau lengths

When the cushion was traversed with 2 wheels on, 1.8m was the most effective at the car driver's seat and was also the best at the bus driver's seat, although there was little difference for other lengths. Either 1.8m or 2.5m were best for the taxi driver and 2.5m or 6m for the taxi passenger (Figure 32). For the ambulance, 6m was best for both driver and passenger. It was concluded that plateau lengths different from 1.8m would not improve performance.

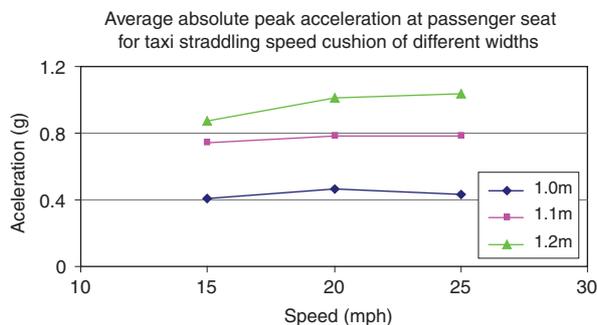
**Figure 33** Average absolute maximum and minimum vertical acceleration at rear passenger seat for taxi straddling speed cushions with different plateau widths

Similarly, for a plateau length of 1.8m, various alternative plateau widths were tested – 1.0m, (1.1m) and 1.2m – for vehicles straddling the cushion. As expected, a narrower 1m speed cushion was less severe and a wider 1.2m cushion more severe than a 1.1m cushion (see Figure 33 for the rear passenger seat in the taxi), with a width of 1.1m a good compromise.

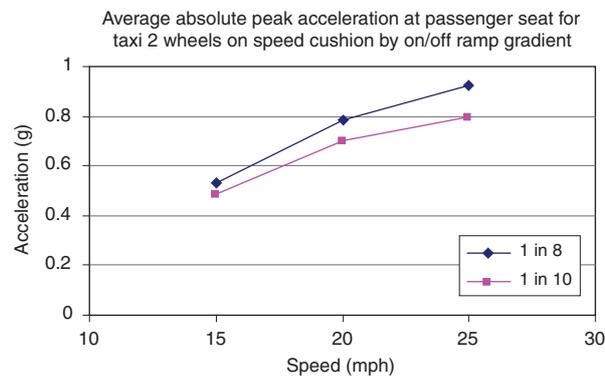
**Figure 34** Average absolute maximum and minimum vertical acceleration at rear passenger seat for taxi over speed cushions (2 wheels on) with different on/off ramp gradients

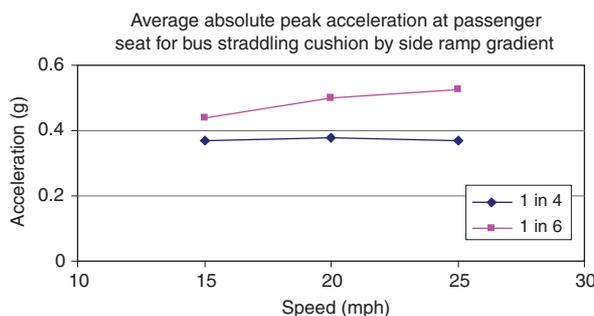
**Figure 35** Average absolute maximum and minimum vertical acceleration at passenger seat for bus straddling cushion with different side ramp gradient lengths

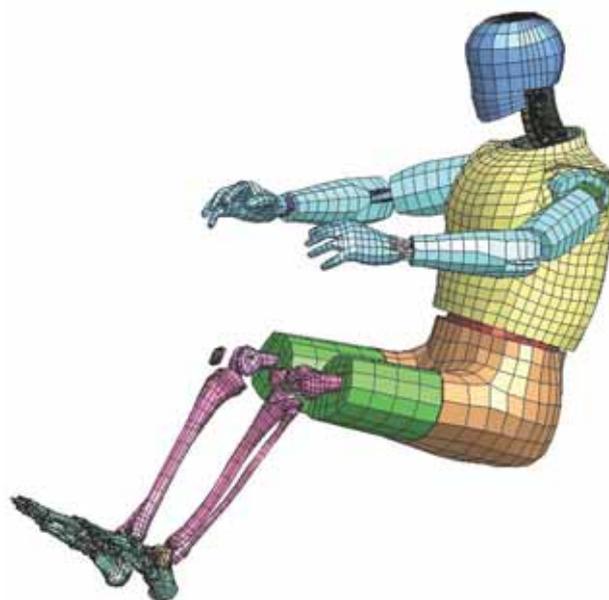
Figure 36 FE model of human dummy

Figure 36 shows the FE model of the human dummy in a seated position and Figure 37 shows details of the base of spine and pelvic region.

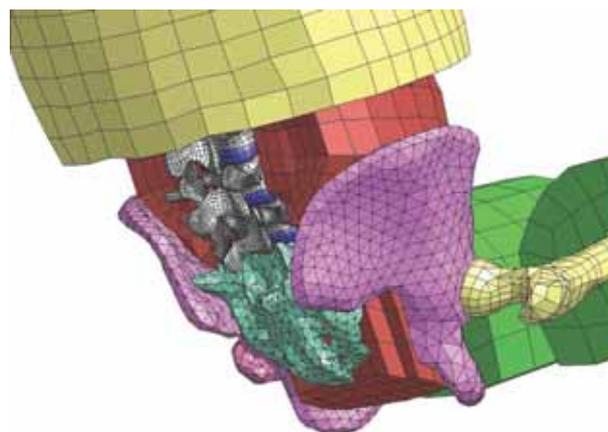
Figure 37 Detail of base of spine and pelvic region

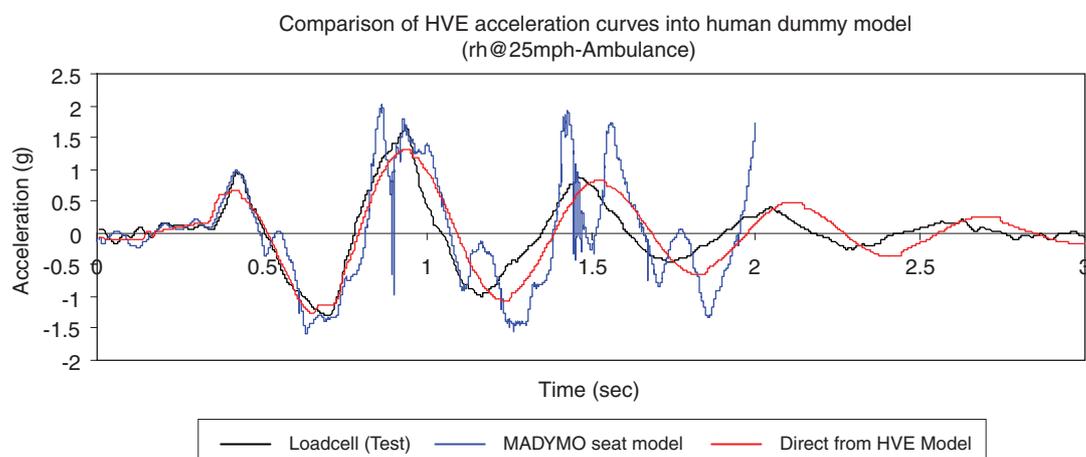
**Figure 38** Comparison of test data acceleration with input data direct from HVE model and using the MADYMO seat model for the ambulance at 25mph over the round top (RH) hump

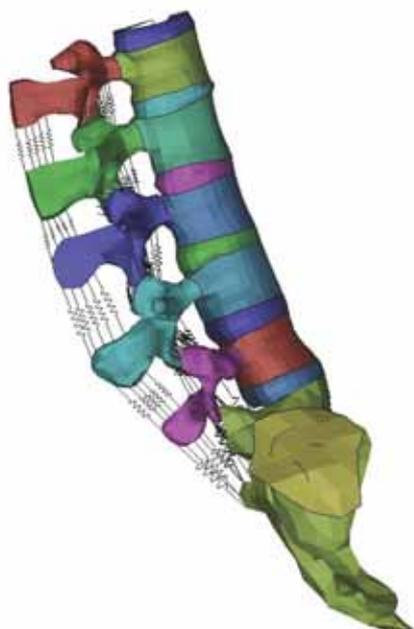
**Figure 39** Lumbar vertebrae, intervertebral discs and ligaments

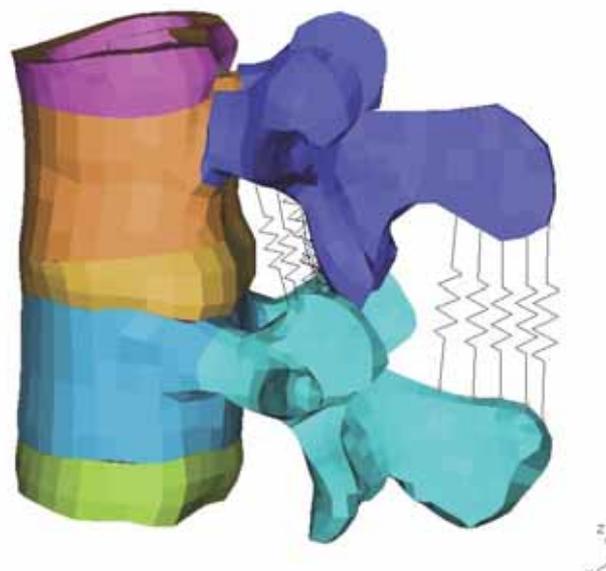
**Figure 40** Supraspinous (SSL) and ligmentum flavum (LF) ligaments

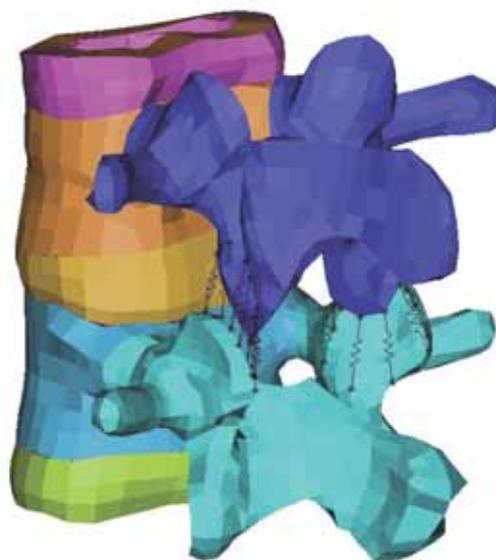
**Figure 41** Capsular (CAPS) ligament

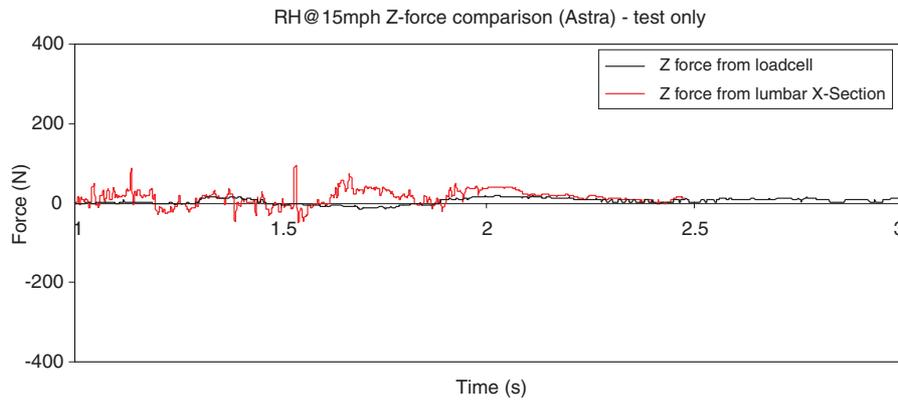
**Figure 42a** Round top hump (RH) at 15mph Z-force comparison for the car – test data

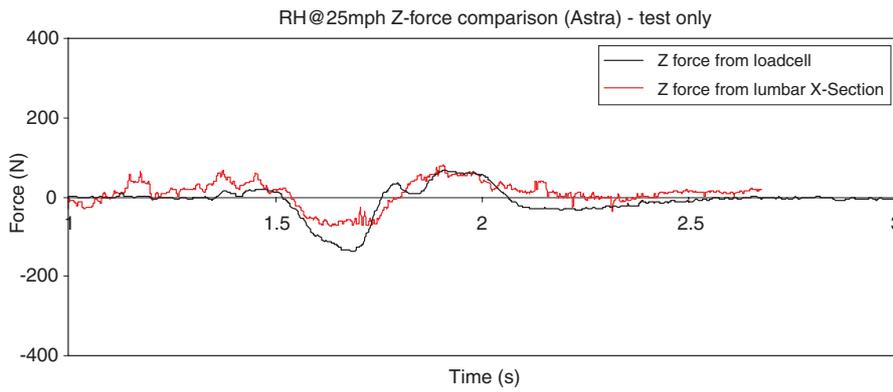
**Figure 42b** Round top hump (RH) at 25mph Z-force comparison for the car – test data

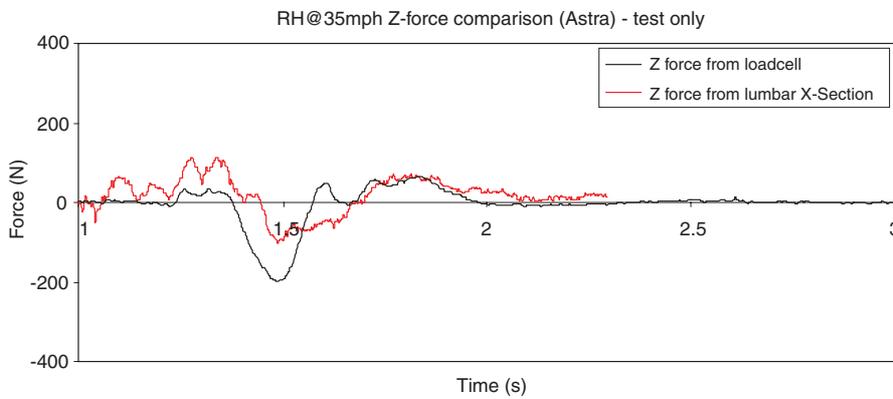
**Figure 42c** Round top hump (RH) at 35mph Z-force comparison for the car – test data

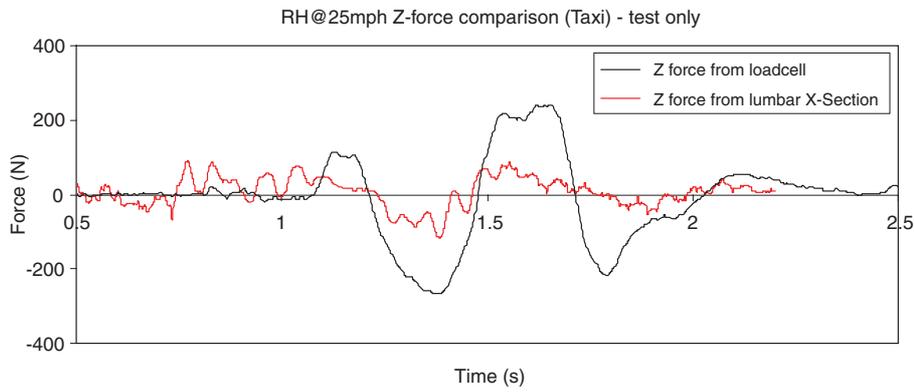
**Figure 43a** Round top hump (RH) at 25mph Z-force comparison for the taxi – test data

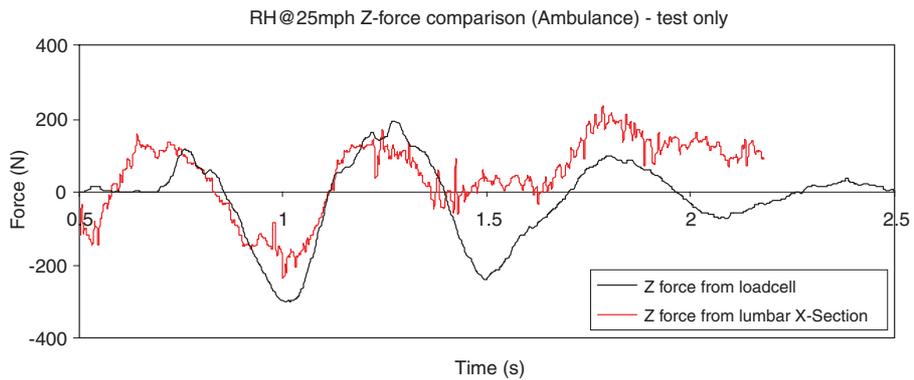
**Figure 43b** Round top hump (RH) at 25mph Z-force comparison for the ambulance – test data

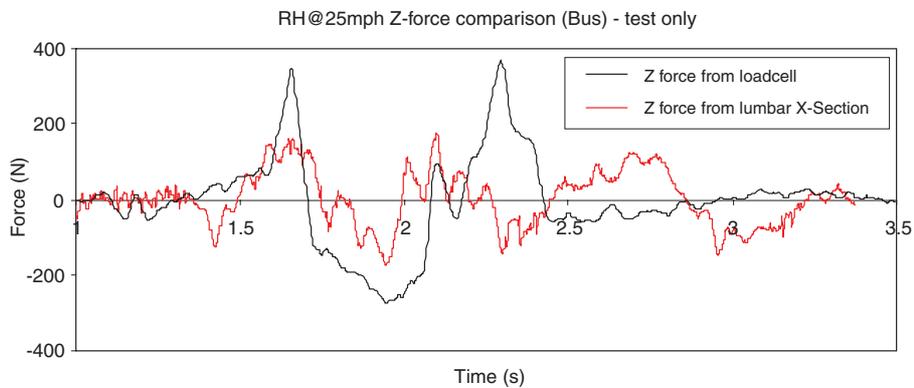
**Figure 43c** Round top hump (RH) at 25mph Z-force comparison for the bus – test data

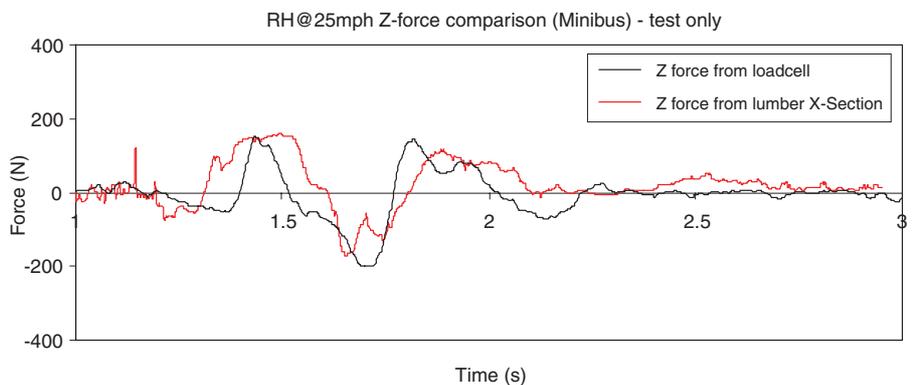
**Figure 43d** Round top hump (RH) at 25mph Z-force comparison for the minibus – test data
