# **Impact of road humps on vehicles and their occupants**

**Prepared for Charging and Local Transport Division,  
Department for Transport**

J Kennedy, C Oakley, S Sumon, I Parry (TRL Limited)  
and E Wilkinson, J Brown (Millbrook Proving Ground Ltd)

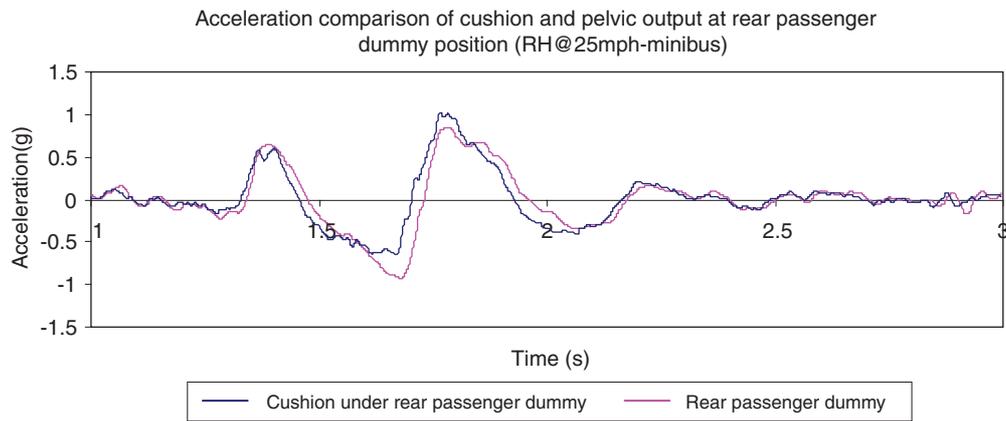
**Figure 44** Comparison of acceleration curves at cushion under rear passenger dummy and in load-cell (Round top hump RH at 25mph, minibus)

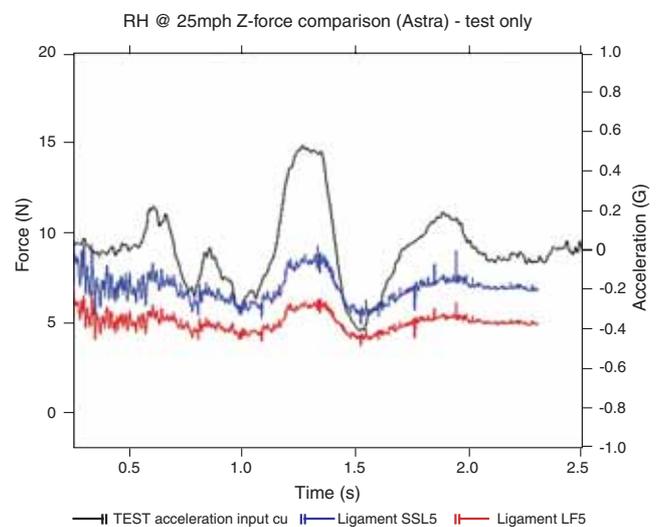
**Figure 45a** Relationship of ligament force to shape of acceleration history in the car at 25mph over the round top hump using test data

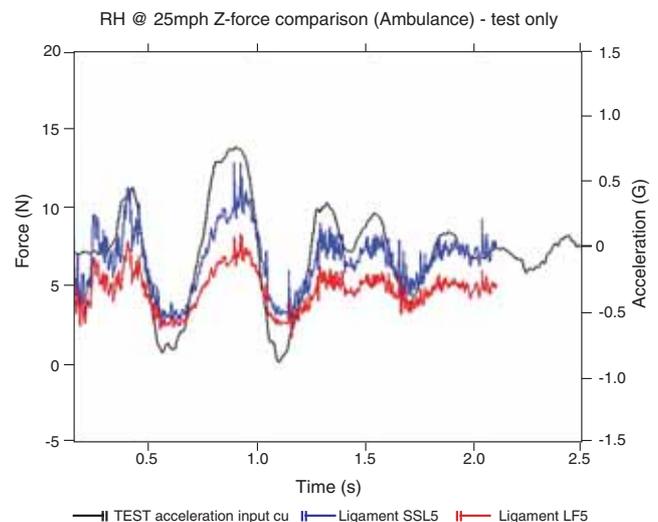
**Figure 45b** Relationship of ligament force to shape of acceleration history in the ambulance at 25mph over the round top hump using test data

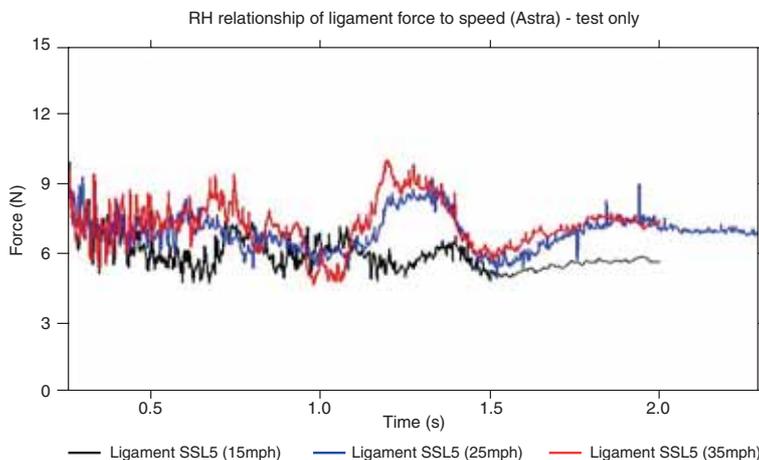
**Figure 46a** Relationship of ss15 ligament force to speed for the car over the round top (RH) hump using test data

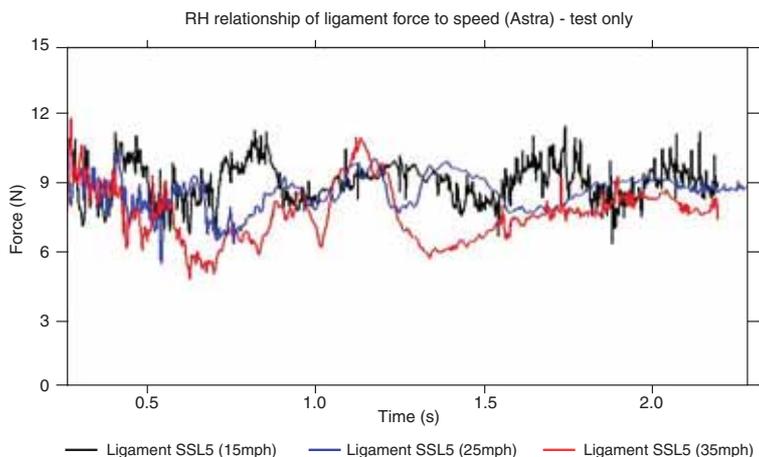
**Figure 46b** Relationship of ss16 ligament force to speed for the car over the flat top (PH) hump using test data

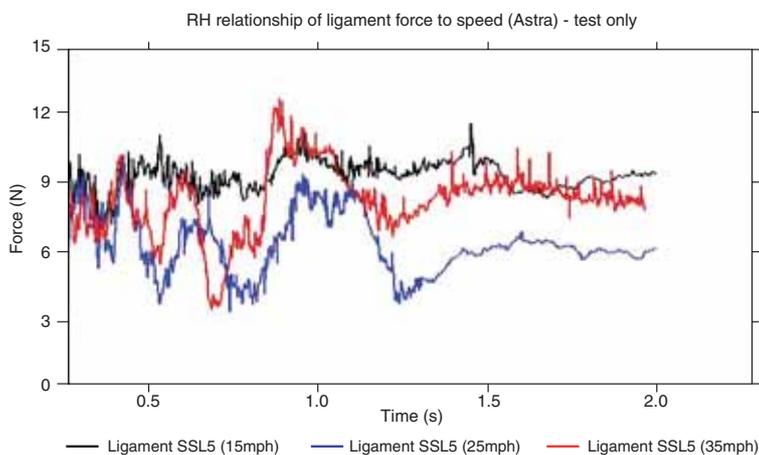
**Figure 46c** Relationship of ss15 ligament force to speed for the car over the sinusoidal (SH) hump using test data

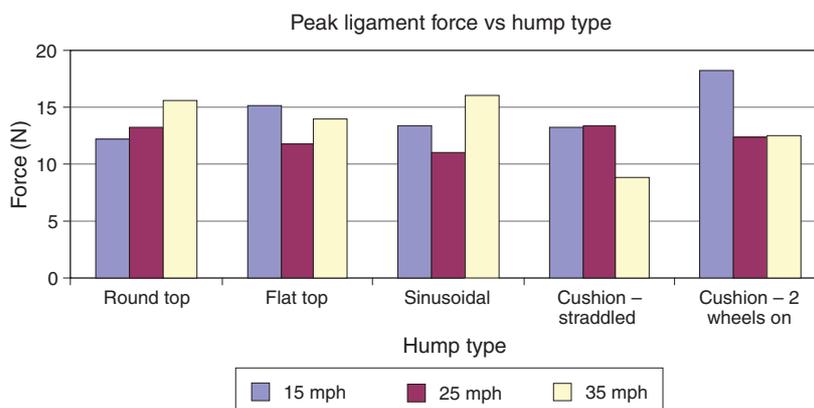
**Figure 47** Relationship of peak ligament force (N) to hump type for car occupants

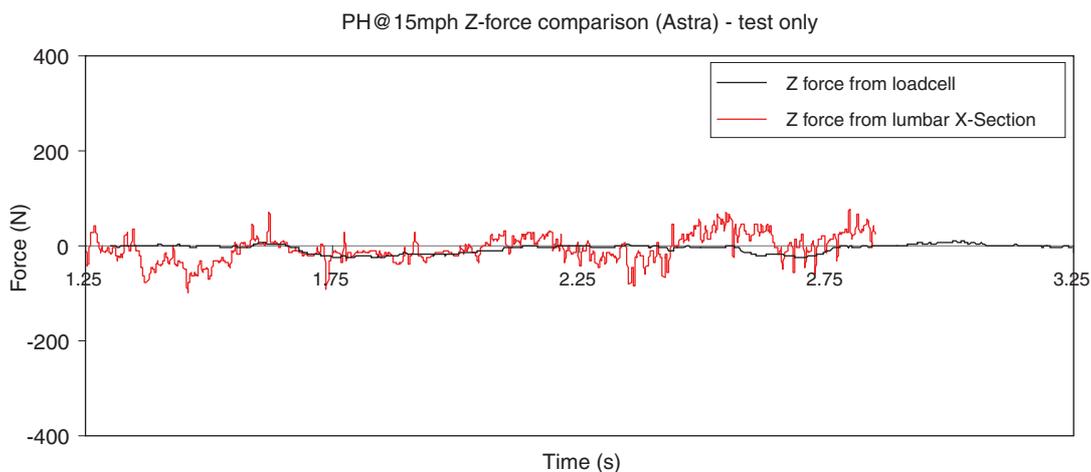
**Figure A1a** Flat top hump (PH) at 15mph Z-force comparison for the car – test only

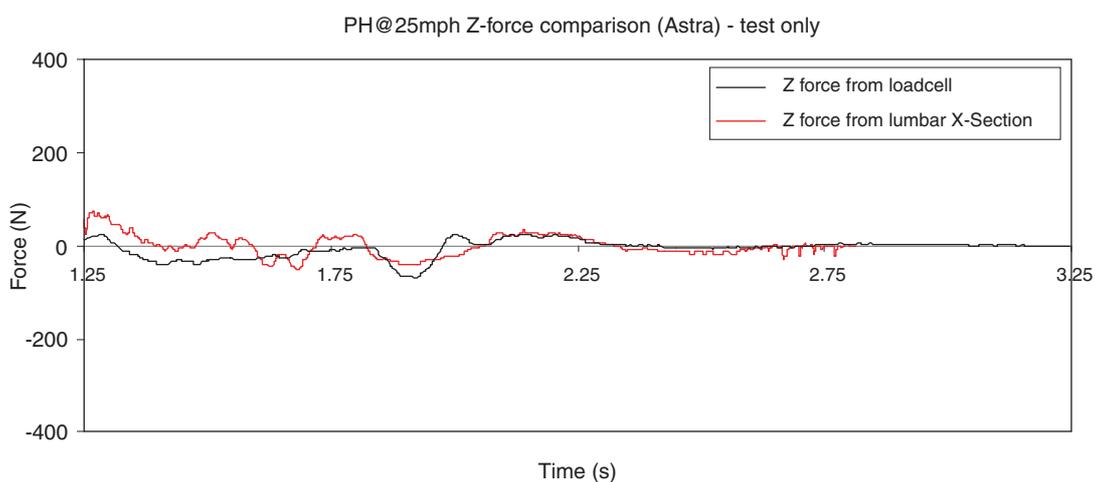
**Figure A1b** Flat top hump (PH) at 25mph Z-force comparison for the car – test only

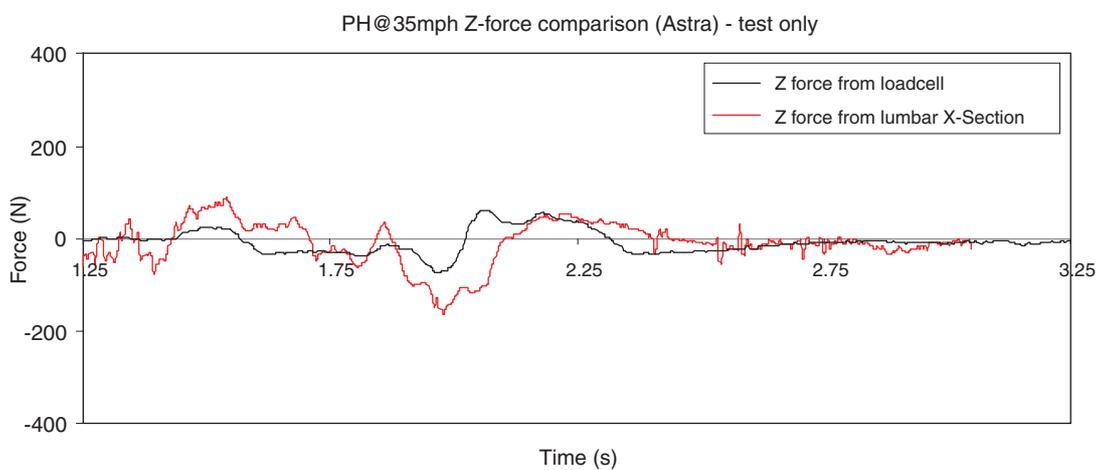
**Figure A1c** Flat top hump (PH) at 35mph Z-force comparison (Astra) – test only

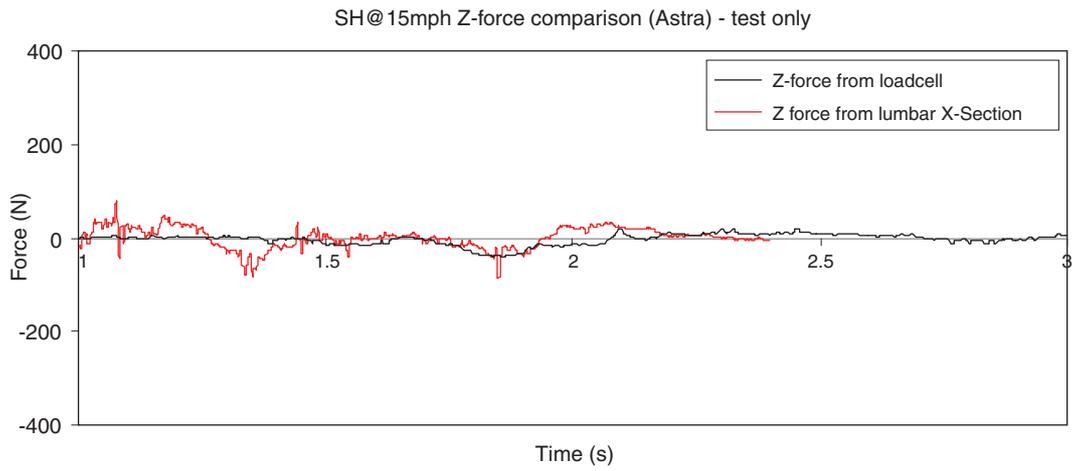
**Figure A2a** Sinusoidal hump (SH) at 15mph Z-force comparison for the car – test only

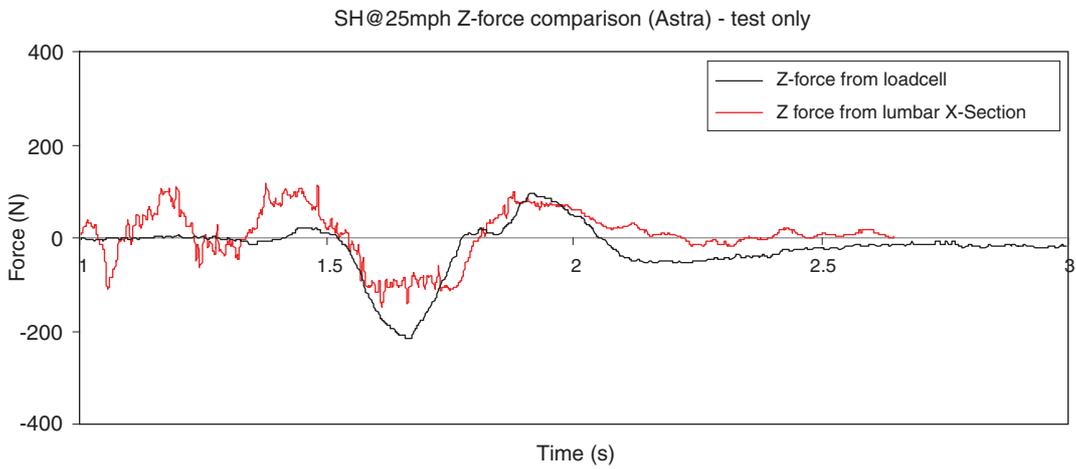
**Figure A2b** Sinusoidal hump (SH) at 25mph Z-force comparison for the car – test only

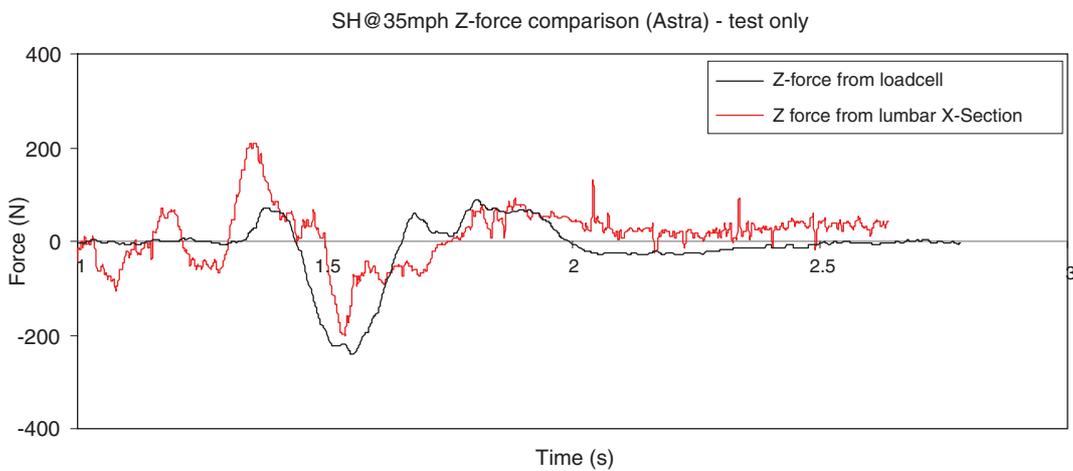
**Figure A2c** Sinusoidal hump (SH) at 35mph Z-force comparison for the car – test only

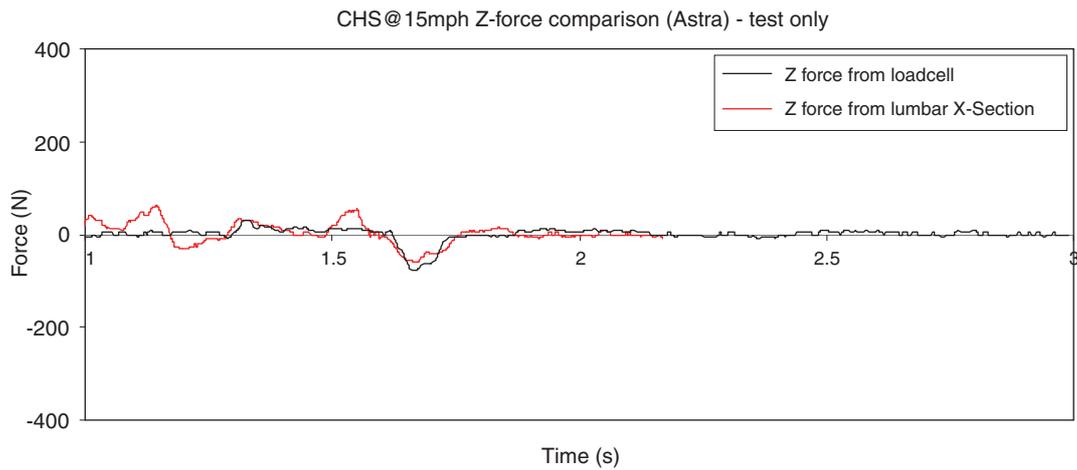
**Figure A3a** Speed cushion straddled (CHS) at 15mph Z-force comparison for the car – test only

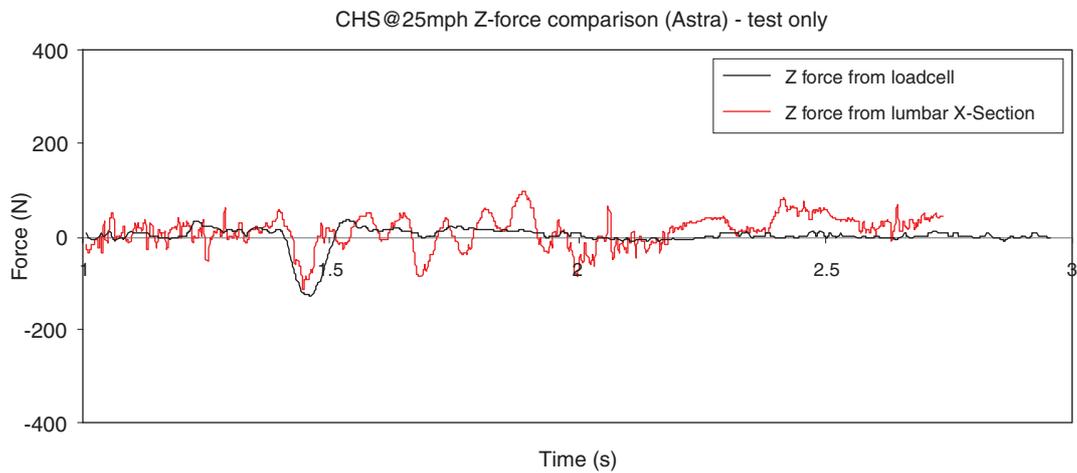
**Figure A3b** Speed cushion straddled (CHS) at 25mph Z-force comparison for the car – test only

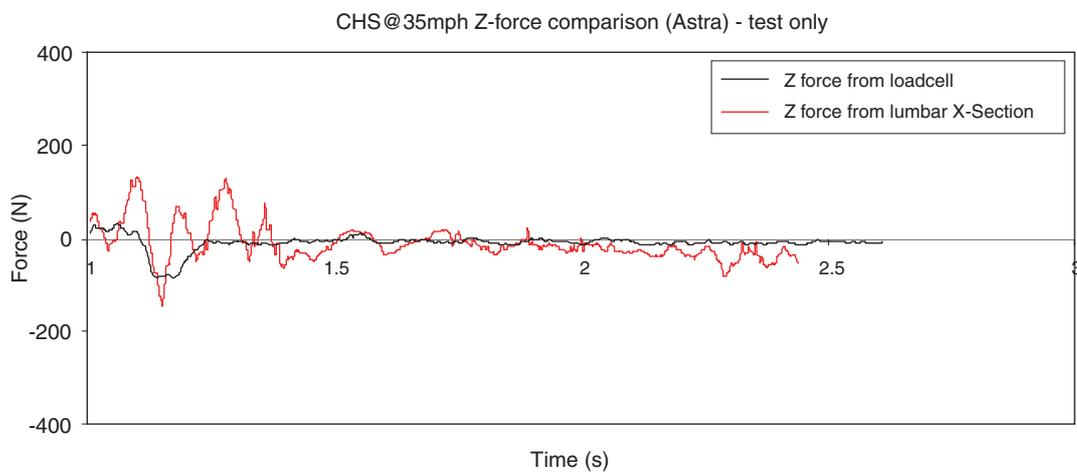
**Figure A3c** Speed cushion straddled (CHS) at 35mph Z-force comparison for the car – test only

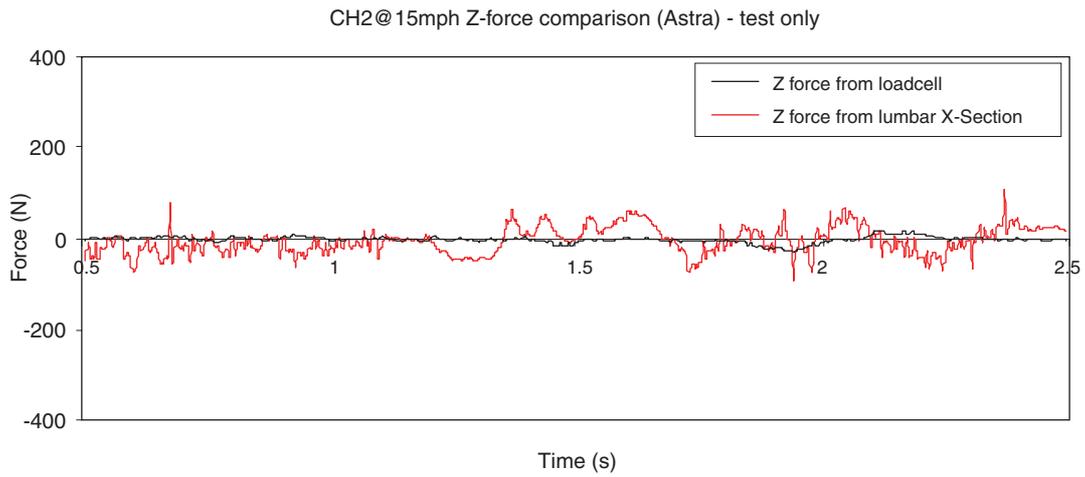
**Figure A4a** Speed cushion - two wheels on (CH2) at 15mph Z-force comparison for the car – test only

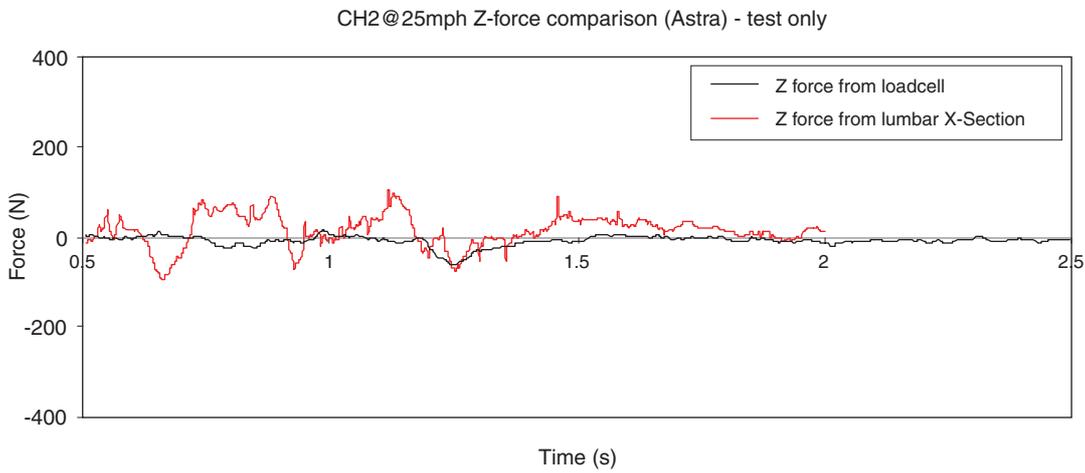
**Figure A4b** Speed cushion - two wheels on (CH2) at 25mph Z-force comparison for the car – test only

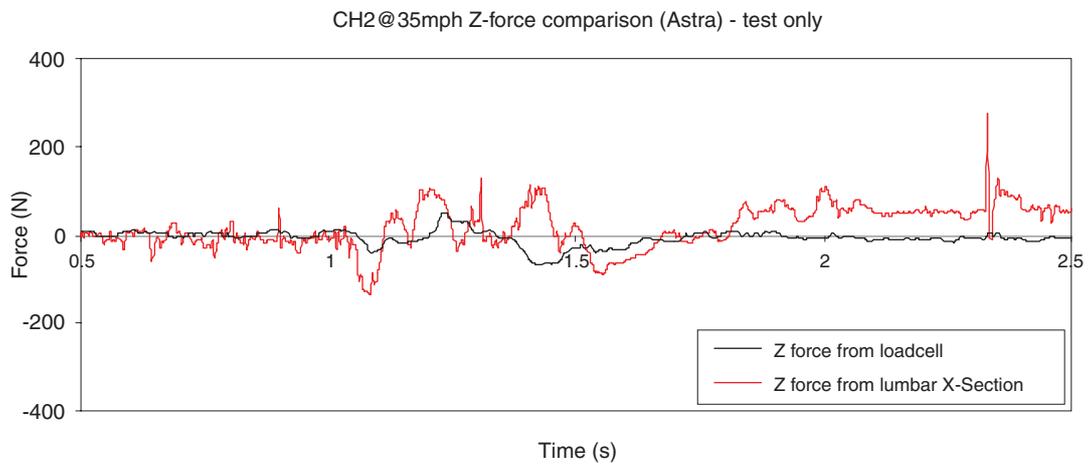
**Figure A4c** Speed cushion- two wheels on (CH2) at 35mph Z-force comparison for the car – test only
