PROJECT REPORT PPR873

Innovative Geotechnical Repair Techniques

Effectiveness of Fibre Reinforced Soil

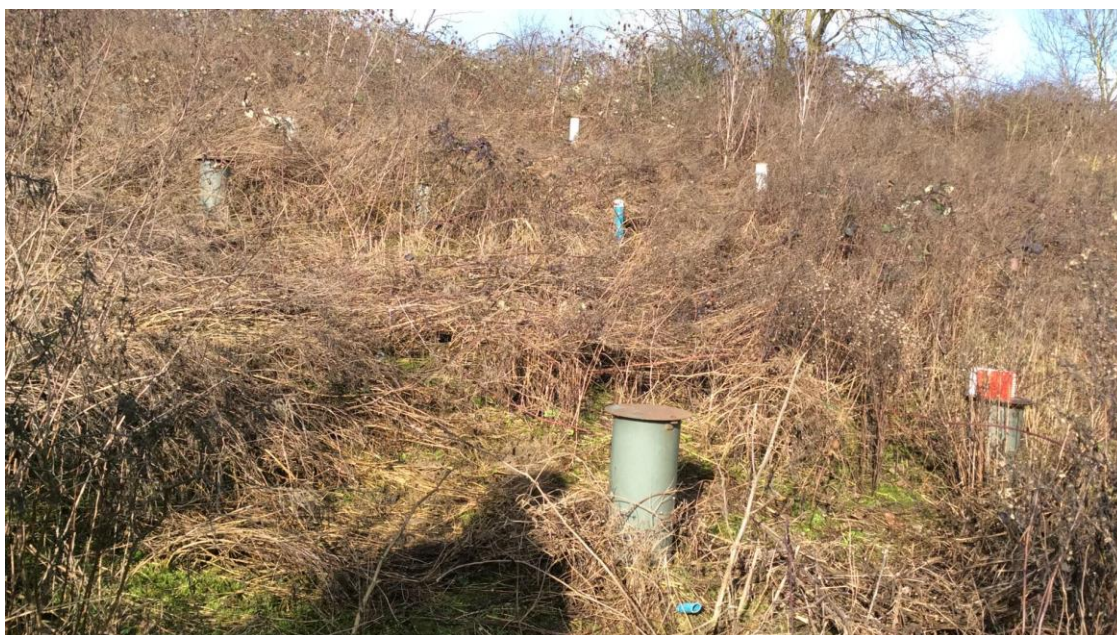
Geotechnical monitoring installations were evident, including raised piezometer / inclinometer covers (Figure 2). These appeared to be in reasonable condition although some of the inclinometer covers appeared to be rotated by 3° to 5° to the east (downslope). It was considered that this could be an indication of shallow slope creep, although equally could be due to the method of installation.

Figure 2: Heavily vegetated FRS slope. Raised installation covers rotated between 3° and 5° to the west

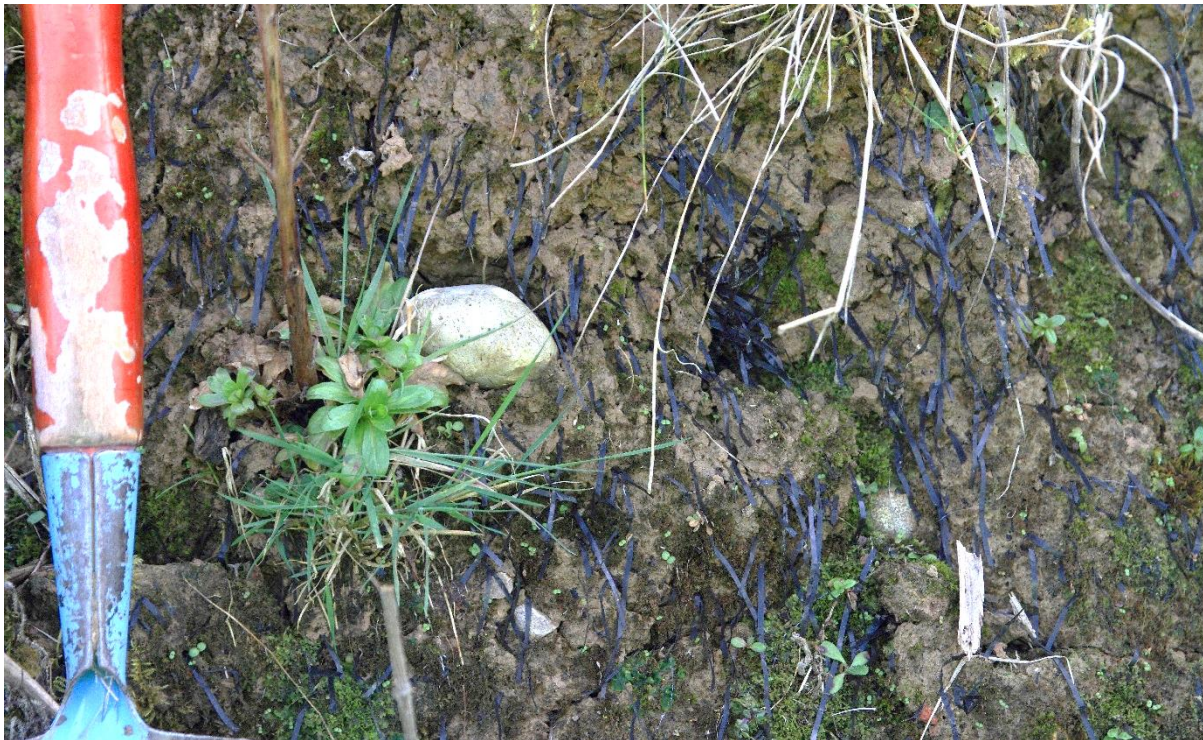
The middle of the back scarp corresponds approximately to the boundary between the fibre reinforced Bay 1 and Bay 2 where unreinforced soil was used to reconstruct the slope. The back scarp extends into Bay 1 which was constructed with FRS. This corroborated by inspection of the soil exposed in the back scarp which had formed in very soft clay with fibres entrained within it (Figure 5).

Figure 5: Fibres entrained within the soil of the back scarp at A27 Polegate/Bay Tree Lane FRS trial (Site Photograph 7DW_4191)

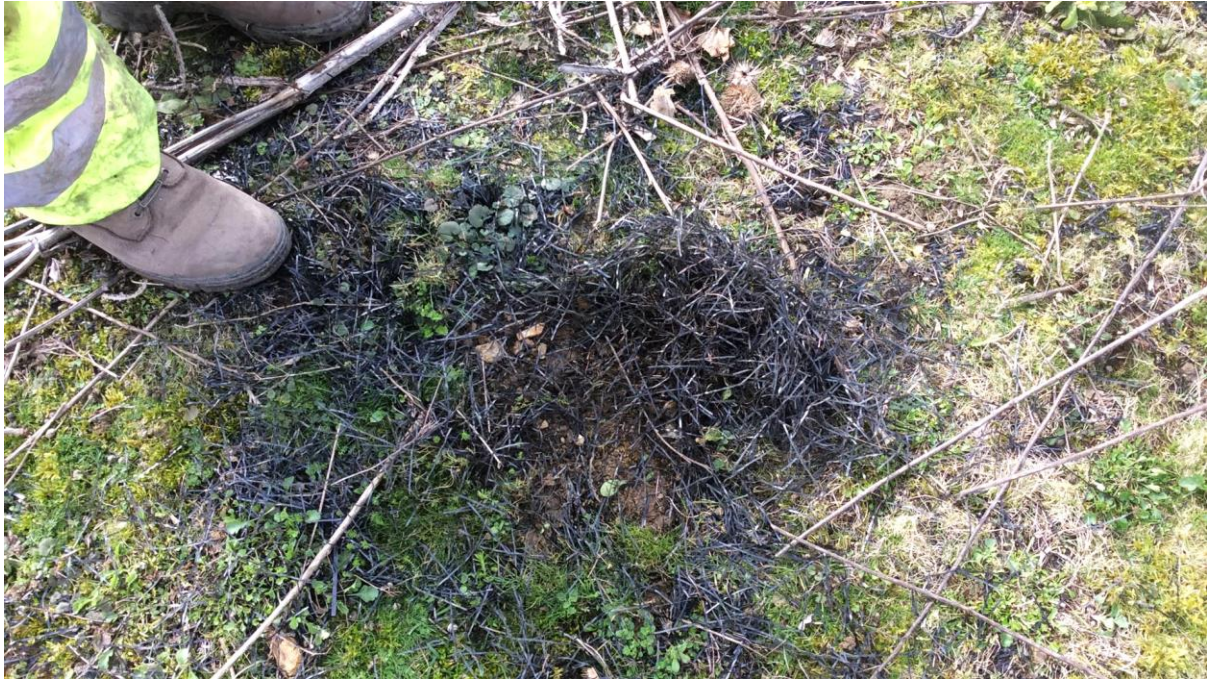
The slope was predominantly covered in short grass and moss with occasional trees. In places, significant accumulations of polypropylene fibres were evident on the ground surface. The concentration of these fibres was much greater on the surface than in the freshly exposed soil. The soil exposed was a brown sandy clay and is considered to be the

Figure 7: Fibres present on the ground surface and to a lesser degree in the exposed made ground

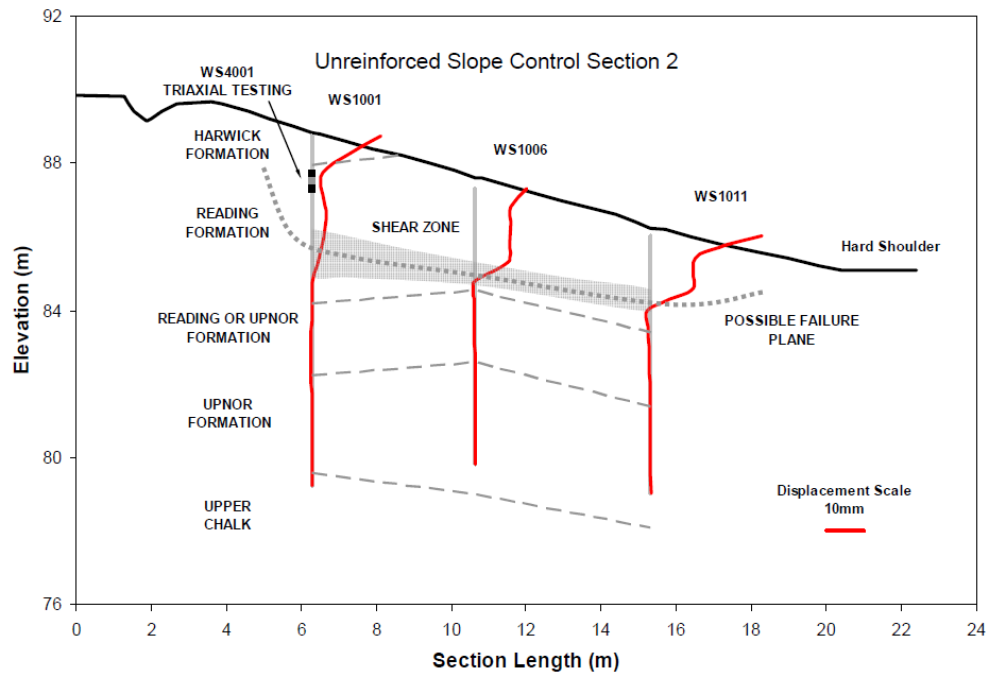
Monitoring in the unreinforced Control Section 2 (Figure 8) indicated that movements were consistent with shrink swell behaviour caused by season wetting and drying. The associated vertical movements were most pronounced in the top 1.0m in the upper parts of the slope. The maximum cumulative settlement measured in the extensometers over the monitoring period was 17mm which occurred at 0.1m bgl.

Figure 8: A1(M) J1 Control Section 2 inclinometer data, May 2008 to March 2011 (Mouchel 2012)

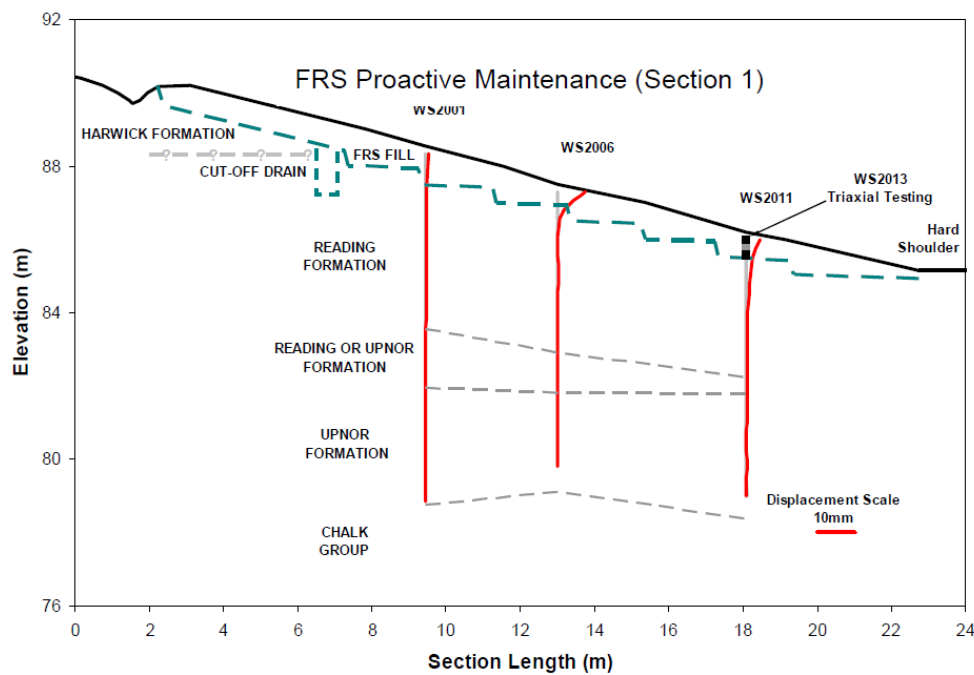
Monitoring of the extensometers in the FRS repairs undertaken in Sections 1 and 3, indicates that the vertical movements associated with shrink swell were reduced. In Section 1 (Figure 9), the cumulative settlements measured by the extensometers over monitoring period ranged between 4mm and 16mm. In Section 3 (Figure 10), over the same monitoring period, the cumulative settlement was between 6mm and 12mm.

The shallow cumulative downward movement of the slope measured over the monitoring period ranged from 0mm to 8mm in Section 1 and from 8mm to 13mm in Section 3. This movement was most pronounced in the middle and toe of the slope as defined in Figure 9 below

Figure 9: A1(M) J1 proactive maintenance Section 1 cumulative movement, April 2009 to March 2011 (Mouchel 2012)

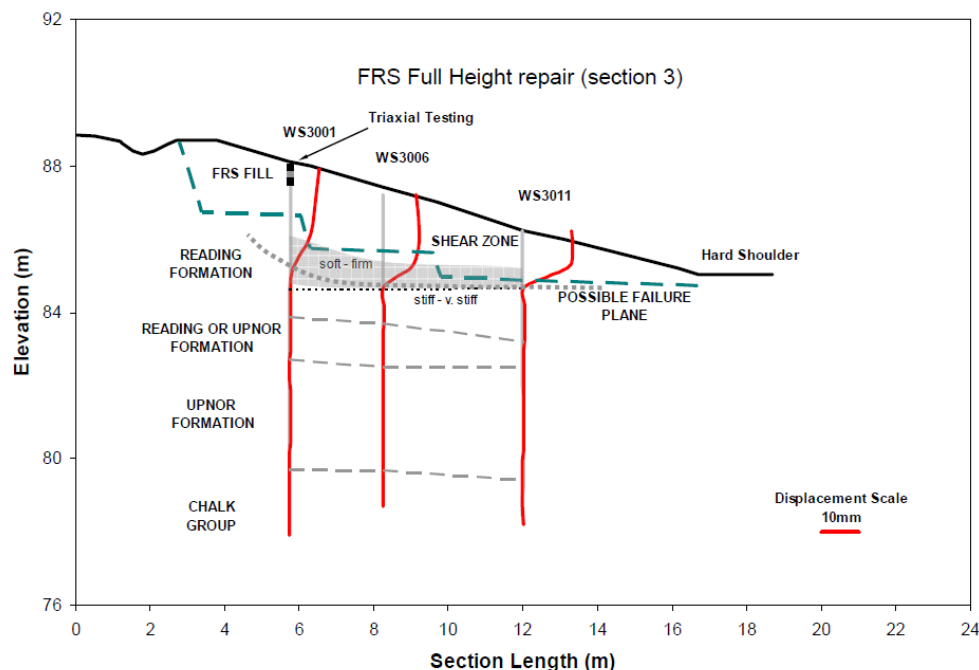
The reduction in down slope movements in Section 3 was less. It was considered by Mouchel (2012) that this may have been due to existence of pre-existing shears which were not removed during the excavation and reconstruction of that section as shown by the ‘possible failure plane’ in Figure 10.

Figure 10: A1(M) J1 full height repair Section 3 cumulative movement, April 2009 to March 2011 (Mouchel 2012)

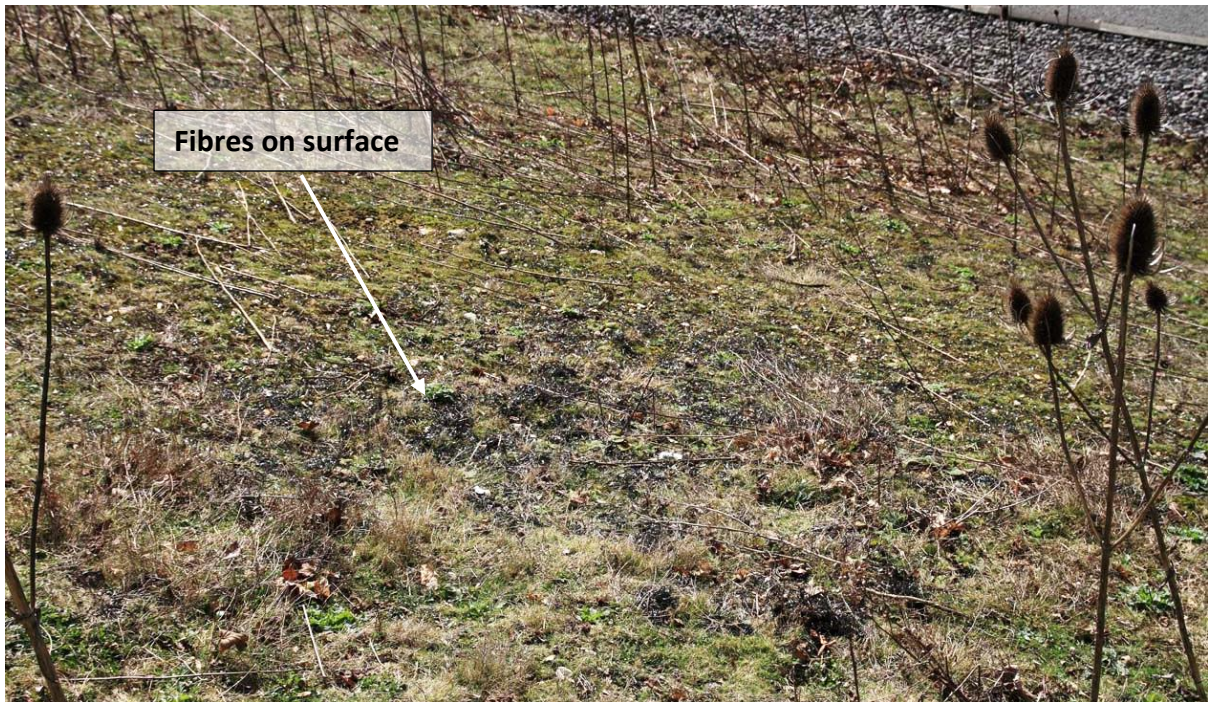
During the walkover, the earthwork appeared to be stable although small tension cracks, back scarps and toe bulges were noted. These may be indications that the stability of the slope is deteriorating but they may also be attributable to settlement under the self-weight of the fill due to insufficient compaction and high placement moisture contents. Depending on which mechanism is occurring, and the impact this will have on the FRS slope, will dictate how effective the solution is considered to be in the long-term. Given the lack of post-construction monitoring data, it is difficult to comment on how successful the scheme is likely to be in providing a long-term, robust solution. In the short-term, from site observations, the FRS appears to be performing adequately.

Figure 11: M20 Smeeth showing sunlight reflecting off multiple areas where fibres are present at the surface of the slope (Site Photograph 7DW_4185)
