PUBLISHED PROJECT REPORT PPR1034

Forensic Examination of Critical Special Geotechnical Measures: Counterfort Drain Information Note

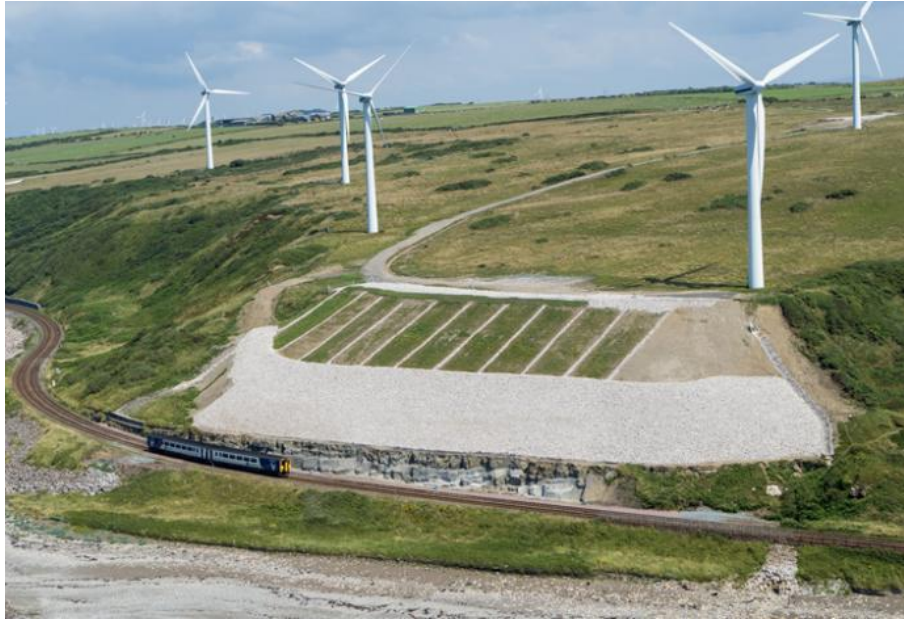
Figure 1: Regraded slope on the Cumbrian Coast Railway with Counterfort Drains. The upper slope above the rock fill blanket is clayey till and the area covered by the rock fill blanket is glacial sand (believed to be an esker). The counterforts also have slope (herring bone) drains to pick up localised water, they are generally concealed by the rock fill blanket. This highlights the need for detailed as built records to aid with future inspections, analysis and maintenance. Note the crest drain for the slope outfalls via a reno mattress lined channel on the right-hand side of the (image J. Murphy and Sons Ltd.)

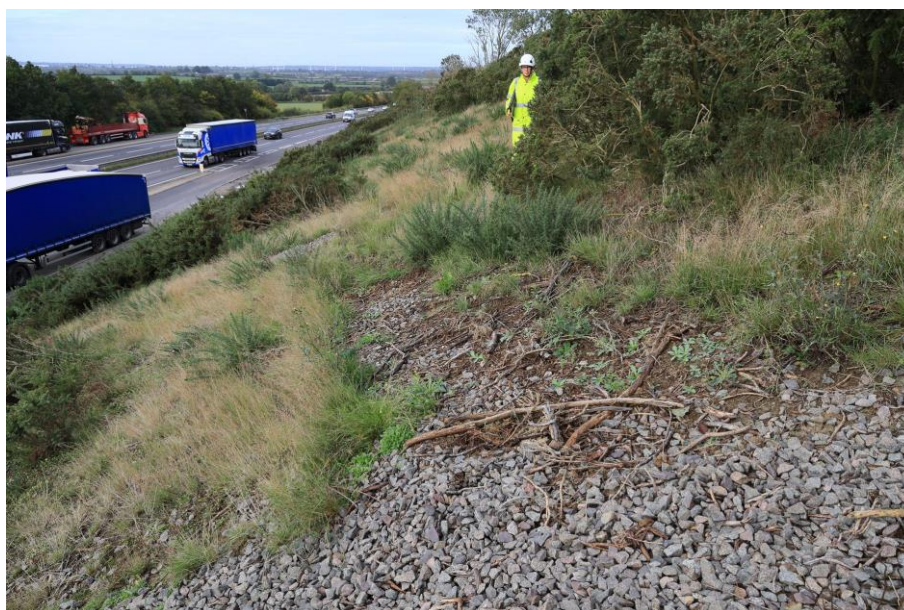
Figure 2: Vegetation debris from vegetation maintenance with the potential to block the structure of the drainage media (A14 [no SGM number, National Grid Reference NGR SP 62450 77600], October 2020)

A common observation was that the debris left from vegetation management was deposited on the surface of drains potentially clogging the drainage media in the long term (Figure 2) as it decomposes and enters the drain structure. While it is not entirely clear whether the debris was deliberately placed in these locations it did seem more prevalent on sub-horizontal herring bone drains connected to the counterfort drains where these were present (Figure 3). It could be that the debris from vegetation maintenance was not originally deposited on the drain surfaces but transported over time under the action of water and gravity. As the deposition of such debris on slope surfaces has become common practice in recent decades this may have significant implications for drain efficacy and such practices may need to be either carefully managed or ceased on slopes with such sub-horizontal drains.

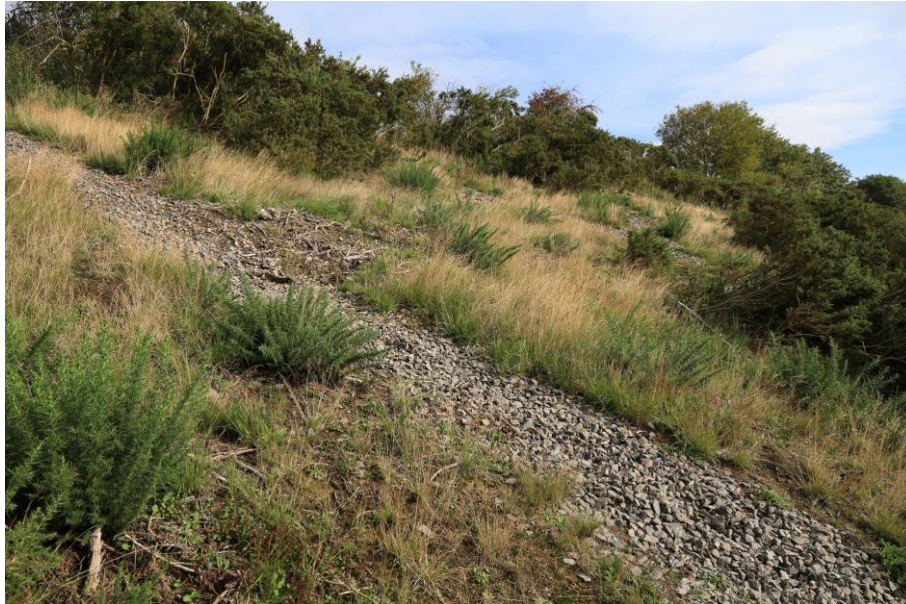
Figure 3: Vegetation debris from vegetation maintenance with the potential to block the structure of the drainage media (A14 [no SGM number, National Grid Reference NGR SP 62450 77600], October 2020)

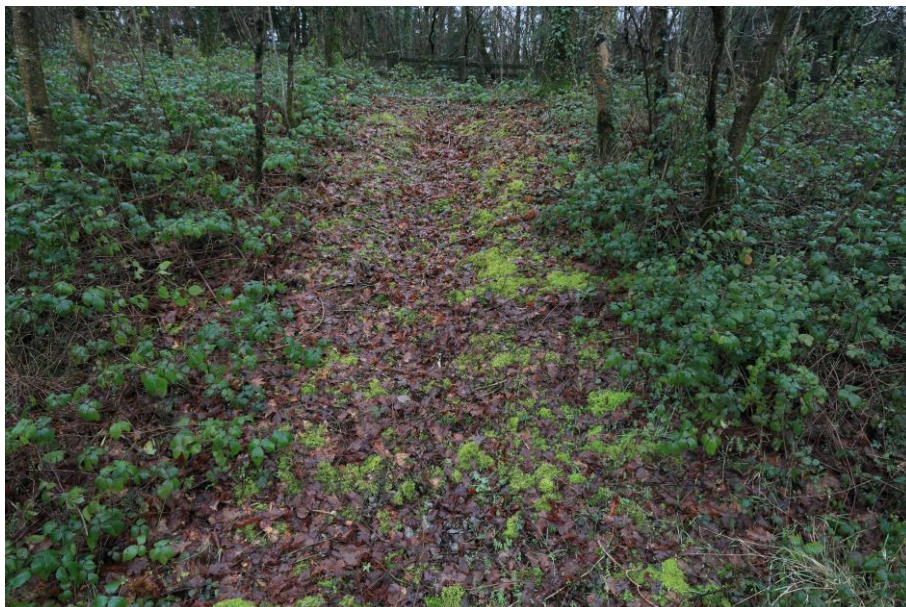
Figure 4: Vegetation debris with the potential to block the structure of the drainage media. The width of the drain is approximately 1.2m (A30, SGM 2053, January 2021)

Figure 4 illustrates the build-up of leaf matter; this appears to be entirely natural and without the implication of being the result of any maintenance activity. Over time as the leaf matter decomposes and enters the drain structure it has the potential to reduce its efficacy. In Figure 4 it is clear that the brambles that largely cover the site have not established within the drains themselves, while in Figure 5 moss with the potential to block the drain can be observed. Vegetation growth can be observed beginning to encroach into the margins of the drain surface (Figure 2 and Figure 3), potentially leading to a significant decrease in the efficiency

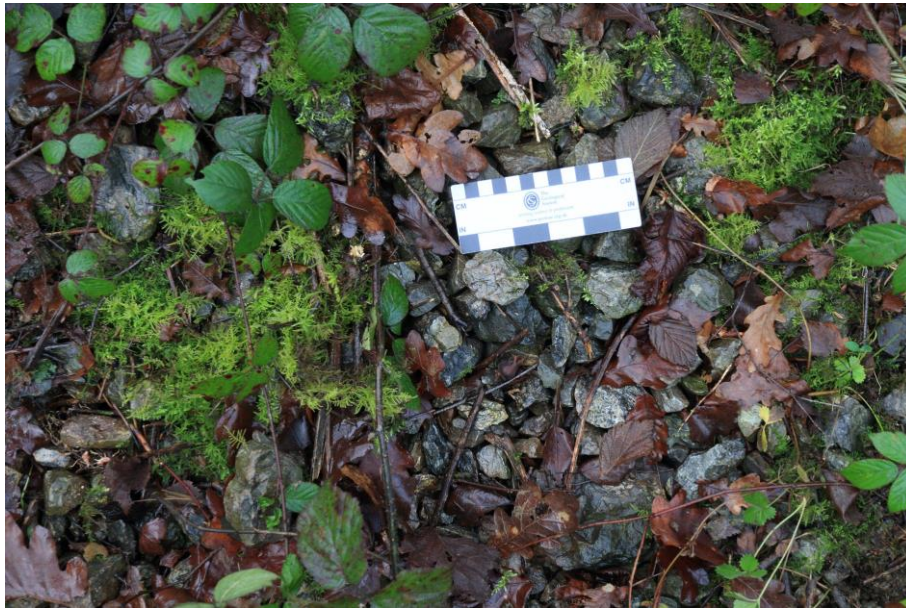
Figure 5: Vegetation debris and moss growing on the surface of a Counterfort Drain with the potential to clog the structure of the drainage media. (A30, SGM 1924, January 2021)

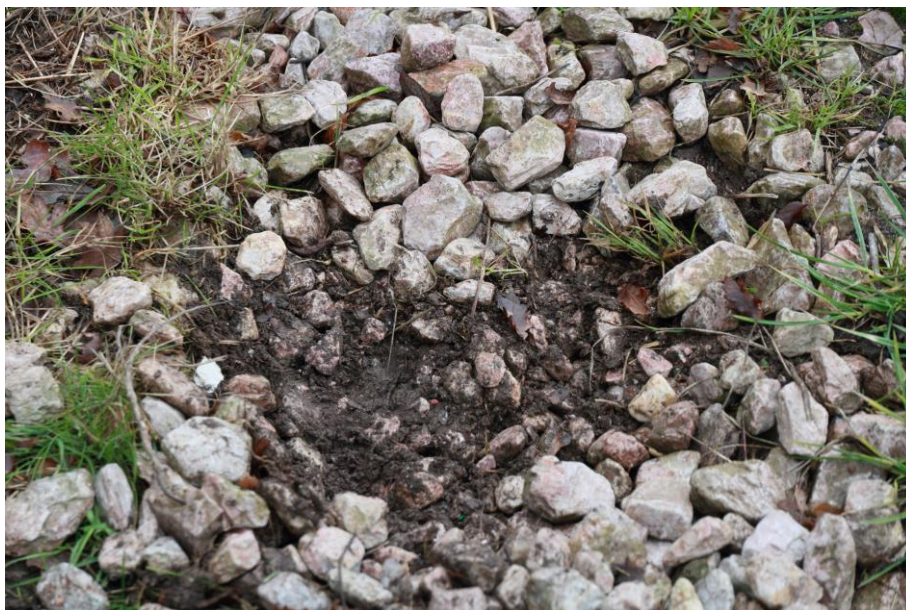
Figure 6: The effects rotted vegetation and soil migration into the drainage media can be seen by the degree of clogging in the centre of this approximately 1m wide Counterfort Drain; the aggregate sizes generally range from around 20mm to 90mm (A30, SGM 2065, January 2021)

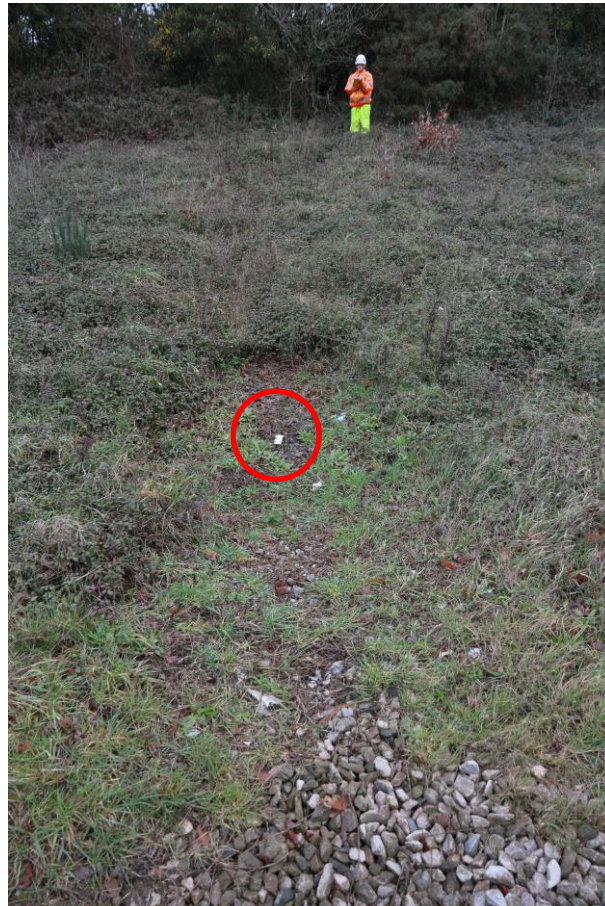
Figure 7: Settlement of drainage media at the junction with a feeder drain, in this case a herringbone drain. A 13cm scale can be seen towards the top-centre of the image within the red circle (A30, SGM 2065, January 2021)

Post-construction settlement of drains often occurs at either the head of the drain or at the junction with feeder drains, such as herringbone drains, creating a preferential path for erosion and deposition of material within the drains causing later clogging. An example of such settlement is illustrated in Figure 7 at the junction with a herringbone drain on a cutting slope. This has created a preferential water path and associated erosion and downslope washout of the drainage media. Such settlement can also be observed in Figure 8 which is an

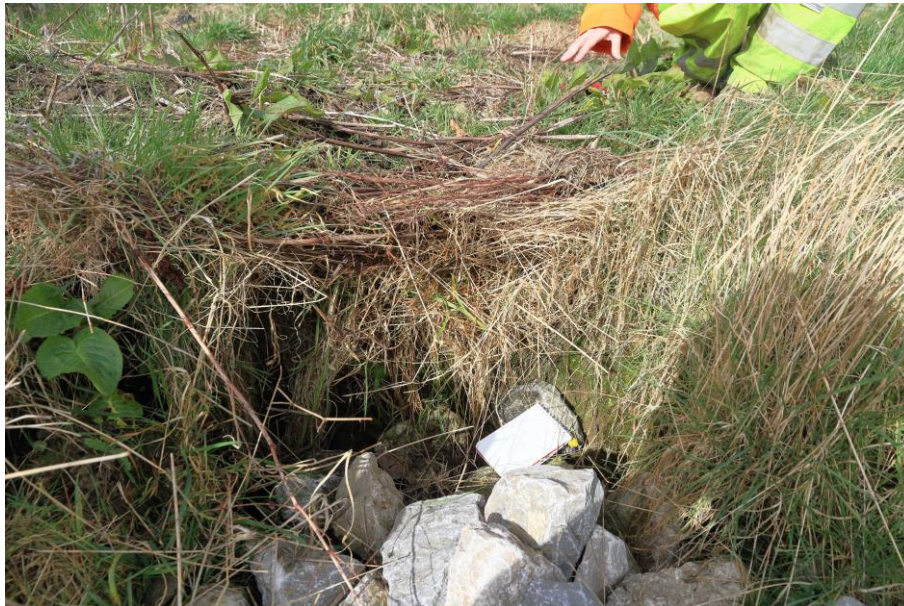
Figure 8: Settlement of large-sized drainage media at the head of a herringbone drain, that links to a counterfort drain (M6 J34 northbound on-slip, no SGM number, NGR SD 49665 65240, March 2021)

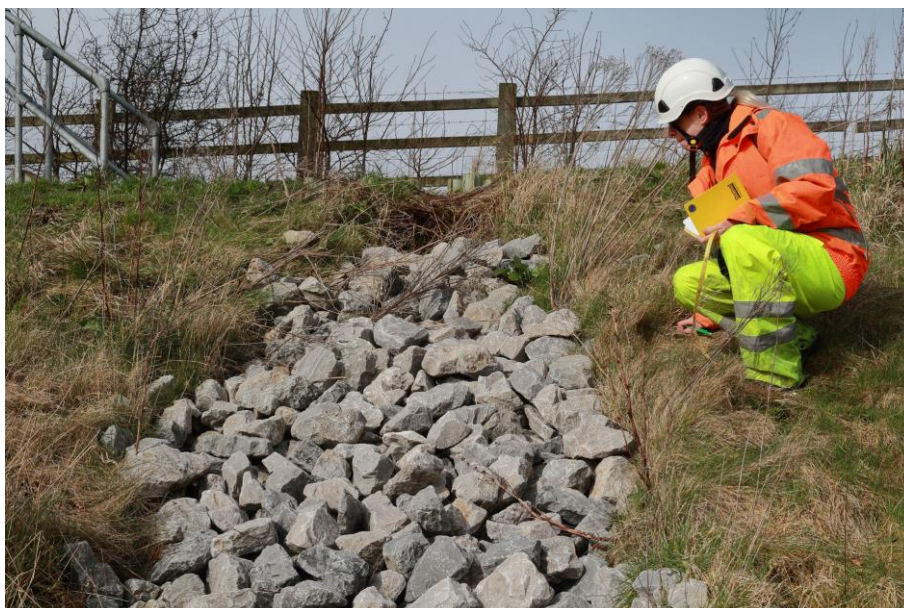
Figure 9: Settlement of large-sized drainage media at the head of a counterfort drain (M6 J34 northbound on-slip, no SGM number, NGR SD 49665 65240, March 2021)

The scale of the issue at this site can be gauged from Figure 9, a counterfort drain that extends to the top of the cutting slope, where the cavity extends the full width of the drain and vertically by around 0.5m. The potential for future erosion of material that could be transported to the carriageway below is clear. Indeed, this may explain the oversized fill at the surface potentially having been placed as a means of preventing the erosion of standard drainage (typically Type A or Type B) media which can be more readily mobilised and transported.

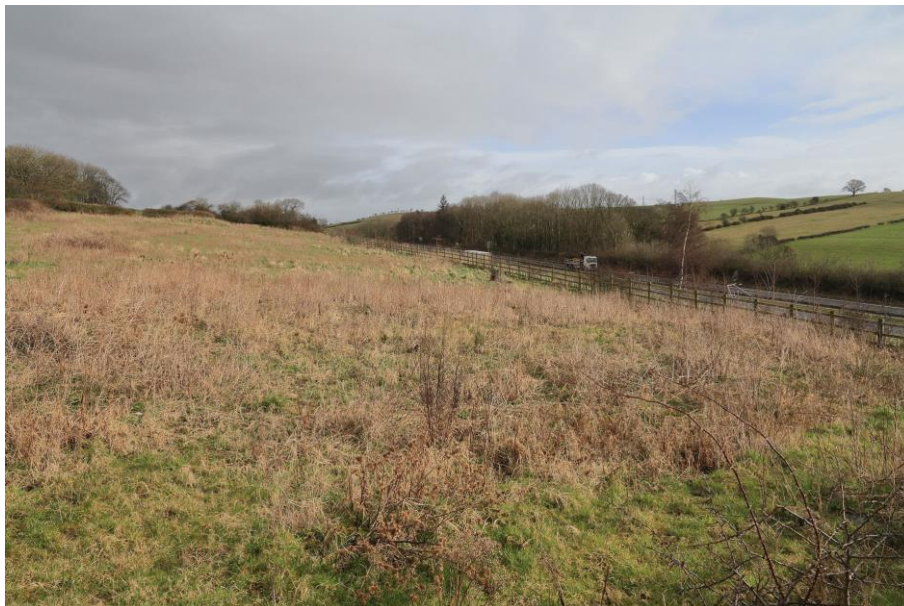
Figure 10: The field above the slope referred to in Figures 8 and 9, and Figures 11 to 12. While not particularly evident from the photograph the field forms a large bowl-shaped catchment, is observably boggy and wet, and the line of existing near-surface land drains are also evident in places (M6 J34 northbound on-slip, no SGM number, NGR SD 49665 65240, March 2021)

The primary function of a counterfort drain is to intercept the water from within the earthworks slope. There is, however, often a desire to additionally intercept surface and near-surface water from the earthworks slope and any slope above as well, including from existing drainage. The counterforts at the M6 Junction 34 site are understood to have been installed in response to washouts experienced and wet areas observed on the cutting slope during and after Storms Eva, Frank and Desmond. The need for adequate drainage of the cutting slope was very clear from observations made by the authors from the M6 during this time period. It is also clear that the field above (Figure 10) has a role to play in ensuring an effective

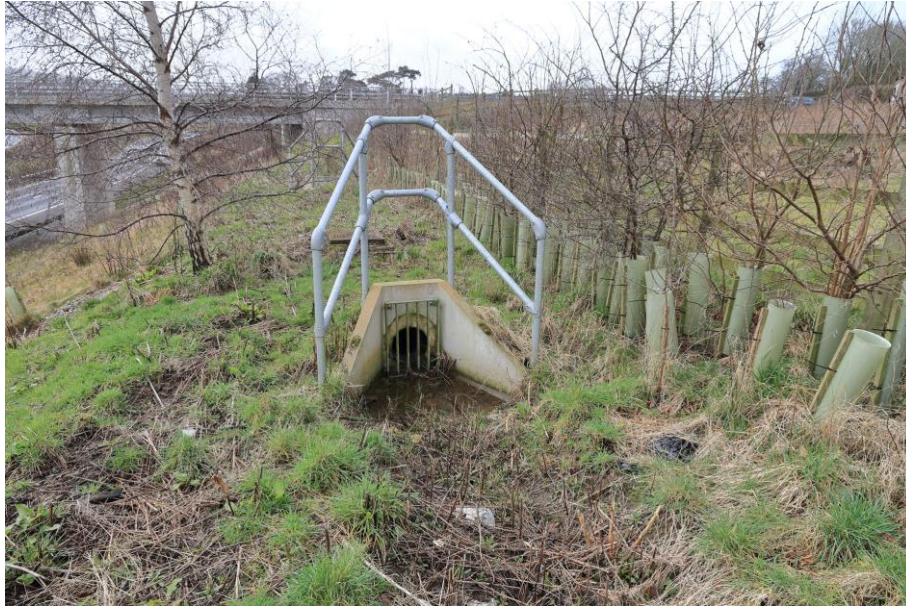
Figure 11: Slope crest drain and headwall intended to channel water into the counterfort drain below. Note the invert of the pipe is at a slightly higher elevation than the sidewall of the crest drain. As a result, water overtops the crest drain prior to entering the pipe and flows onto the slope and the Counterfort Drain below, see Figures 8 and 9 (M6 J34 northbound on-slip, no SGM number, NGR SD 49665 65240, March 2021)

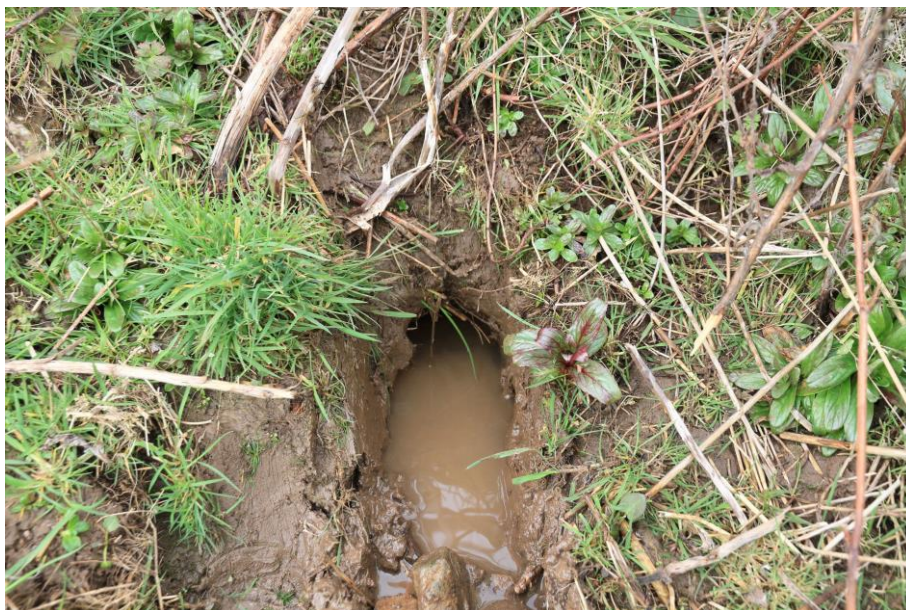
Figure 12: A land drain daylighting on the slope surface approximately 2m to 3m from the nearest counterfort drain (M6 J34 northbound on-slip, no SGM number, NGR SD 49665 65240, March 2021)

One of the land drains referred to above can be seen in Figure 12 where it reaches the slope surface approximately 2m to 3m from the nearest counterfort drain; a steady flow of water was observed, demonstrating that the drain was active following heavy rain the preceding day. Neither the crest drain at this site, nor the counterfort drains, intercept the existing field drains in an effective manner (this is one of several such instances that were observed at the M6 site).

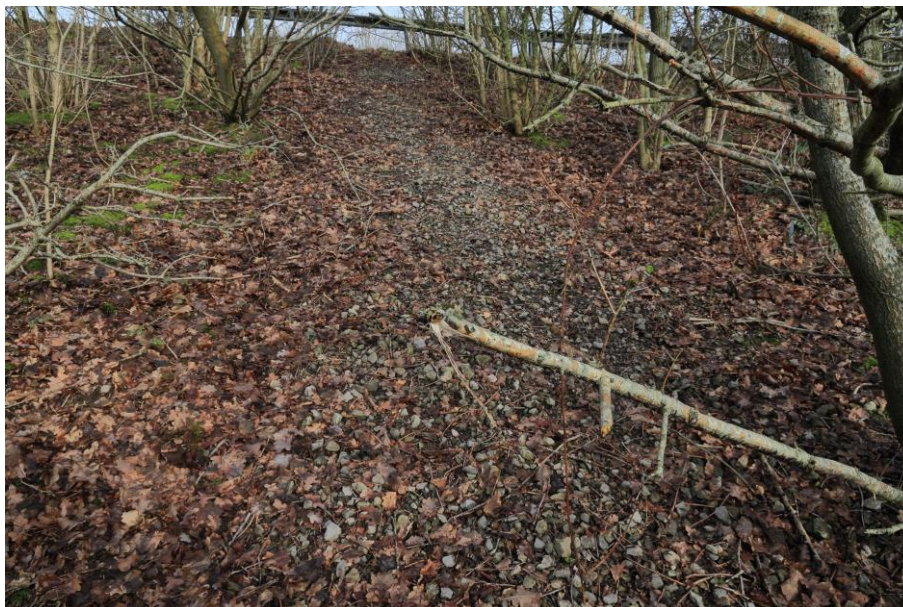
Figure 13: Counterfort constructed with the intention that it only act as a counterfort, that is without having a drainage function (A303, SGM 3329, January 2021)

The foregoing has focussed purely on counterfort drains. However, one site was encountered at which the counterforts were apparently designed without a drainage function (Figure 13) smaller sized aggregate was used, and the available design details allude to this approach. Clearly, this is a valid approach, but its benefits seem somewhat obscure especially as additional drainage was not introduced during the remedial works to install the counterforts and the counterforts appear to have been completely enclosed. The use of a suitable drainage media and a simple tie-in to the existing embankment toe drain would have been relatively straightforward and potentially added value to the project.

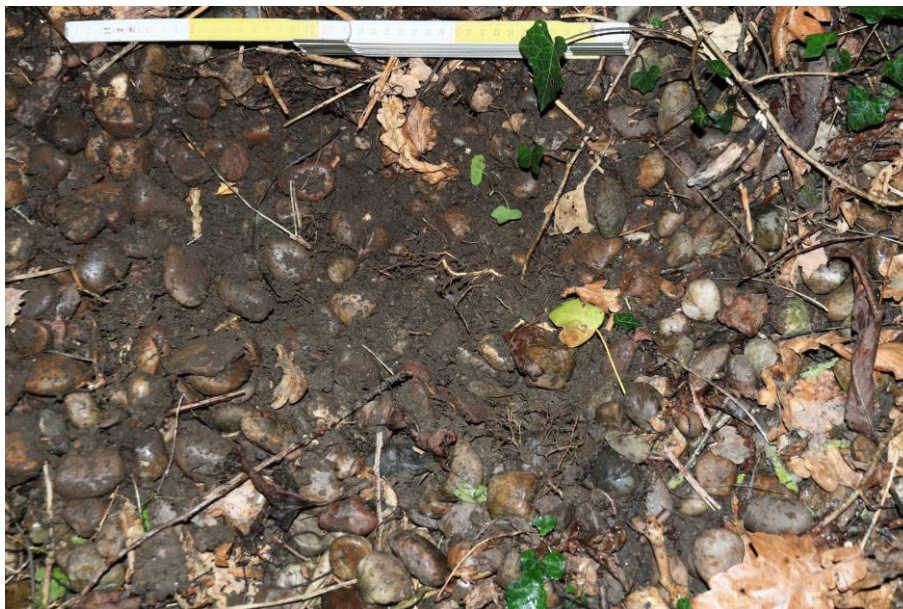
Figure 14: A counterfort drain that has become clogged over time with leaf litter, humous, fines and invasive roots (M42, SGM 9685, February 2022)

Issues surrounding clogging of counterfort drains (and filter drains in general) were also highlighted (Figure 14). Surface clogging due to a build-up of leaf litter and humous and washing in of fines (fouling) were all observed. This clogging was worsened where trees were found to be growing on top of the drain and also where roots had actively followed and invaded the course of drains (Figure 15).

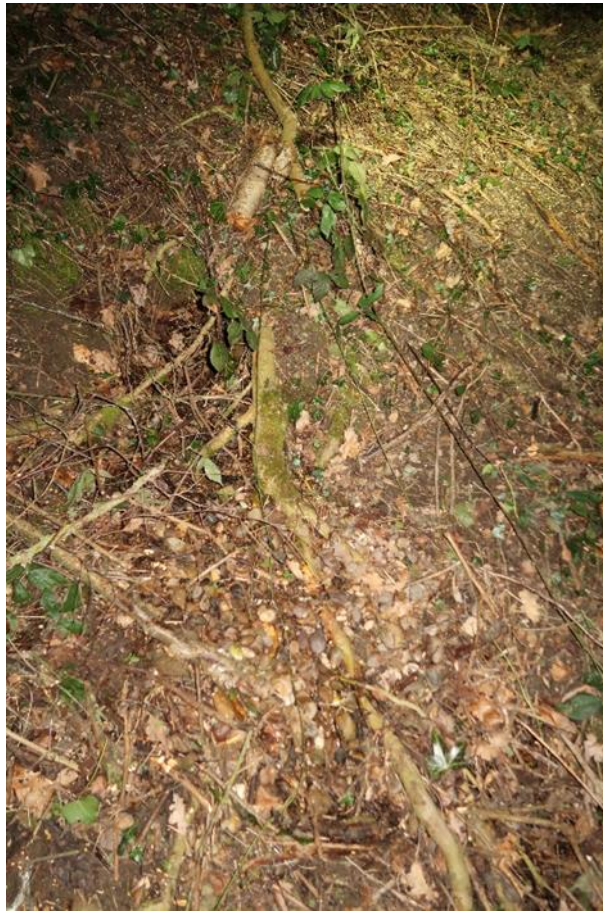
Figure 15: A counterfort drain with a series of tree roots following the drain (M42, SGM 9685, February 2022)

Counterfort Drains, Slope Drains and other filter type drainage are particularly prone to root ingress (Figure 15) which causes damage to the drain and can act to trap debris (Spink et al., 2014). Spink et al. (2014) and WRc (2012, 2018), in their 'Sewers for Adoption' documents, provide guidance on the proximity of different types of vegetation from drainage systems. They recommend that three metres either side of the drain are cleared of vegetation at least every seven years and provide guidance on the proximity of various types and species of vegetation. Counterfort Drains are typically spaced at between 5m and 10m and strict adherence to this guidance would render between all and approximately two-thirds of the slope free of trees and shrubs. As vegetation can assist with the management of water on slopes and the roots can have a reinforcing effect, there clearly needs to be a site-specific balancing of the advantages and disadvantages of vegetation planting. However, what is clear is that both planted and self-seeded trees and shrubs on slopes with Counterfort Drains will require active management during the service life of the drains and that this should include a commitment to ensure that debris from such activities is not deposited on top of the drains or in locations where it may migrate to the tops of the drains.

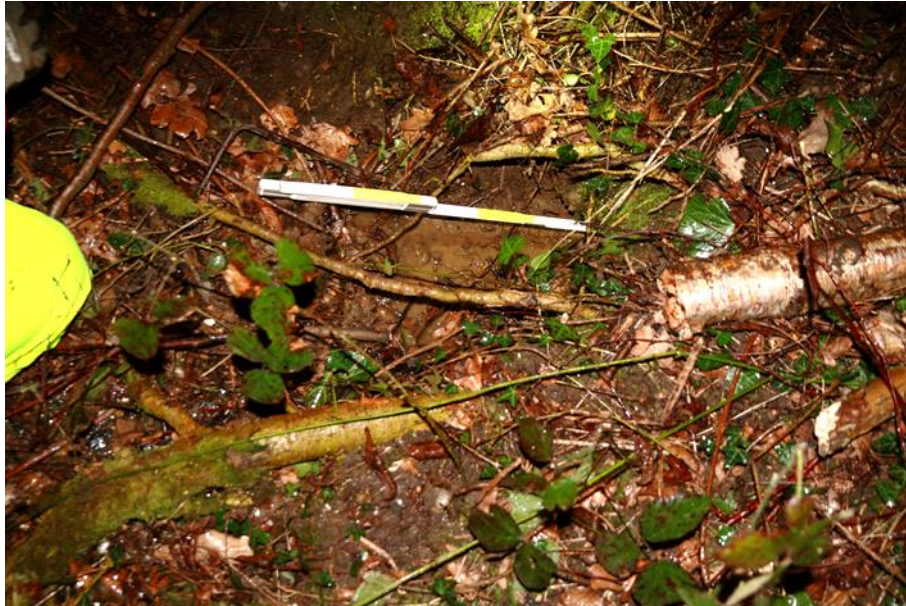
Figure 16: A spring like feature at the head of a counterfort drain (M42, SGM 9685, February 2022)

In contrast, the lower part of the slope was considerably wetter, and spring-like features were observed at locations consistent with a geological boundary (Figure 16). The flow of water from one of these features had caused soil to clog the surface of the drain (Figure 17) and

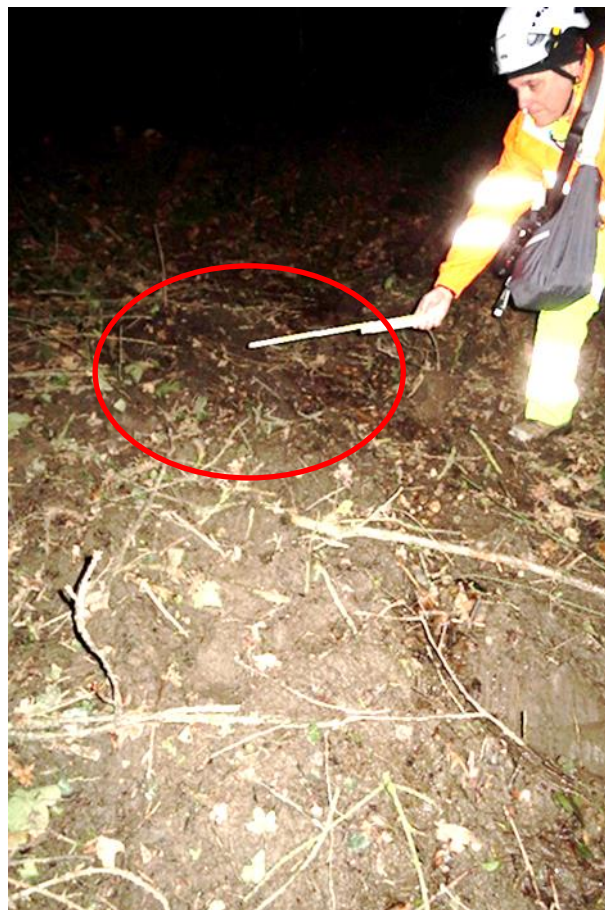
Figure 17: A spring-like feature at the head of a counterfort drain (M42, SGM 9685, February 2022)

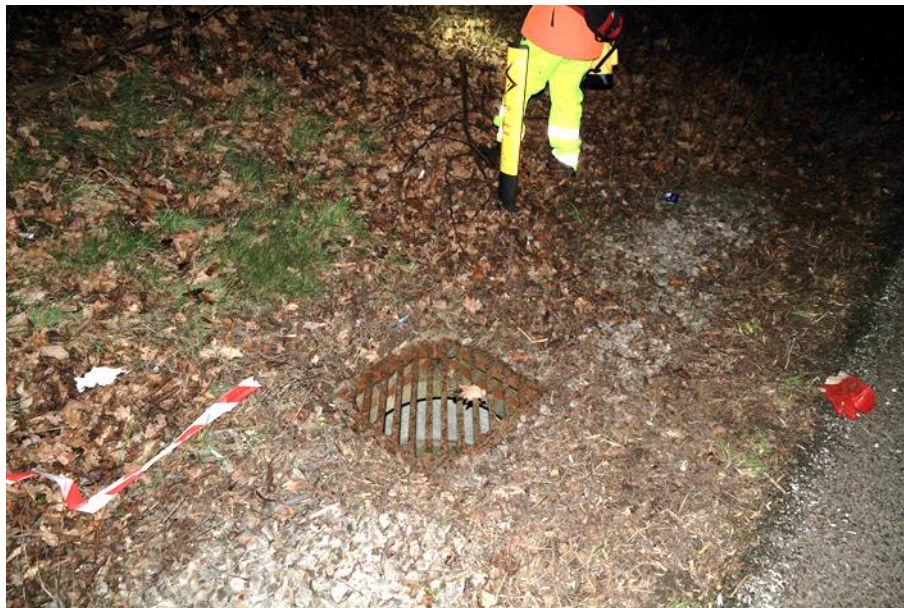
Figure 18: A vertical slope drain is located where the person is standing and the edge of carriageway filter drain runs along the verge with a grated catchpit visible in the foreground (M42, SGM 9685, February 2022)

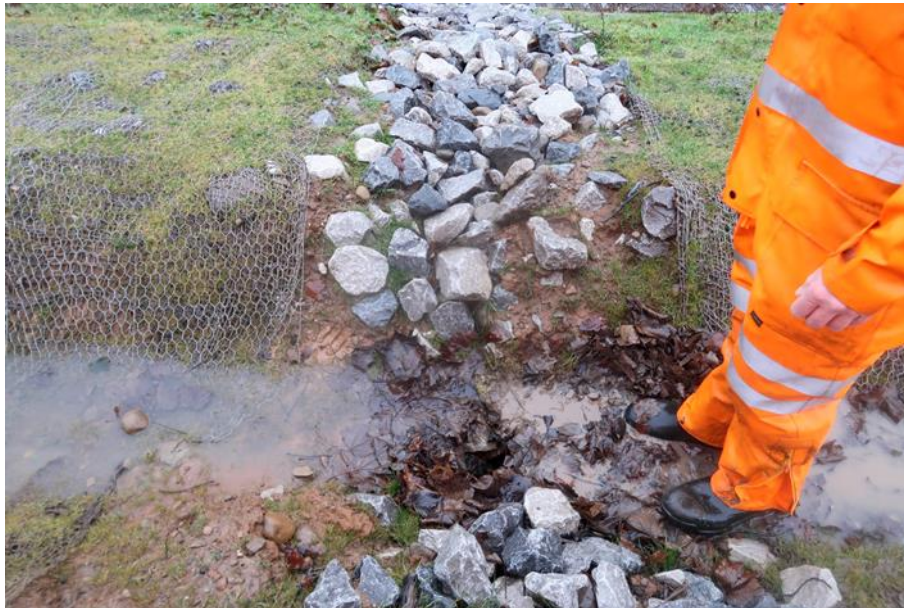
Figure 19: Direct connection of a Crest Drain into an un-modified Counterfort Drain. The rock fill (modified Class 6B) of the counterfort drain is exposed in the base of the Crest Drain. The rockfill has become clogged by leaf litter and soil carried by the surface water flow (image the authors: courtesy of Network Rail)

3. *Use as Carrier*: If Counterfort Drains and their constituent collector pipes are used, without modification, as a carrier to convey water from Crest and Interceptor Drains down slope (Figure 19) it is possible that the collector pipe, and thus the drain, will act as an infiltration feature, releasing collected water into the slope. Given the inherent difficulties in intercepting and collecting water, once it has been collected it should not enter any system where it can escape and potentially create an opportunity for infiltration into the

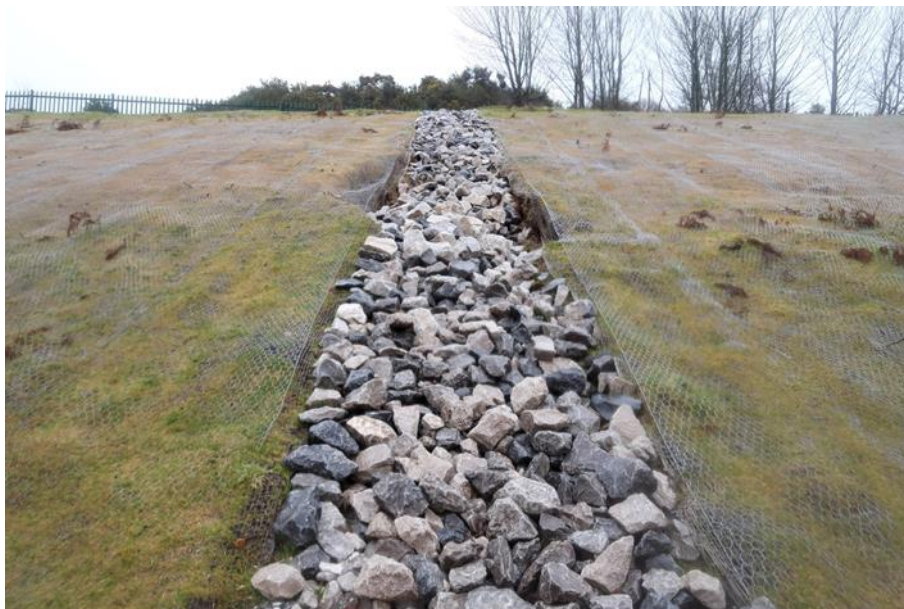
Figure 20: Collapse of a Counterfort Drain and surrounding slope due to internal erosion. The modified class 6B rockfill is in direct contact with the soils. Water could be heard flowing in the Counterfort Drain. The toe of the drain is shown in Figure 19 (image the authors: courtesy of Network Rail)

- b. Have sufficient energy to mobilise and transport soils and drainage aggregate leading to potential erosion, instability and internal erosion of both the slope and the drain. Figure 20 shows an unmodified counterfort drain, without a filter, which was used to convey water from a crest drain down the slope to a toe drain. Internal erosion led to collapse of the counterfort drain and the adjacent slope. The erosion of the drainage aggregate and the surrounding slope at a Counterfort Drain due to surface water flow onto the drain on the SRN has been observed at the M6 Junction 34 site.

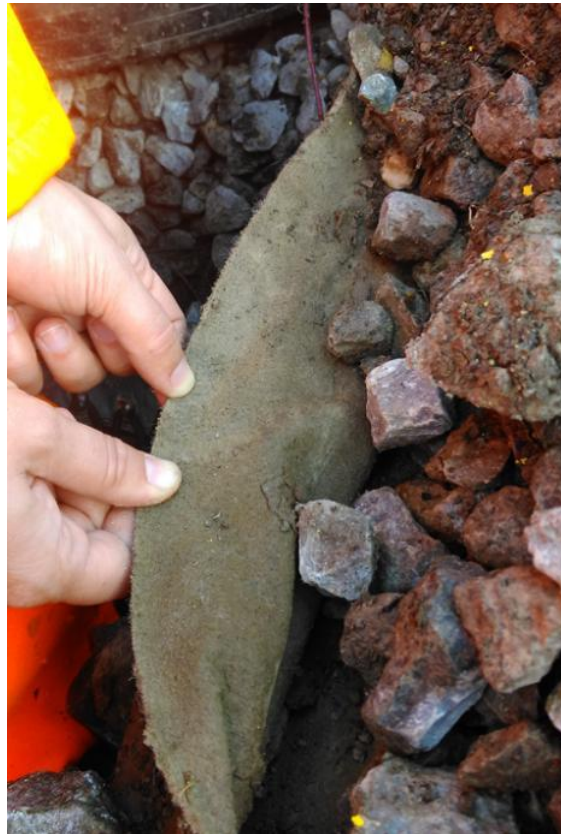
Figure 21: Geotextile filter separator on the upstream edge of a filter drain which had become fouled with fines during construction. The filter drain contains Type B drainage aggregate which is also fouled by fines (image the authors)

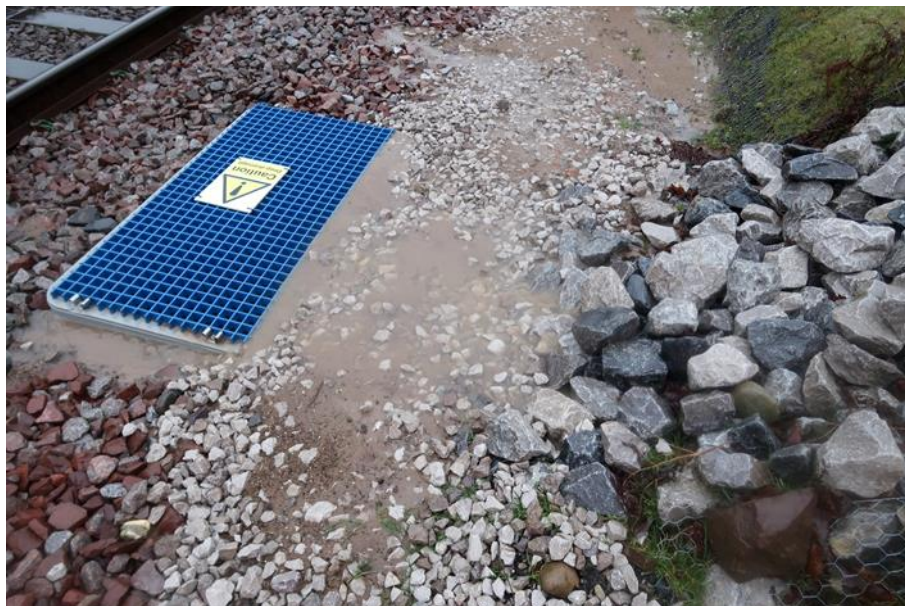
Figure 22: Toe of the Counterfort Drain in Figure 20 showing water issuing from the drain into the cess and carrying significant fines. The toe of the counterfort and the connection with the cess drain has become clogged by fines. Note that this is following removal of a previous build-up of deposited silt and sand (image the authors: courtesy of Network Rail)

6. *Inlet and Outlet*: The lack of positive and robust inlet/outlet connections. These enable the location, inspection and required maintenance of the Counterfort Drains. Their omission can lead to the drain outlet becoming buried and blocked, compromising its function. This can also lead to the drain becoming a means for water infiltration, increasing slope water, and reducing slope stability. The outlet should have a positive outfall at the discharge point to avoid infiltration and saturation of the slope, particularly near the toe (Figure 22).

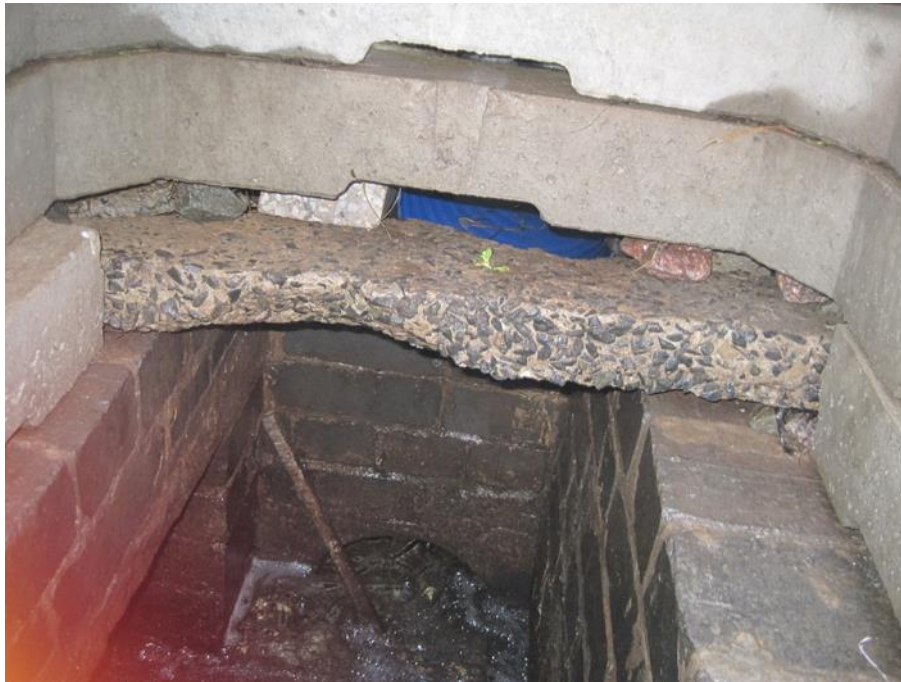
Figure 23: New upper level UPVC pipe (blue) installed above a historic clay pipe drainage system to increase the capacity of the drainage network. The upper pipe (blue) discharges against the sides of the catch pit rings as no opening has been formed (image the authors)

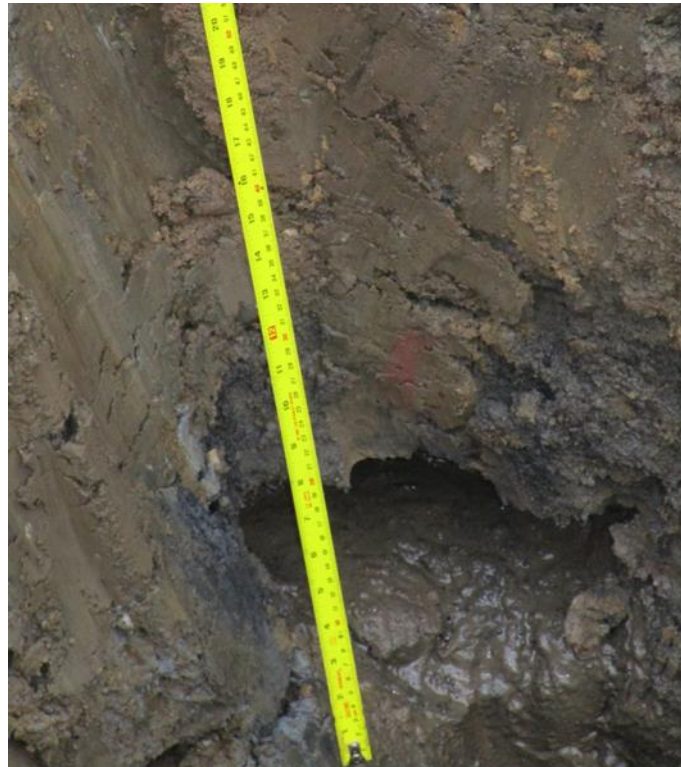
Figure 24: Example of a natural soil pipe, with significant water flow, encountered during the excavation of a crest drain above the location of a washout (debris flow) failure in till, west Cumbria (image the authors)

In addition to manmade land drains, it is the authors' experience, in particular in glacial deposits across northern England and Scotland, that many washout (debris/earth flow) or translational failures occur in locations where natural soil pipes² are observed during forensic inspection of the failures (Figure 24 and Figure 25).

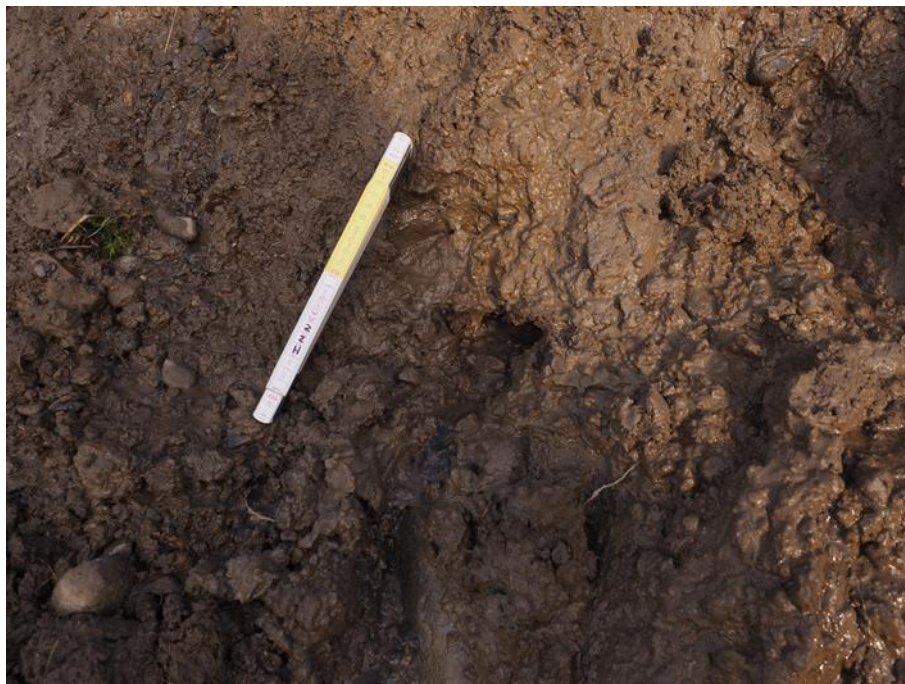
Figure 25: Example of one of a number of natural soil pipes, with significant water flow, observed in the back scar of a washout (debris flow) failure in till, west Cumbria (image the authors)

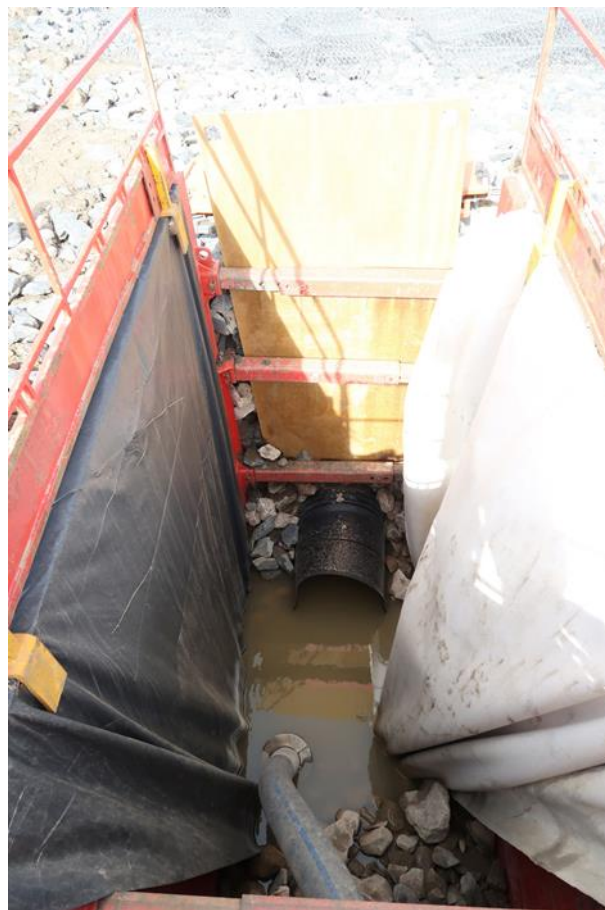
Figure 27: Filter drain excavation with trench support and over pumping of groundwater inflow on the Cumbrian Coast Railway (image the authors: courtesy of J. Murphy & Sons Ltd)

Excavation of trenches should be undertaken in short sections to mitigate for potential side wall collapse. In difficult ground conditions and for deeper excavations some form of trench support is likely to be required (Figure 27).

Where high surface or groundwater flows are experienced, it is likely that over pumping of water will be required (Figure 27).

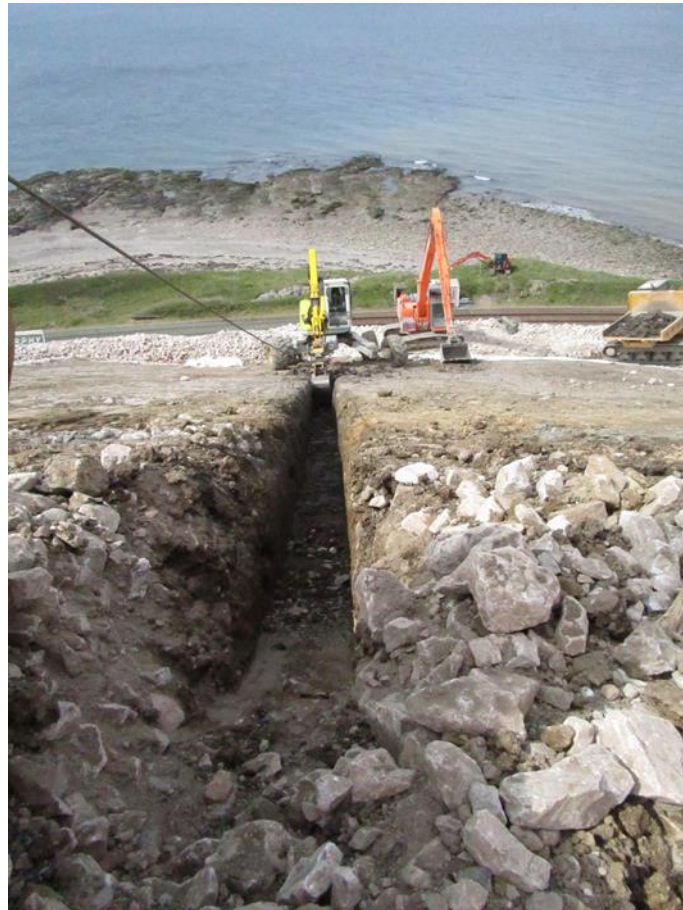
Figure 28: Tethered slope climbing excavator (Menzi Muck) installing Counterfort Drains on a large steep slope on the Cumbrian Coast Railway (image the authors: courtesy of J. Murphy & Sons Ltd)

For steep and or large slopes, specialist plant such as long reach excavators or slope climbing excavators (e.g. Menzi Muck or similar) are likely to be required from both an ease of access and a safety perspective (Figure 28).
