## **PUBLISHED PROJECT REPORT PPR1035**

# Forensic Examination of Critical Special Geotechnical Measures: Gravity Block Wall Information Note

M G Winter (Winter Associates Limited), M Duffy-Turner (Coffey Geotechnics Ltd) and I M Nettleton (Coffey Geotechnics Ltd)

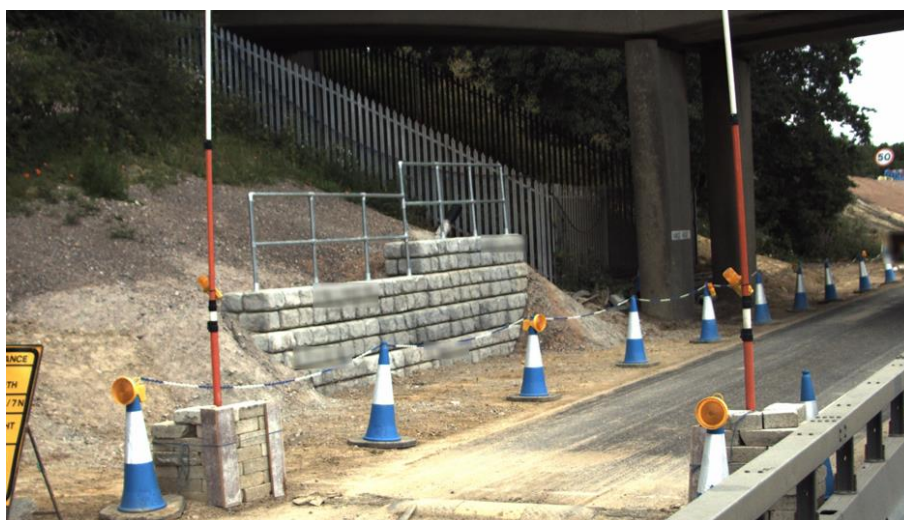
**Figure 1: Modular Block Wall on M23 J9 (©AVIS)**

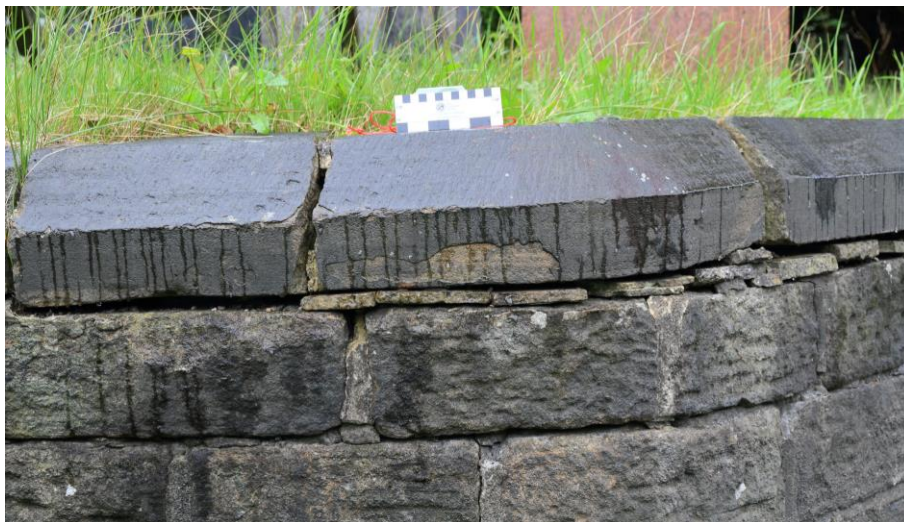
Deterioration of the upper courses was observed as was similar deterioration of the lower courses. The top course deterioration appears to be a result of surface water and/or direct precipitation and vegetation and, in most instances, this was accompanied by a loss of mortar (where present) (Figure 2). Deterioration of the lower courses could be caused by a build up of groundwater behind the wall and/or salt spray affecting the roadside face (Figure 3).

**Figure 2: Deterioration and mortar loss of the top course of a stone block mortared retaining wall (A628, SGM 8885 [unique SGM code from Atkins/Jacobs, 2020], October 2020)**

**Case study 3:** Mortared stone block retaining wall up to 1.65m high (A628, SGM 8885, Figures 2 and 7) The wall shows signs of bulging, leaning and deterioration (including mortar loss) of top course as well as potential changes to the asset alignment. The anomalies to the alignment of the courses relative to absolute level and road level are a cause for concern along with the lack of drainage to the roadside wall that retains the local cemetery. Further, potentially intrusive, investigation of this wall is recommended.

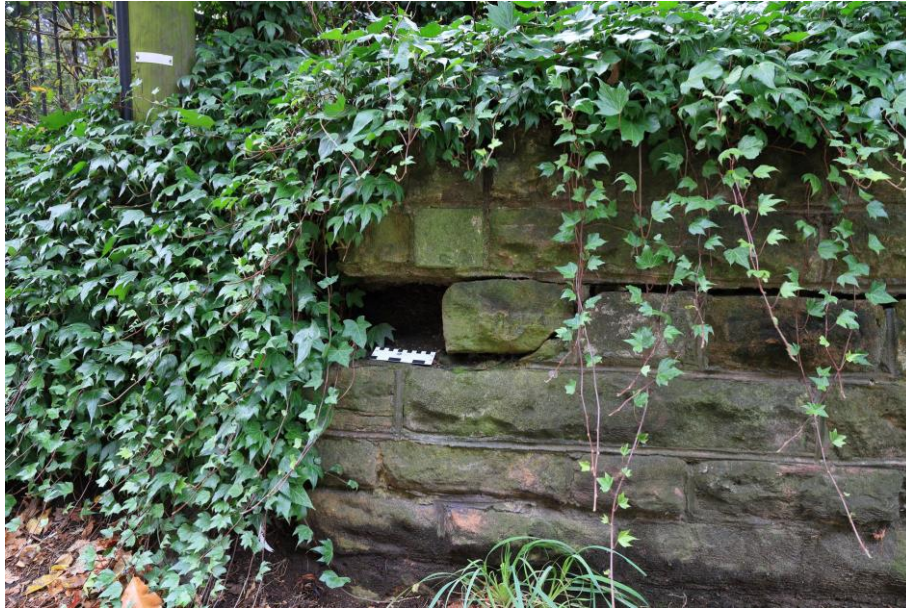
**Figure 3: Deterioration of the lower courses of a stone block mortared wall seems most likely due to salt spray. The deterioration of this wall at this location is through the full height with the loss of block(s) in the central area (A52, SGM 9676, October 2020)**

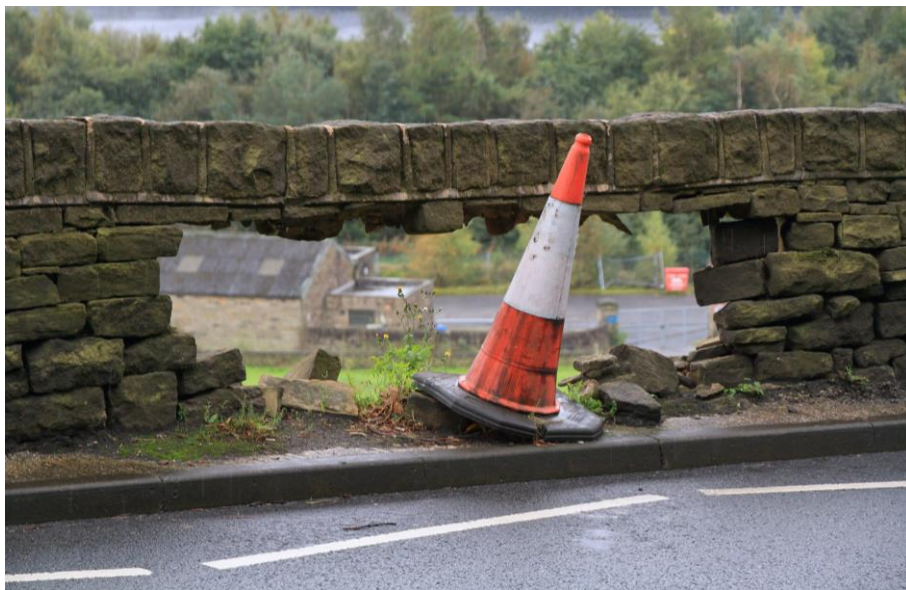
**Figure 4: Upper free-standing part of a dry stone retaining wall (mortared coping) showing the effects of vehicle impact. The wall below the carriageway retains a height of between 2m and 3m below the road. (A628, east of SGM 8885, October 2020)**

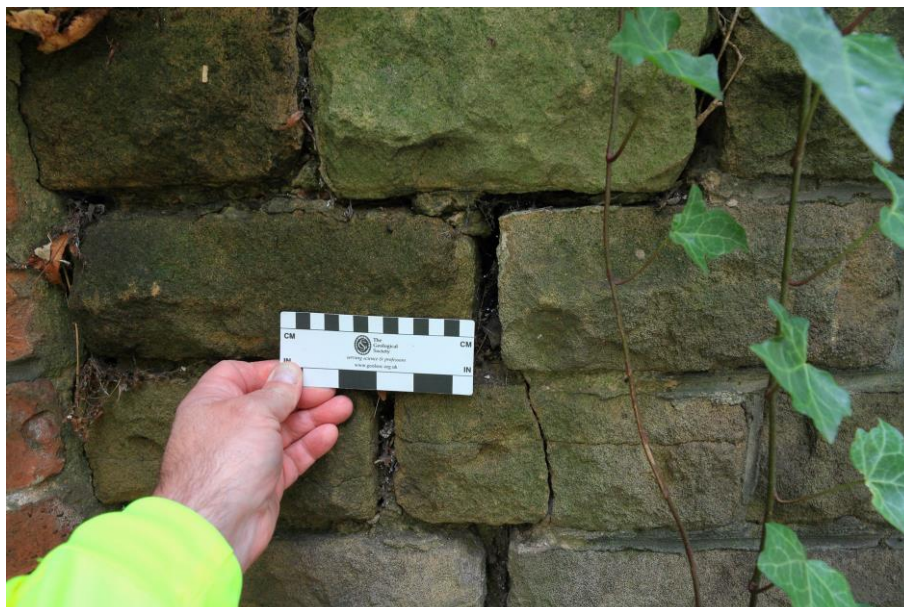
Cracking of blocks and mortar (Figure 5), bulging and leaning (Figures 6 and 7) were all observed during the site inspections. Sagging and hogging of a modular concrete block (mortar free) 'Porcupine'-type wall can also be observed in Figure 8.

**Figure 5: Cracking of stone block mortared wall (A52, SGM 9676, October 2020)**

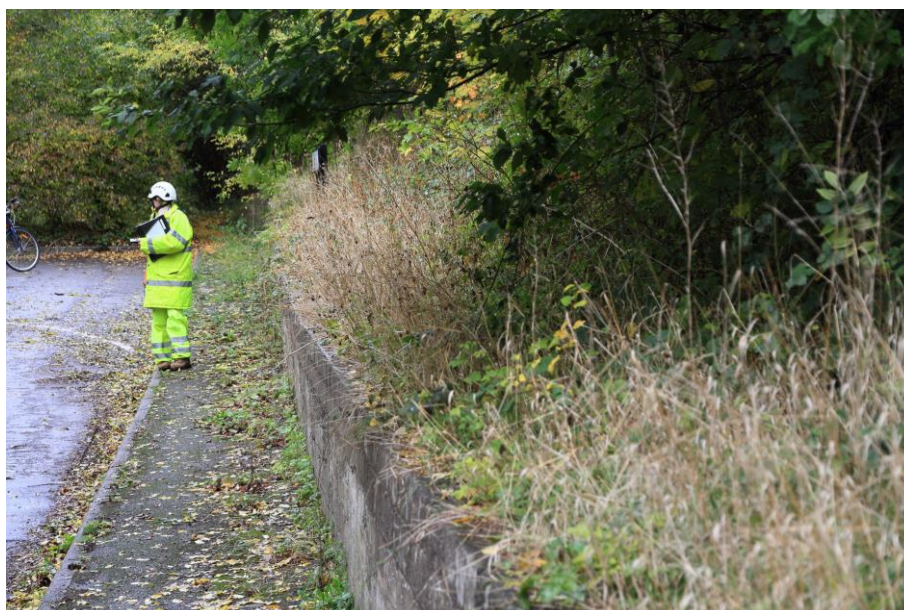
**Figure 6: Bulging and leaning of a concrete block mortared retaining wall approximately 0.9m high along base of embankment (A52, SGM 7825, October 2020)**

**Case study 1:** Mortared concrete block retaining wall, approximately 0.9m high along base of embankment (A52, SGM 7825, Figures 6 and 9). This wall shows signs of cracking, leaning and bulging. However, the complete failure of the wall is likely to cause only minor failure of the embankment but it is considered that this is unlikely to cause immediate damage to the road and/or vehicle restraint system and that it can be managed as and when it occurs.

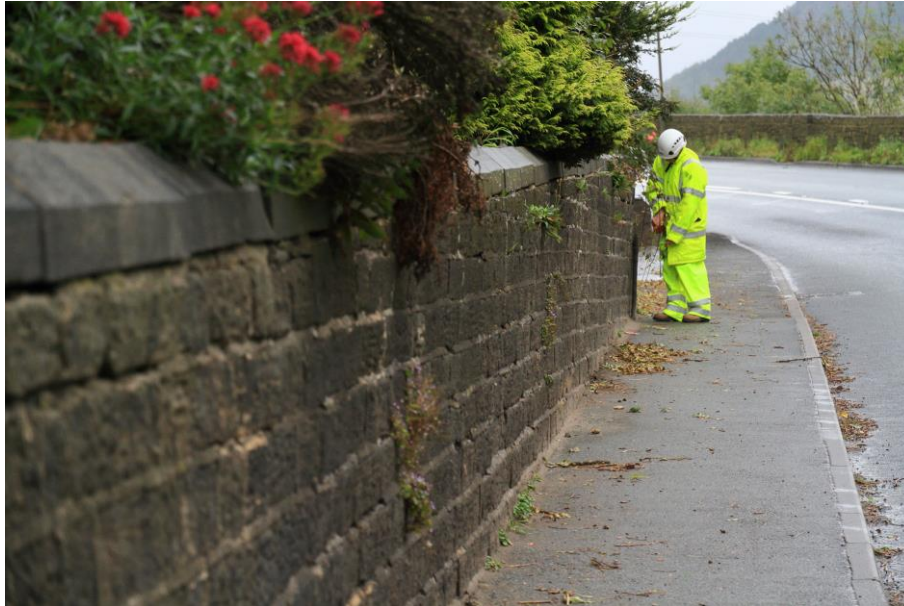
**Figure 7: Leaning stone block mortared wall of approximate height 1.65m. Signs are also evident of bulging and deterioration (including mortar loss) of the top course. Note the change in angle of the masonry courses, the angle between the courses and the coping stones and the vertical alignment of the highway (A628, SGM 8885, October 2020)**

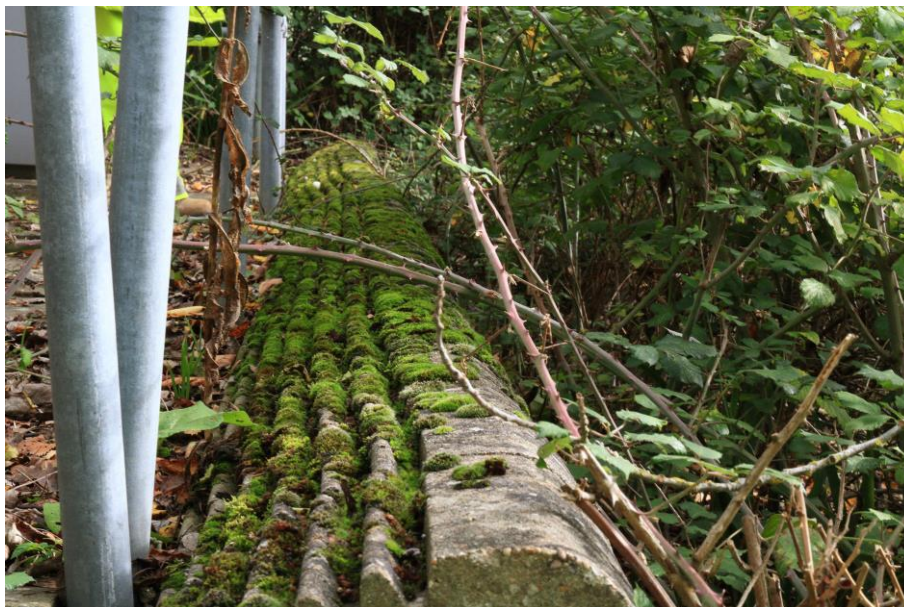
**Figure 8: 'Porcupine' modular concrete block wall showing signs of hogging, sagging and bulging. The wall is located in the middle of a slope showing significant signs of instability (A1307 (formerly A14), above SGM 6082 (Gabion wall), October 2020)**

**Case study 4:** 'Porcupine' modular concrete block wall (A14, above SGM 6082 (Gabion wall), Figure 8). This wall shows signs of hogging, sagging and bulging. While in isolation these are not cause for concern, wider observation of the slope on which the wall is situated reveals that the slope is showing significant and long-term signs of movement and that further investigation is necessary (Figure 16).

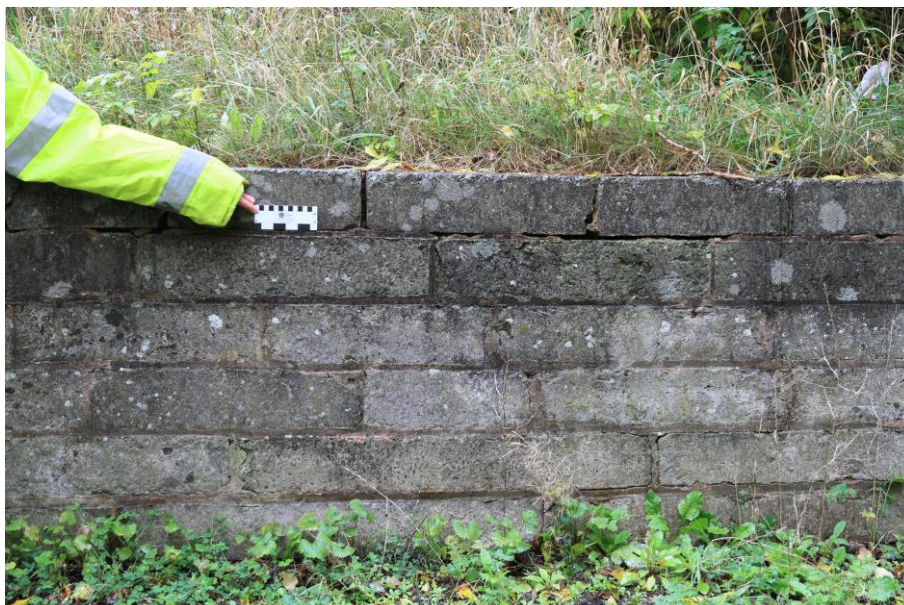
During the site inspections it was found that the provision of weepholes to Block Walls was relatively uncommon. Figure 9 illustrates an example in which there are no weepholes and seepage through the wall can be observed indicating a likely lack of adequate drainage behind the wall. Notable instances in which weepholes were visible are shown in Figures 10 and 11. In addition, no instances of a vertical drainage layer behind the wall being used were noted, although this can be difficult to identify and confirm without significant and invasive excavation. Where weepholes were observed these generally appeared to be working although in Figure 10 the washout of gravel particles may indicate that construction materials are also being washed out, indicating that there may not be a suitable filter / separator in the

**Figure 9: Mortared concrete block retaining wall, approximately 0.9m high along base of embankment showing signs of bulging, leaning and deterioration of top course (A52, SGM 7825, October 2020)**

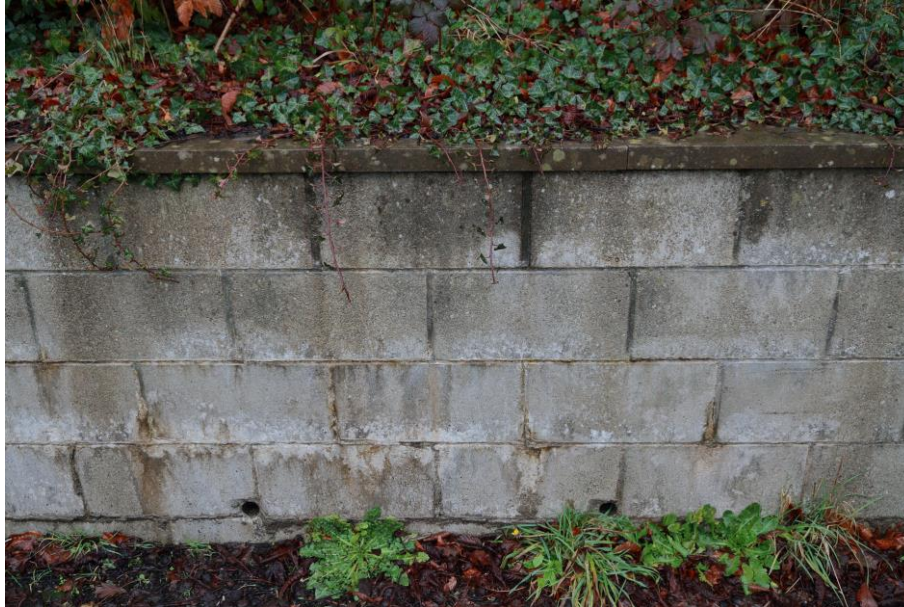
Significant evidence of what appears to be efflorescence was observed at one site (Figures 11 and 12). Efflorescence is formed by soluble salts being drawn out of blocks and concrete by the effects of water including, for example, condensation, rain, snow, dew, spray and the drainage of water through the wall. Efflorescence in and of itself is not generally an indicator of long-term durability issues it can be unsightly. While such aesthetic concerns are unlikely to be an issue on most of the SRN there may be some areas where it does create aesthetic

**Figure 11: Weepholes (50mm internal diameter) in a 57m long, 1m high concrete block wall. The weepholes were observed to be functional, and what appears to be efflorescence was observed in the blocks and mortar (A38, SGM 10857, January 2021)**

**Case study 5:** Concrete block mortared wall where efflorescence is evident in both the blocks and the mortar (A38, SGM 10857, Figures 11 and 12). Efflorescence can be an aesthetic concern in areas accessible to the public and in such cases, cleaning may need to be considered as part of the maintenance regime. The associated osmotic effects can also cause large hydrostatic pressures within block leading to spalling and observations targeted at identifying this phenomenon shadow be part of the inspection regime.

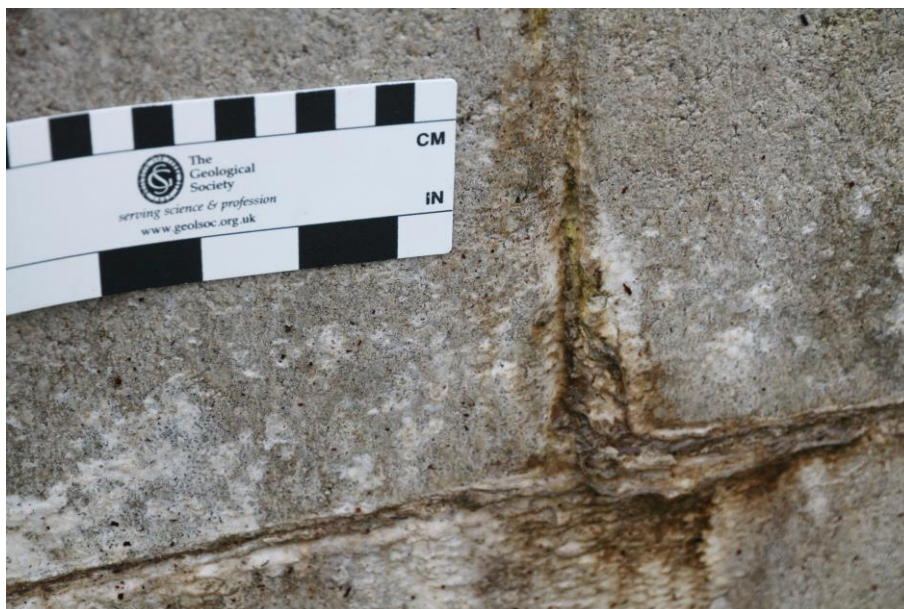
**Figure 12: Concrete block wall showing what appears to be efflorescence in the blocks and particularly in the mortar (A38, SGM 10857, January 2021)**

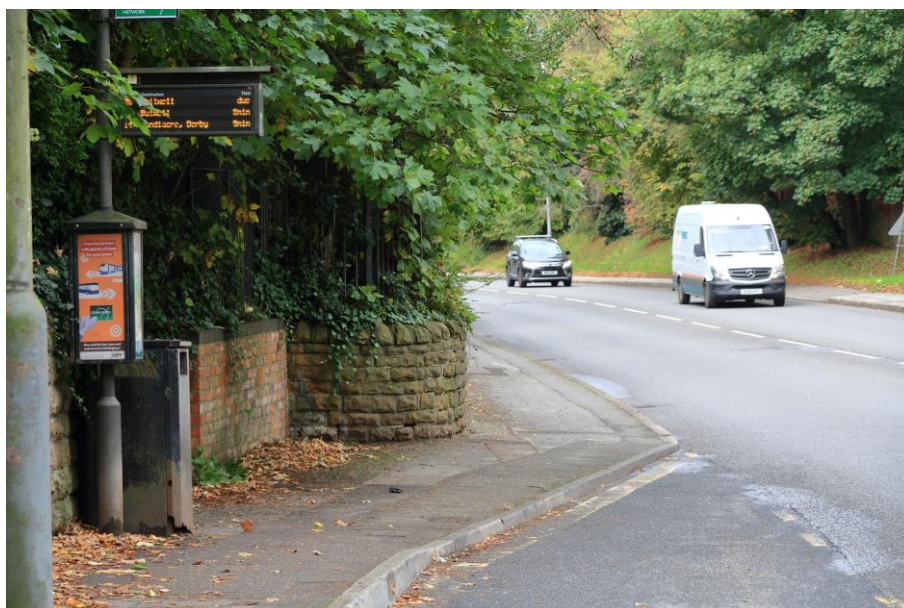
**Figure 13: Mortared stone block wall up to 1.7m high showing signs of leaning, block and mortar loss. Brick infills seem to coincide with former driveways; where the block wall is now retaining this may not have been the case originally (A52, SGM 9676, October 2020)**

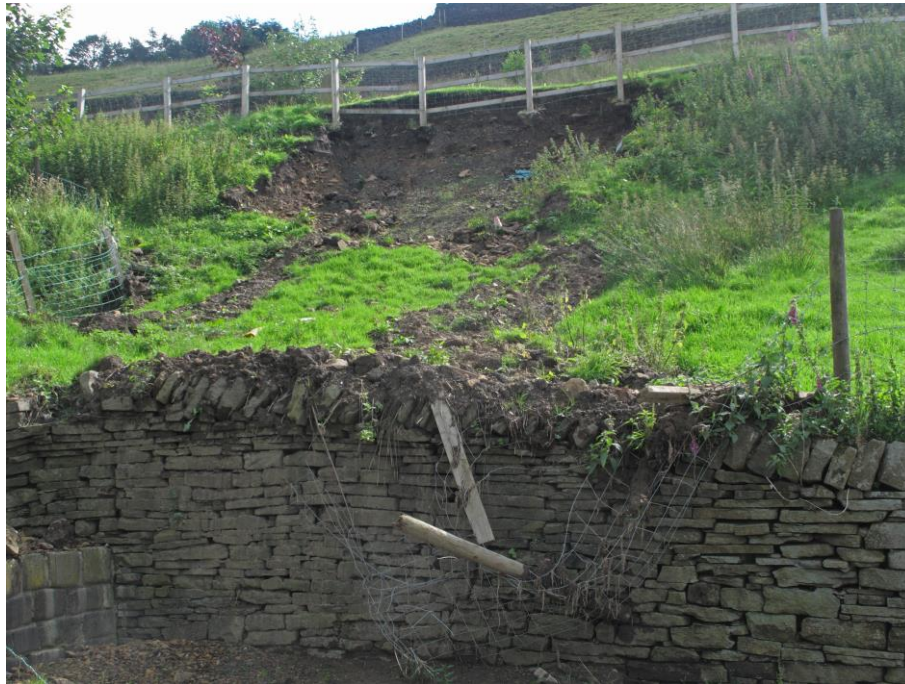
Notwithstanding the issues outlined above, dry stone walls in particular can be a relatively resilient form of structure and Figure 14 shows such a wall that has resisted the effects of a small landslide which has overtopped the wall.

**Figure 14: Dry stone retaining wall approximately 1.2m height that has been affected by the failure of the slope above (off network, West Yorkshire, August 2012)**

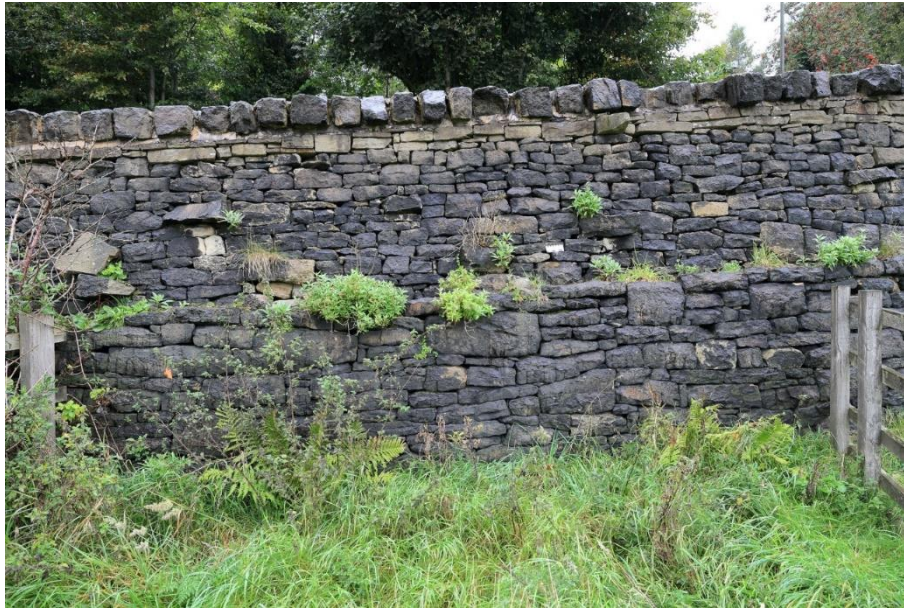
**Figure 15: Dry stone wall approximately 2.5m high including 0.5m free-standing (A628, SGM 8923, October 2020)**

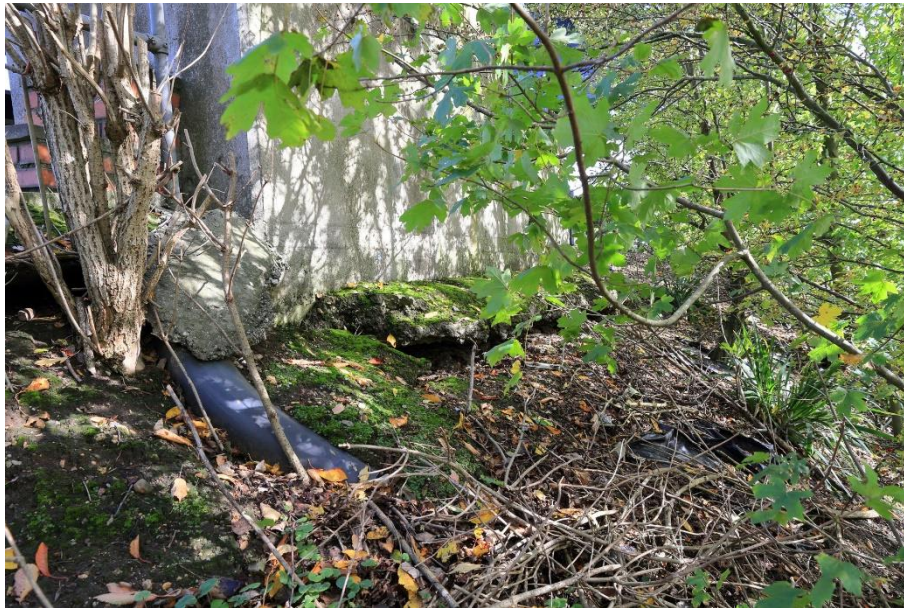
**Figure 16: Slope above the 'Porcupine' modular concrete Block Walls (Figure 2) showing settlement beneath the foundation for a variable message sign and significant long-term twisting of tree trunks indicating a wider instability issue (A1307 (formerly A14), above SGM 6082 (Gabion wall), October 2020).**

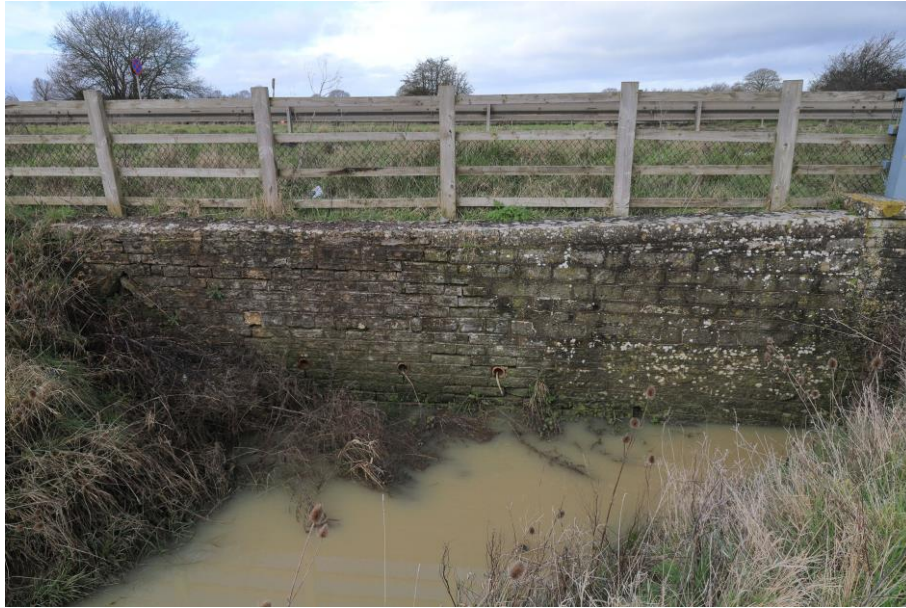
**Figure 17: Stone block mortared wall showing significant signs of instability (A303, SGM 1268, January 2021).**

**Case study 6:** Stone block mortared wall (A303, SGM 1268, Figures 17 and 18) forms the headwall to a deep drain that subsequently leads to a larger channel (Bearley Brook) that passes under the carriageway. Visual observations indicate that there is substantial mortar loss, sagging and bowing of the wall and that, in places, this has led to substantial misalignment of the individual blocks with the potential for individual blocks, or groups of blocks, to be lost. Failure of the wall would most likely lead to undermining of the foundation of the vehicle restraint system (just visible through the wooden fence in Figure 17). It is recommended that further assessment of the stability of the wall is undertaken. It is also notable that remediation works have been carried out to the wall effectively burying the structure in the area immediately adjacent to the wall pictured in Figures 17 and 18.

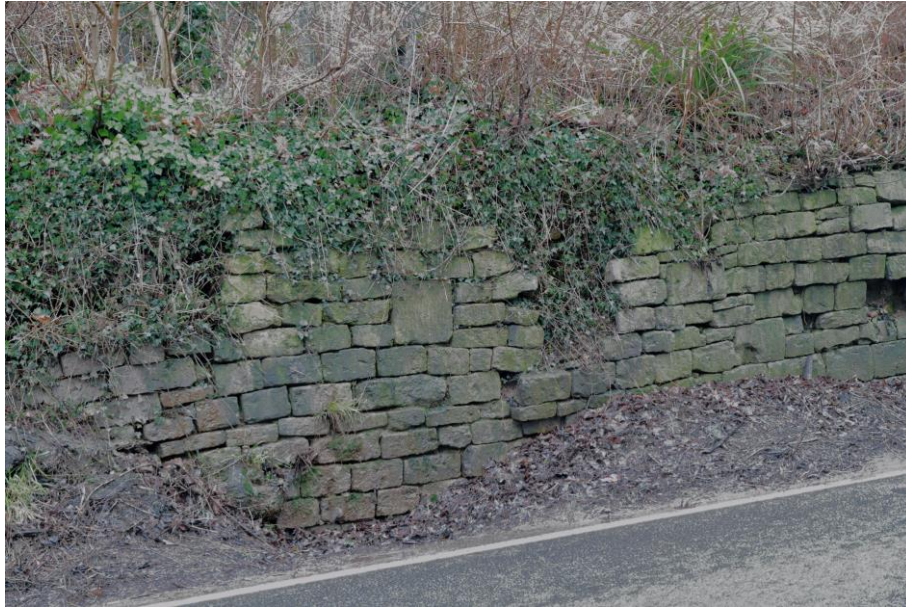
**Figure 19: Dry stone wall showing significant signs of instability (A36, SGM 9077, January 2021).**

**Case study 7:** Dry stone wall (A36, SGM 9077, Figure 19) immediately adjacent to the carriageway exhibits substantial bowing, distortion and block loss as a result of vegetation invasion, landsliding and potentially the action of frost and de-icing damage. It is clear that reconstruction of this wall is a priority and it is understood that this is planned for the near future.
