PUBLISHED PROJECT REPORT PPR1036

Forensic Examination of Critical Special Geotechnical Measures: Gabion Wall Information Note

M Duffy-Turner (Coffey Geotechnics Ltd), M G
Winter (Winter Associates Limited) and
I M Nettleton (Coffey Geotechnics Ltd)

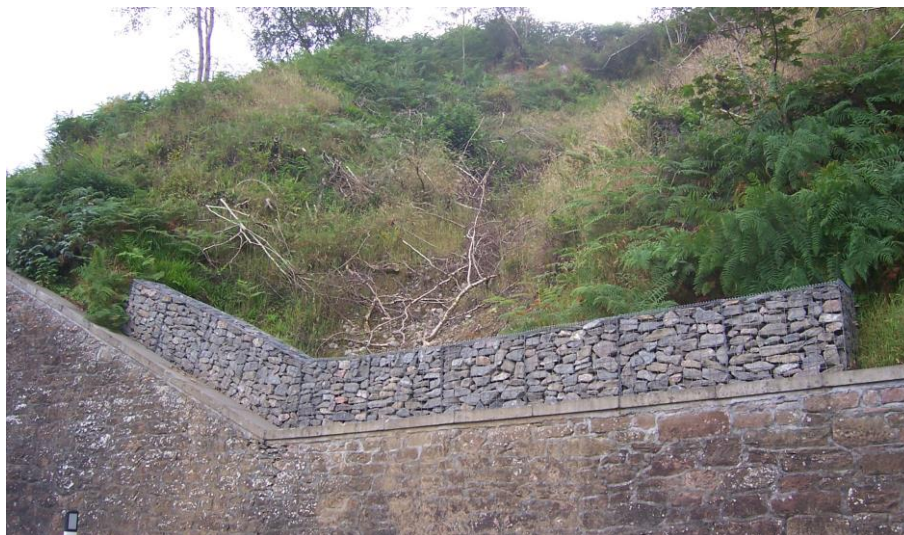
Figure 1: Example of a retaining structure formed from Gabion baskets (from Winter et al., 2009)

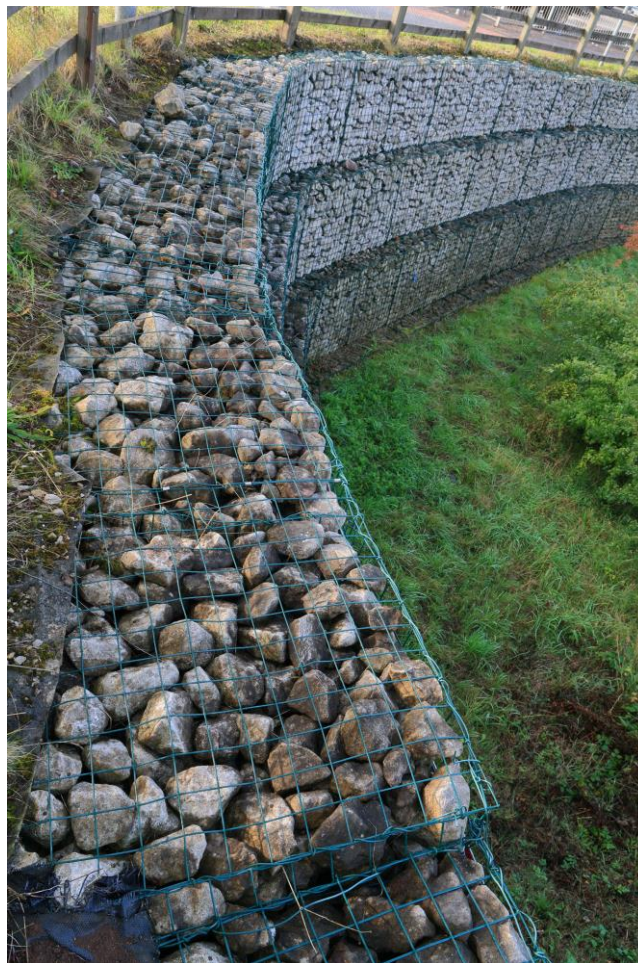
Figure 2: Curved Gabion Wall (A38/A61 Junction, SGM 7630 [unique SGM code from Atkins/Jacobs, 2020], October 2020)

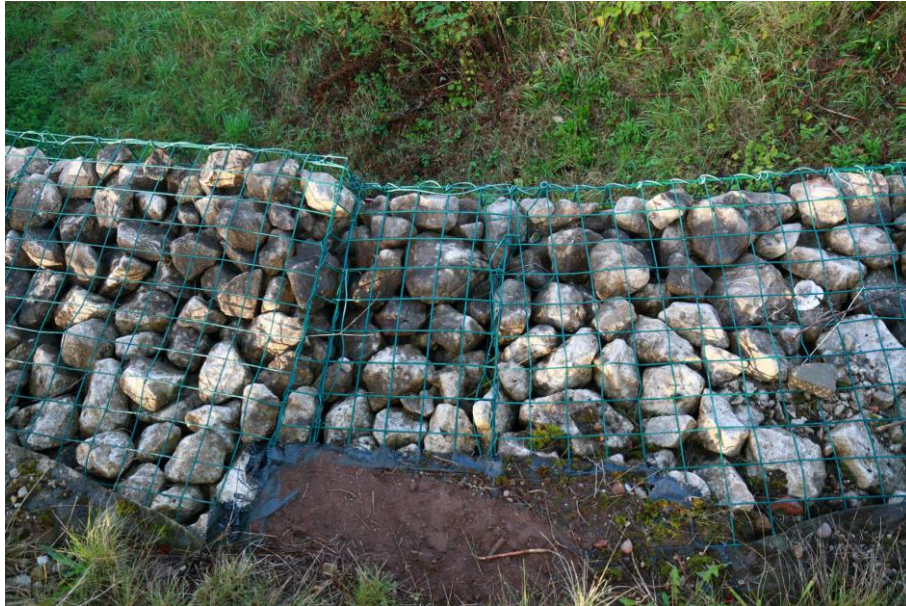
- That the visible faces (front, side and top) of welded mesh baskets were often seen to overlap with adjacent baskets with a single piece of mesh forming the panel to more than one basket in whole or in part (Figure 3). Effectively the walls were not comprised of individual baskets but of inconsistently interlinked and overlapped panels; this will render any future repairs and decommissioning both difficult indeed and potentially hazardous.
- Cutting of wires and wear to the corrosion protection may be introduced, both of which may reduce the service life of the wire (Figures 4 and 5).
- The incorrect fastening of baskets compromising the structural integrity of the individual baskets (Figure 6).

Figure 3: Top view of a curved Gabion Wall showing overlapping front panels (A38/A61 Junction, SGM 7630, October 2020)

It is recommended that modifying gabion baskets on site shall be reserved for only those instances in which recognised manufacturers cannot produce a prefabricated suitable solution. Any modifications should be done in accordance with manufacturer's instructions and will require agreeing as part of the technical approvals process.

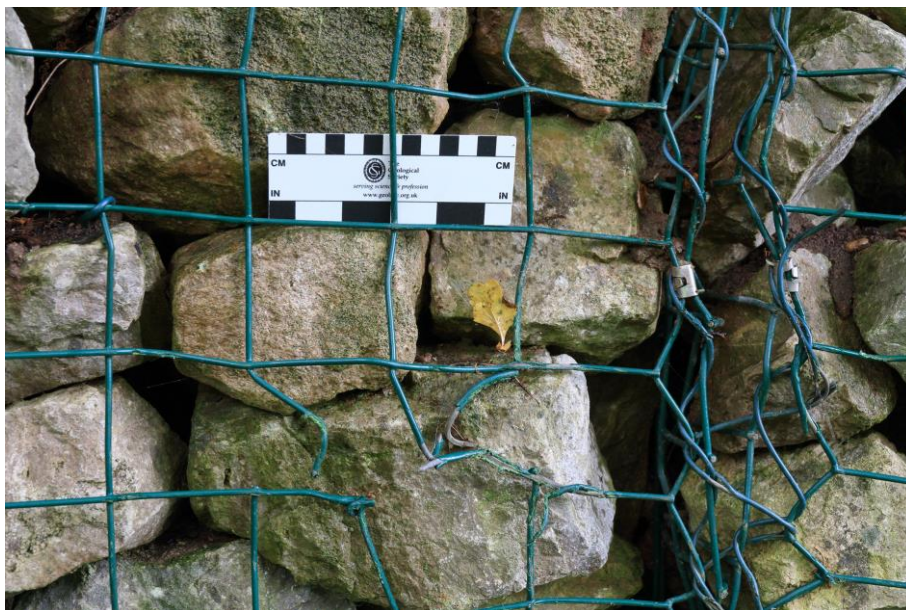
One issue that was observed for welded mesh baskets, but is relevant to both types, is that large voids can be created if filling of the baskets is not undertaken with great care. This can lead to movement of the fill within the basket during the service life putting undue strain on the mesh and the system used to join the panels of the baskets, where additionally the baskets are formed from welded mesh this may cause undue strain on the welded joints. This is a particular issue when non-rectilinear are used to accommodate, for example, curved walls (Figures 2 and 3) and typically such walls are formed using welded mesh baskets, but the primary point relates to both basket types and such internal movements, if sufficiently great, could potentially compromise the overall stability of the structure.

Figure 4: Large voids can be left if baskets that are not rectilinear are not filled correctly. The void reaches back for more than 0.5m behind the front facing stone in the left hand basket (A45/A46 Junction, SGM 9117, October 2020)

Other than where carefully placed (e.g. Figure 10), the use of oversized stone was associated with significant voids. Such voids were also associated with undersized material that could be readily removed from the baskets (e.g. Figures 8 and 11).

Placing gabion baskets in areas in which vandalism may readily occur, including adjacent to public footpaths, especially where those using the footpath are shielded from view (Figures 4 and 14) for example, and the use of low height baskets where vehicle overrun may cause damage (Figure 15) should be very considered carefully.

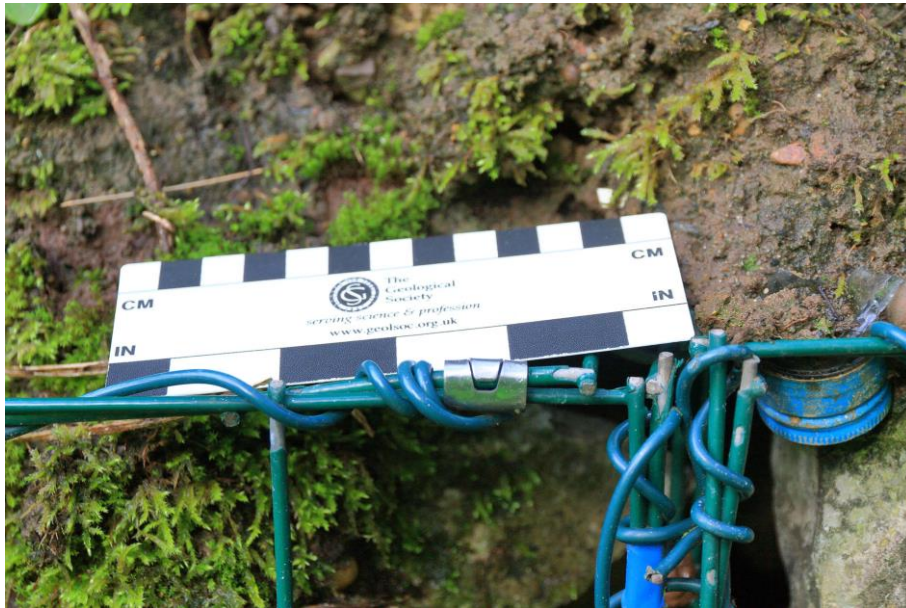
Both galvanised and plastic-coated corrosion protection were observed and both good and bad instances were observed of each. The poor examples showed damage (possibly transport, construction, site or general wear) to the corrosion protection (galvanisation and plastic) on some of the welded baskets which could be peeled off using the observer's fingers without difficulty (Figure 7). Corrosion or damage to the corrosion protection was not observed on

Figure 5: Plastic coating peeling away at the edges of the gabion basket where the mesh and wires have been cut (A45/A46 Junction, SGM 9117, October 2020)

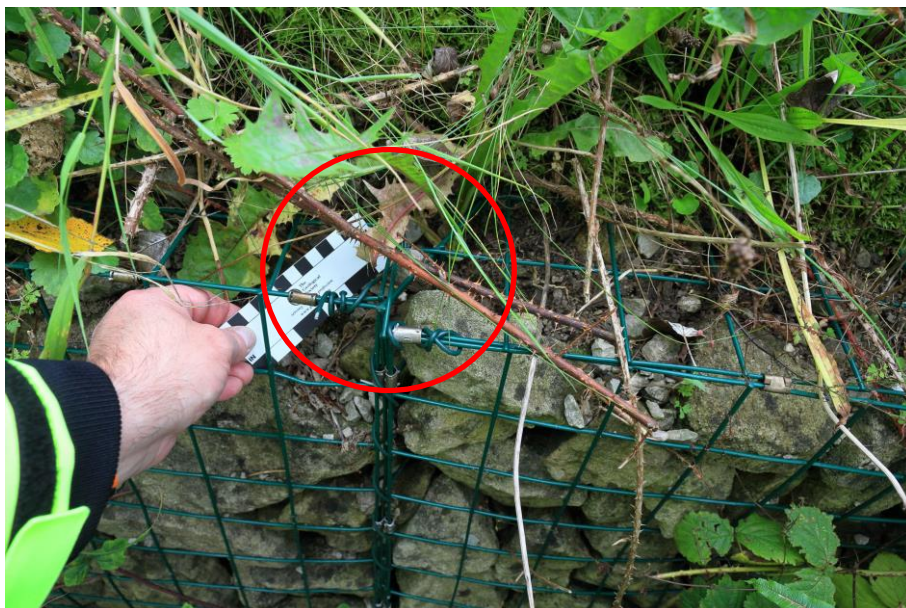
Figure 6: Top of gabion basket fastened to the adjacent basket compromising the structural integrity of the basket (M60, SGM 5281, October 2020)

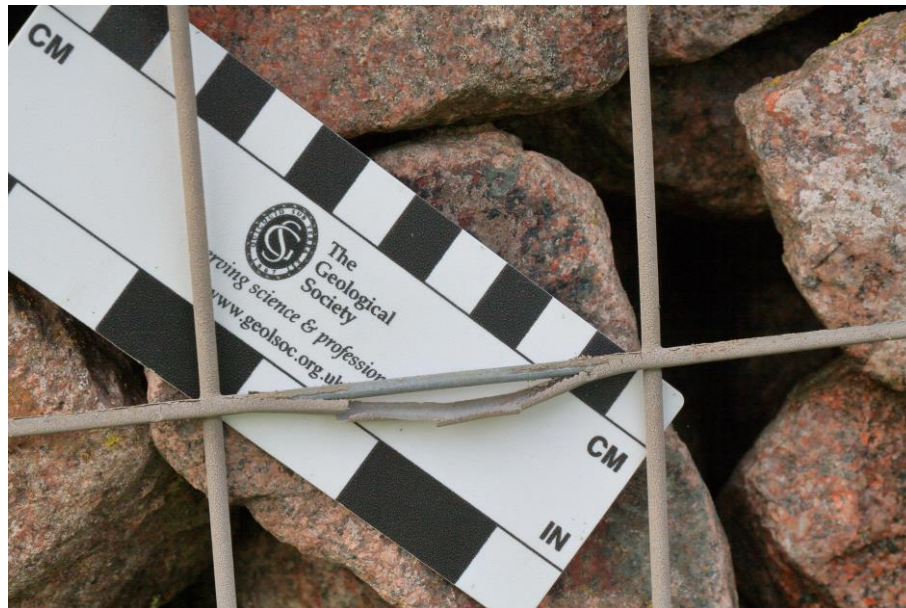
Examples of a plastic coating upon galvanisation were observed in some locations (Figure 7). In one case the coating appeared to be brittle and thin and was considered to be unlikely to conform to the requirements in the MCHW.

Figure 7: Coating peeling away from mesh on welded gabion basket (A453, SGM 4025, October 2020)

A wide range of stone fill materials has been observed from a granite, that clearly conformed to the requirements of MCHW (Figure 7) to a shale (argillaceous) that did not and was showing significant signs of deterioration (Figure 8). Significant deterioration causing settlement of the fill was observed in the latter material. Signs of deterioration in both sandstone and limestone rock fill were also observed, albeit not to a degree so as to raise concerns about the long-term integrity of the fill. Other seemingly unsuitable fill materials observed, that would most likely not meet the MCHW requirements, included chalk and waste-derived concrete, asphalt and brick (e.g. Figure 9).

Recommendation 7: Issues identified during the site inspections highlighted that double corrosion protection was not always used and that the wire may be thinner than required; therefore, it is apparent that further enforcement of the specification is required by the Works Examiner.

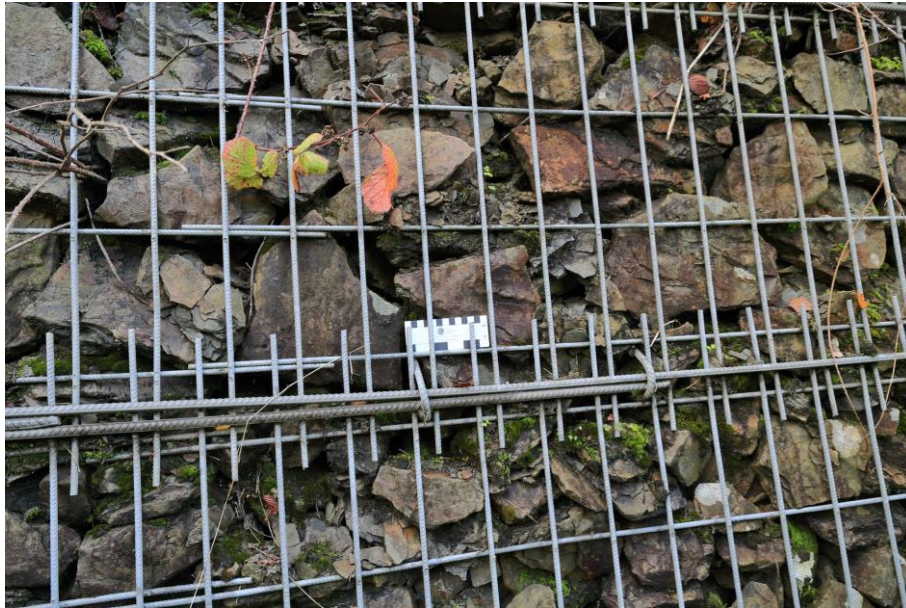
Figure 8: Shale showing significant signs of deterioration: this material is considered not to meet the MCHW requirements (M60, SGM 7038, October 2020)

Recommendation 3: That the requirements given in MCHW Volume 1 Clause 626 be updated to (say) ‘stone fill used in gabion walls should be sufficiently durable so as not to suffer deterioration sufficient to impair the performance of the system during the design life of the installation’. This brings the recommendation broadly in line with BS 8002:2015 and would prevent the use of inappropriate stone fill.

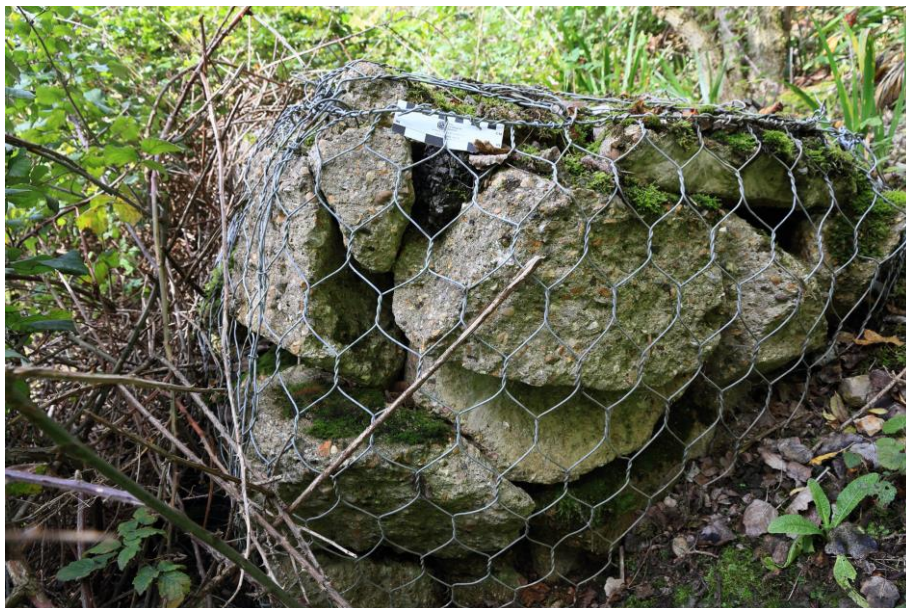
The fill used in the gabion baskets pictured in Figure 9 is also oversized compared to the allowable limit in the MCHW. This undoubtedly contributed to the overall unsatisfactory condition of the baskets which were observed to be barely containing the fill due to distortion and breakage of both the wire and the fastenings. The embankment slope retained by the gabion wall was observed to be moving which may be attributed to loss of support from the gabion below. At the crest of this slope was a concrete foundation which was becoming undermined by the slope movement below.

Figure 9: Oversize concrete fill leading to large voids within the gabion baskets. The oversize fill also means that the gabions have been unable to be properly sealed along the top, instead they are secured at pinch points where the fill allows (A42, SGM 6082, October 2020)

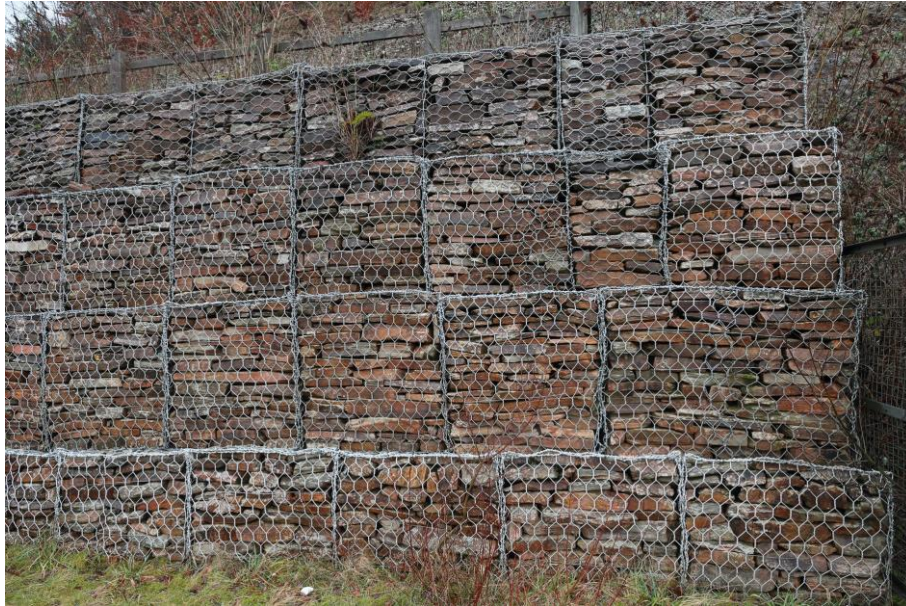
One example, for which the maximum size of fill was exceeded (Figure 10) used carefully placed local building stone to provide an attractive finish to the baskets. Although the maximum fill size was exceeded this is generally considered acceptable, provided that a Departure from Standards was granted in advance of the Works.

Figure 10: Gabion wall with local building stone used to provide an attractive front face (note that the use of the baskets at ninety degrees to their normal orientation is not considered to be problematic). These gabion baskets were the only instance of double corrosion protection observed during the site inspections. (A38, no SGM number, January 2021)

Recommendation 6: Gabion fill which does not meet the requirements of the MCHW should not be used on site unless there is a specific aesthetic requirement such as that shown in Figure 10. Any deviations should be discussed in advance and agreed as part of the approvals process.

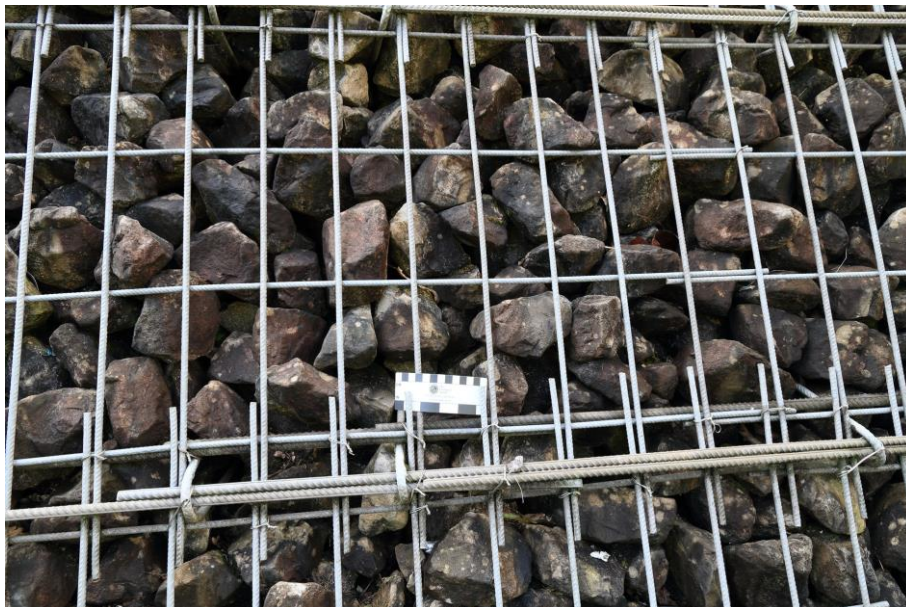
Figure 11: Gabion-type wall with a significant proportion of undersized material that could be readily removed from behind the mesh by hand (M60, SGM 7066, October 2020)

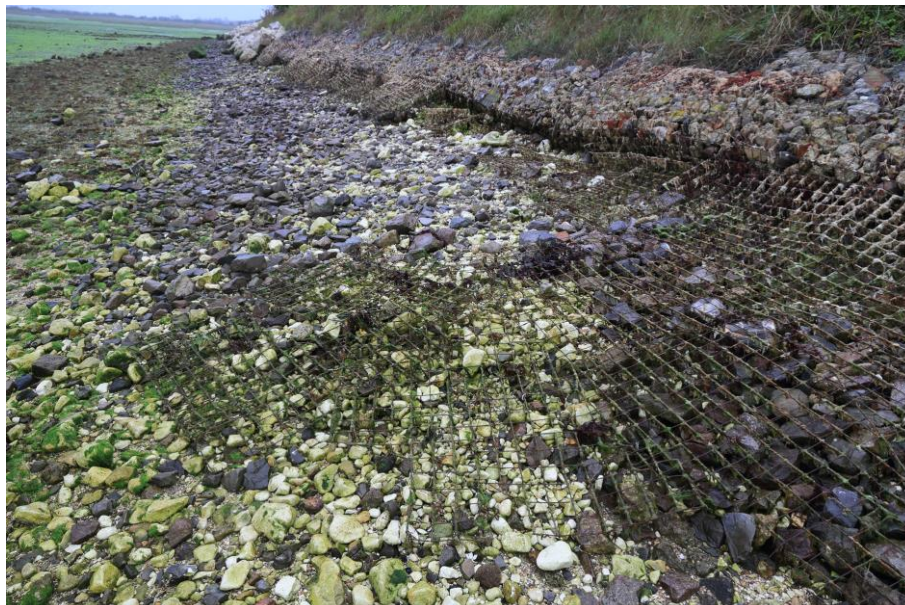
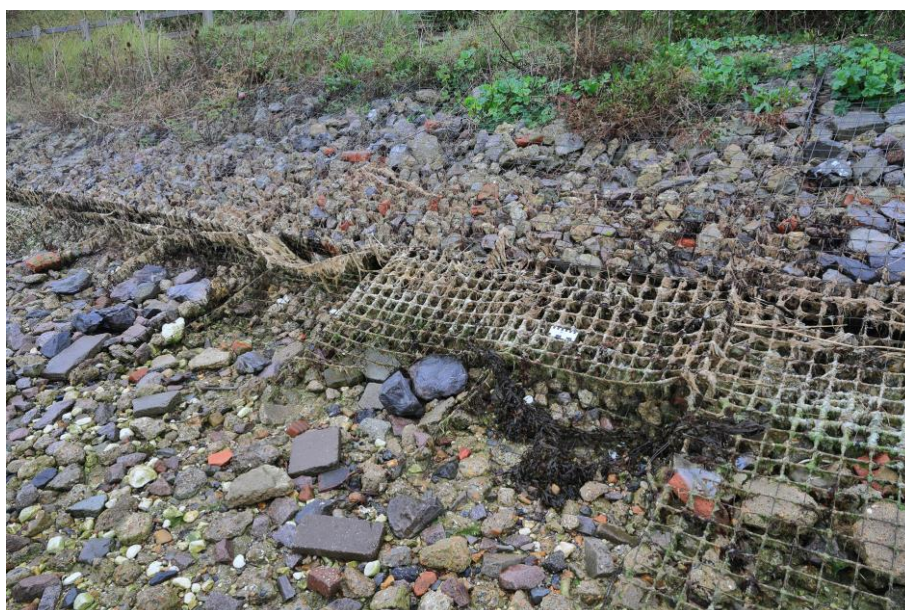
The environment in which gabion baskets are placed is also important. Significant corrosion was observed in a series of baskets that were placed in a marine environment and the damage

was significant to the extent that in places the loss of fill exceeded 80% rendering the SGM ineffective in fulfilling its support function (Figures 12 and 13).

Figure 12: Gabions used within a marine environment leading to significant corrosion and loss of fill. The upper gabions are becoming undermined which will eventually lead to loss of support for the slope above (A27/M3 Junction, SGM 10797, October 2020)

Figure 13: Gabions used within a marine environment leading to significant corrosion and loss of fill. The upper gabions are becoming undermined which will eventually lead to loss of support for the slope above (A27/M3 Junction, SGM 10797, October 2020)

Two gabion SGMs were observed in the same marine environment. Both appeared to be formed from galvanised wire and had suffered significant corrosion, loss of mesh, and consequent loss of fill. The mesh panels had completely broken off in places leading to rusted metal sticking out of the beach below posing a risk to the public (Figures 12 and 13). In these

In marine environments a stainless steel mesh would be more appropriate or an alternate solution such as a block wall or armourstone. In addition, Maccaferri advise against using welded mesh within water environments due to the risk of differential settlement (Maccaferri, 2021). This applies to all watercourses, not just marine environments.

Recommendation 5: As part of the technical approval process it should be ensured that a Gabion Wall solution is the most appropriate for the environment. This includes careful consideration before designing Gabion Walls within tidal and marine environments, adjacent to public footpaths where vandalism is a possibility and low-height gabions placed in location where vehicle over-run is likely.

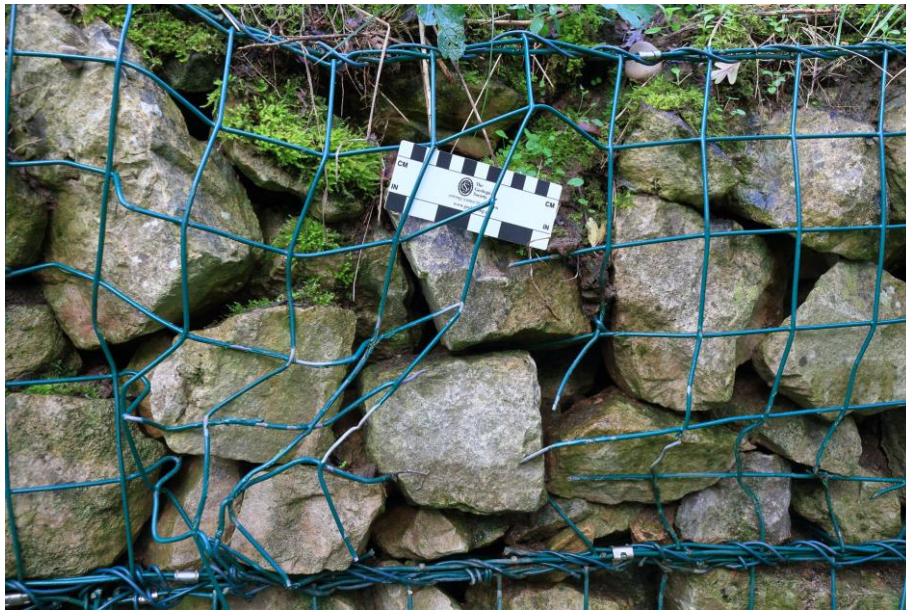
Significant apparent vandalism was also observed at two separate locations; vandalism was observed where the mesh appeared to have been cut and this had led to loss of fill, either deliberately or from the action of gravity, and corrosion of the wire (Figures 4 and 14). Similarly, vehicle overrun appeared to be the cause of the damage to another Gabion Wall (Figure 15).

Figure 14: Vandalism of gabion basket which is located along a public footpath. The wire mesh appears to have been cut (A45/A46 Junction, SGM 9117, October 2020)

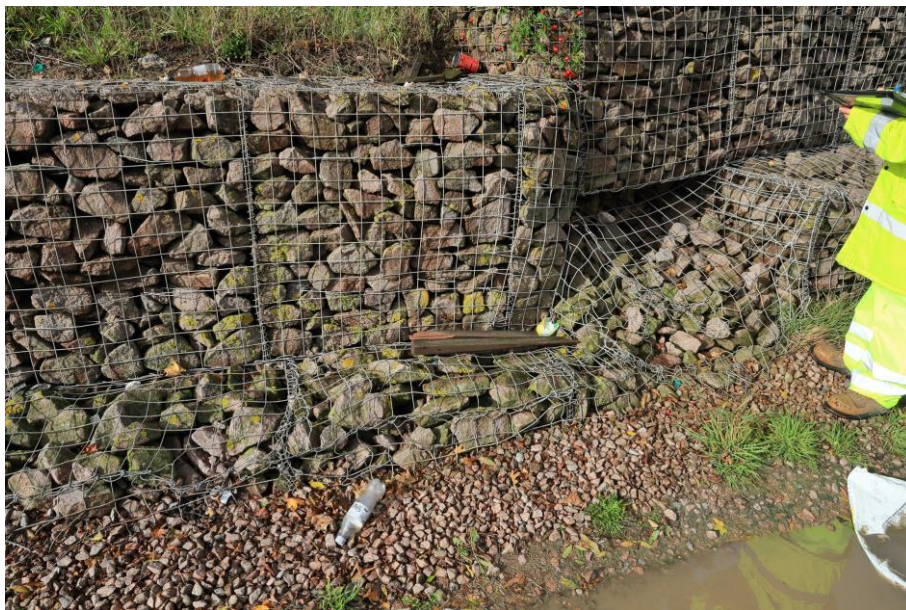
Figure 15: Vehicle overrun appears to be the primary cause of the significant damage to low height Gabion Wall at this location (A453, SGM 4025, October 2020)

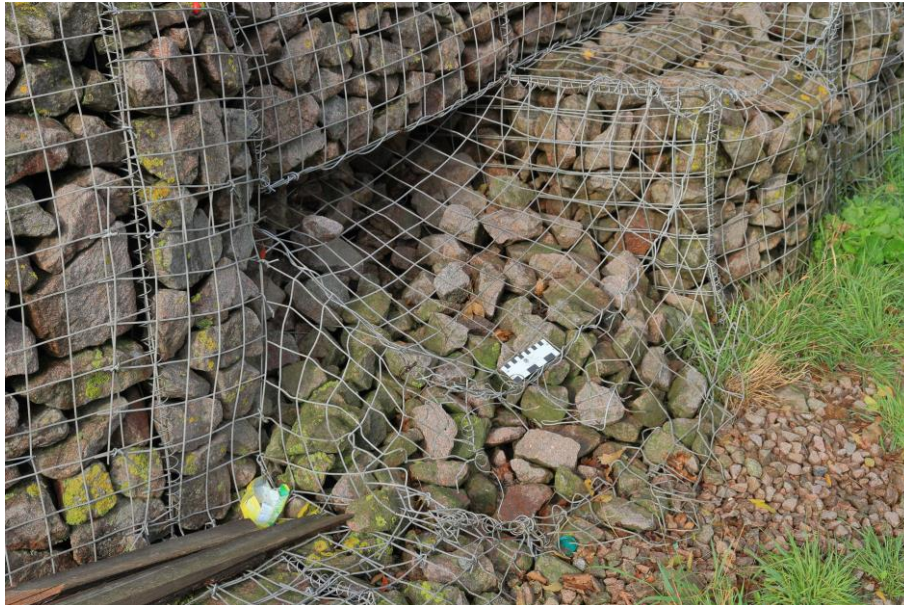
- Helicoil spring (also referred to as Helicals or Spirals) – These can be galvanised or stainless steel and can be used for welded baskets. These form the strongest connections and are also useful to reduce the probability of catching/snagging where gabions are used in public areas (Enviromesh, 2021). The helicoil spring was observed on one site during the inspections where the wall had been struck by a vehicle but due to the strength of the connection the top baskets were unaffected by the loss of support below (Figure 16).

Figure 16: Helicoil springs used on the vertical edge joins of the welded mesh gabion baskets. Lower gabions struck and damaged by vehicle but upper baskets have remained in place despite the lack of support below (A453, SGM 4025, October 2020)
