**PUBLISHED PROJECT REPORT PPR2015**

**Pedal Misapplication Study**

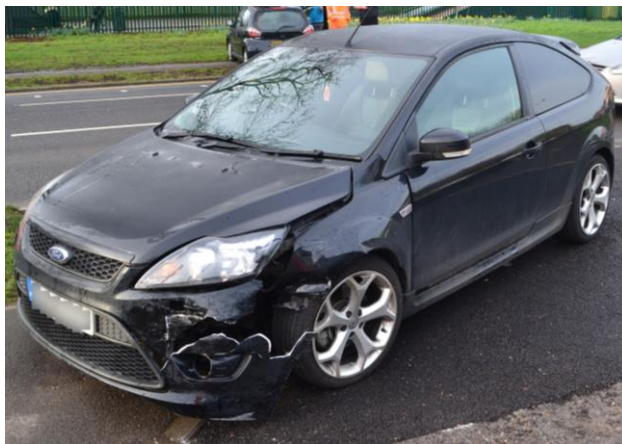
**Figure 19: V2 (other vehicle) with damage to the front nearside corner****Key Causation Factors:**

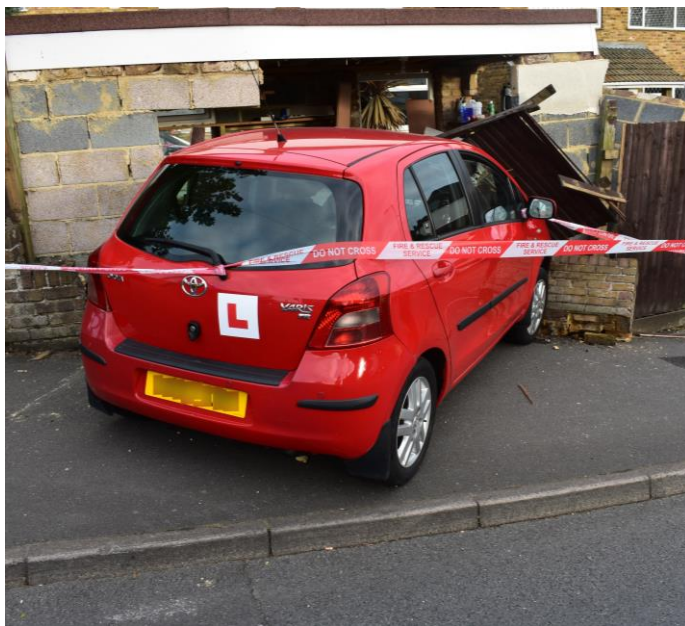
This collision occurred during daylight hours, in an urban area. The weather was fine without high winds and the road surface was dry. Visibility was good. At a T-junction of a B classified, single carriageway road, leading onto a unclassified road with a speed limit of 30 mph. V1 (Toyota, Yaris, Car) turned left from the main road just after an automatic traffic light controlled junction and entered a long downhill straight. It appears V1 clipped the nearside kerb before steering hard left over the kerb and footpath, colliding with a breezeblock outhouse located outside a residential premise. The vehicle knocked down the outer wall and came to rest half-way through the building with the vehicle fully across the footpath. V101 (adult, female, driver) and V102 (adult, male, front seat passenger) and V103 (child, male, rear offside passenger) were all restrained and uninjured. V101 was a learner driver, and this was the first time they had used an automatic vehicle; it is suspected that the driver **unintentionally accelerated when attempting to brake** when confronted by the hill which led to the initial loss of control.

Figure 20: V1 (pedal misapplication vehicle) with L plates having impacted a building

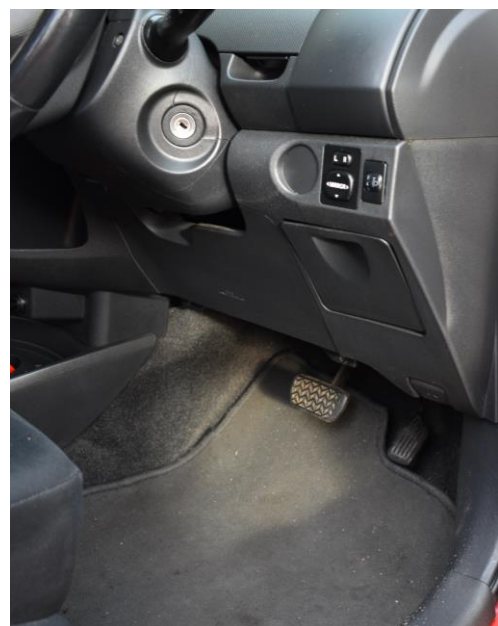
Figure 21: Automatic driving pedals within the footwell of V1

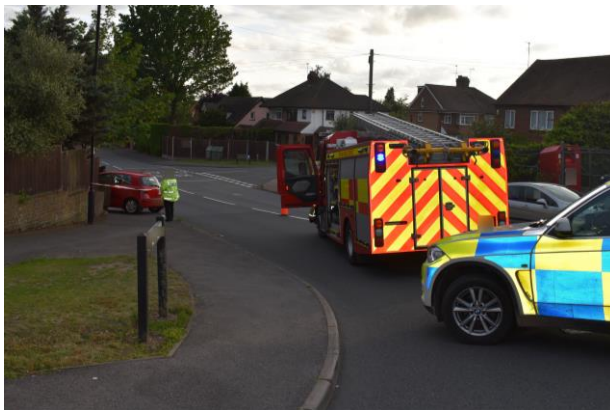
**Figure 23: Path of V1 travelling downhill on a left hand bend****Key Causation Factors:**

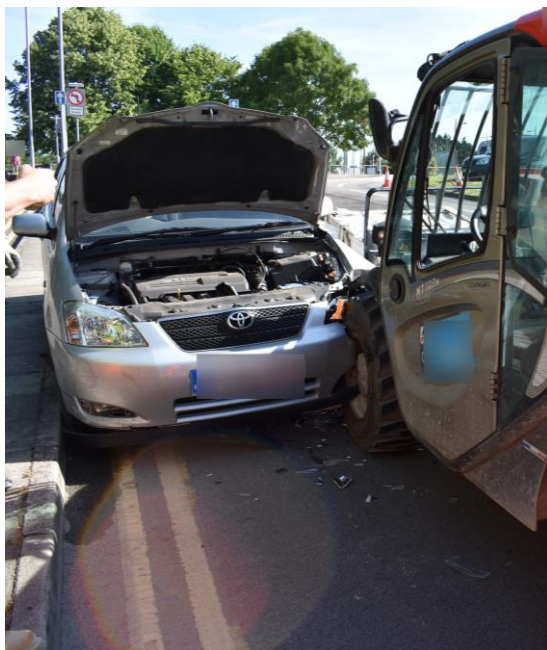
This collision occurred in daylight hours; the weather was fine without high winds. V1 (Toyota, Corolla, Car) was being driven by V1O1 (elderly, male, driver). V1 was preparing to exit a parking space they had driven front first into. After starting V1, **instead of reversing, V1O1 applied accidental acceleration (pedal confusion and automatic gearbox)** causing V1 to leap forwards, over the grass verge, through railings, over cycle lane, over raised pavement, onto one way street, facing the wrong direction. V2 (Manitou, MT625H, Forklift truck) was carrying a pallet of bricks on the forks at the front of the vehicle, and was on the one-way street already, travelling in the correct direction. V2O1 (adult, male, driver) reacts to V1 and comes to a stop and sounds the horn. V1 does not stop and impacts the stack of bricks and the front nearside tyre of the forklift. V1O1 claims to have been wearing a seatbelt but evidence suggests he was not (including a head strike to windscreen). V1O1 sustained minor injuries and was taken to hospital. V1O1 fails roadside eyesight test and has license revoked. V2O1 was uninjured.

Figure 24: Impact configuration of V1 (pedal misapplication vehicle) and V2

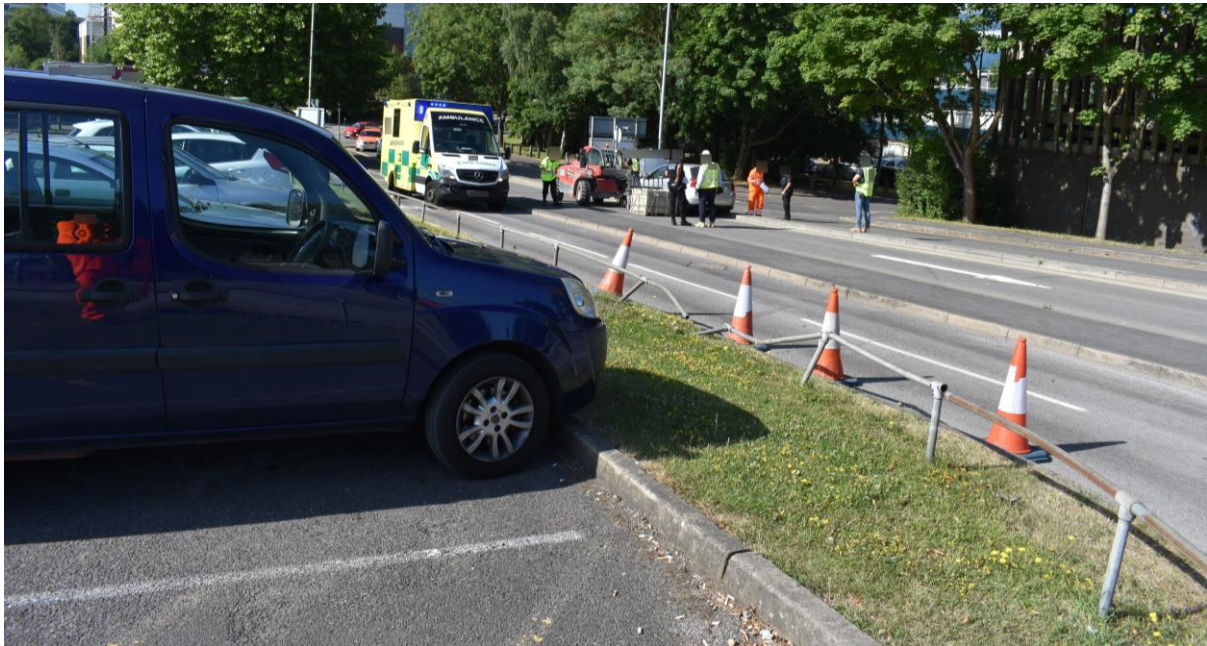
**Figure 26: Path taken by V1 who was parked in the bay occupied now by the blue vehicle**
