PUBLISHED PROJECT REPORT PPR857

Cycle gates

Understanding bicycle movements at traffic light controlled cycle gates

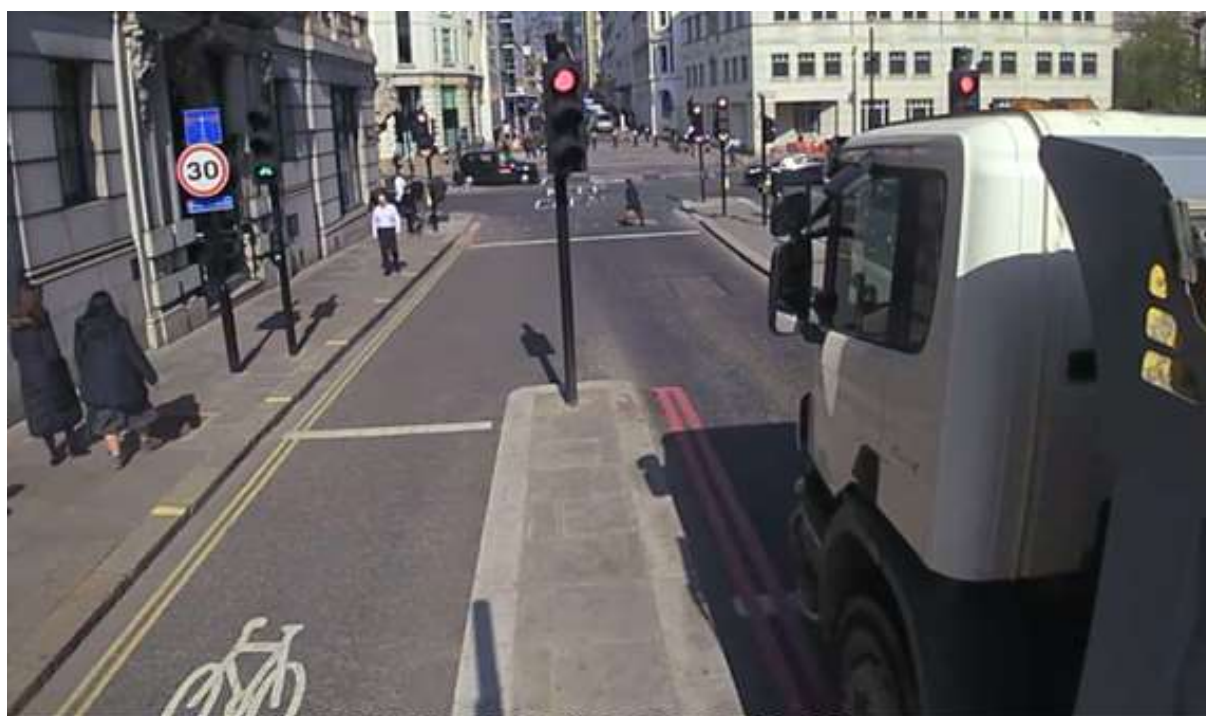
Cycle gates have recently been introduced in London, as a method of separating cycle traffic and general traffic at signal-controlled junctions where a significant proportion of motor vehicles turn left. This report presents the findings of research into road user behaviour and attitudes at two cycle gates on Cycle Superhighways, these being at Queen Street Place (see picture below) and at Lambeth Road.

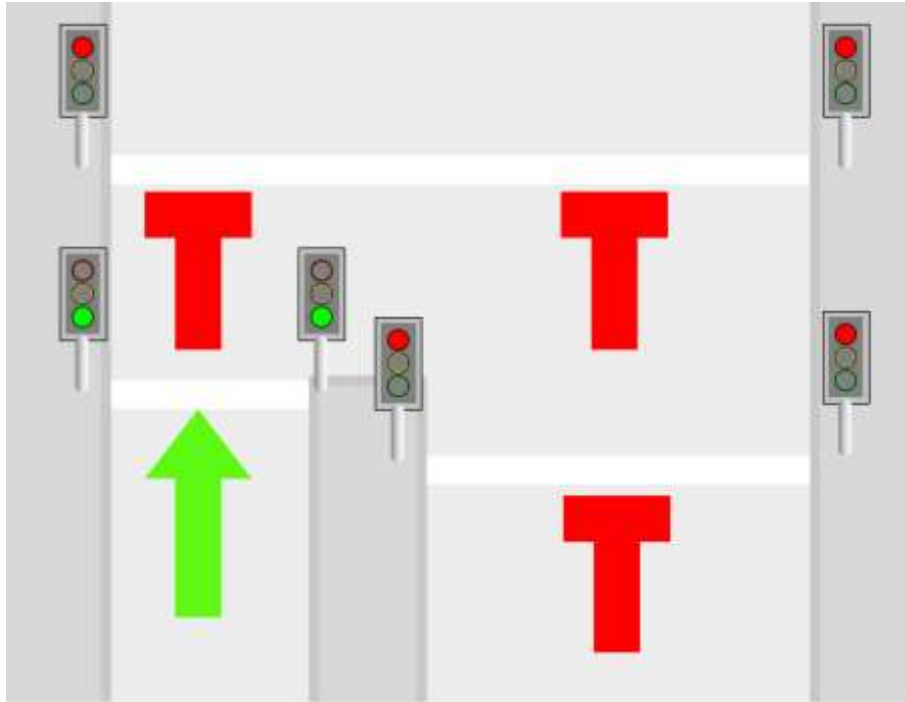
A typical cycle gate arrangement as in the schematics below, separates the cyclist on approach by providing a separate stopline and cycle-specific signals, with a separate stopline for general traffic. The signals never show green to both movements at the same time.

Stage 1 – Cyclists enter the reservoir

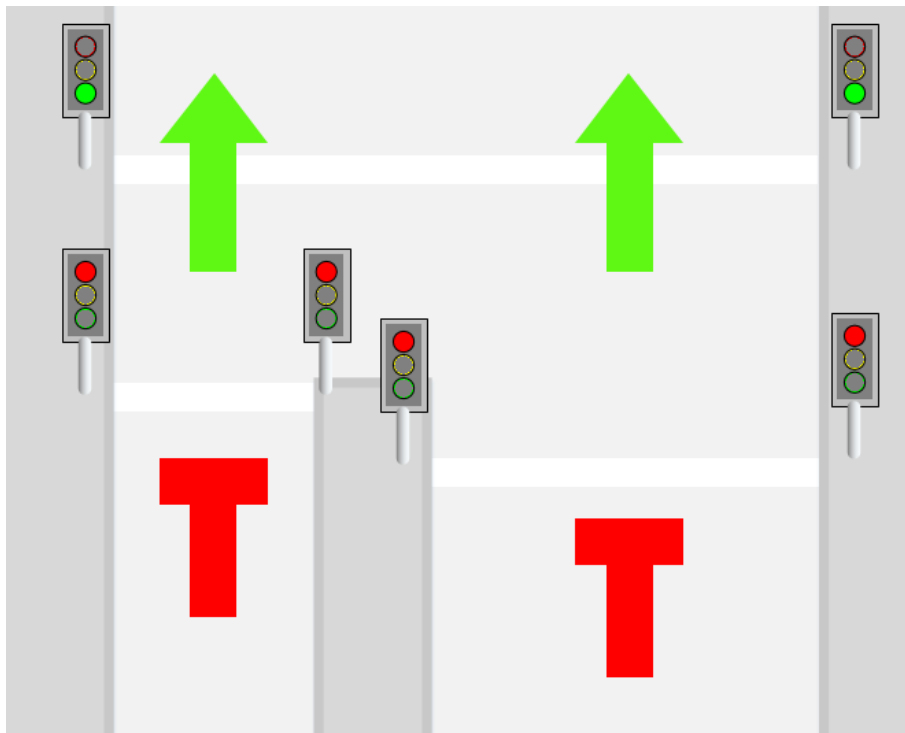
This allows cyclists to enter the large reservoir ahead of the other traffic (when this is held on red) and the cyclists are then held at the second stopline positioned at the junction itself.

Stage 2 – cyclists (and trapped vehicles) enter junction from Reservoir

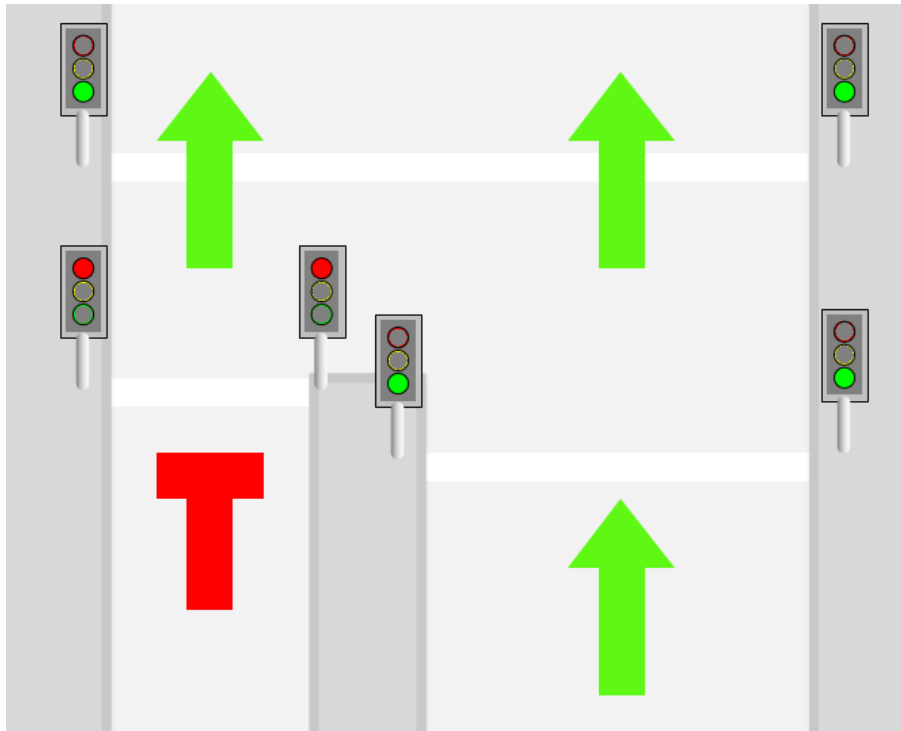
When the green is illuminated at the second stopline, the cycle gate will display a red, preventing any other cyclists from entering the reservoir. This green is shown a few seconds before the general traffic is released into the reservoir, ensuring that those cyclists in the reservoir have proceeded past the left turn conflict before the general traffic.

Stage 3 – Cyclists in reservoir held and traffic enters junction (through both stoplines)

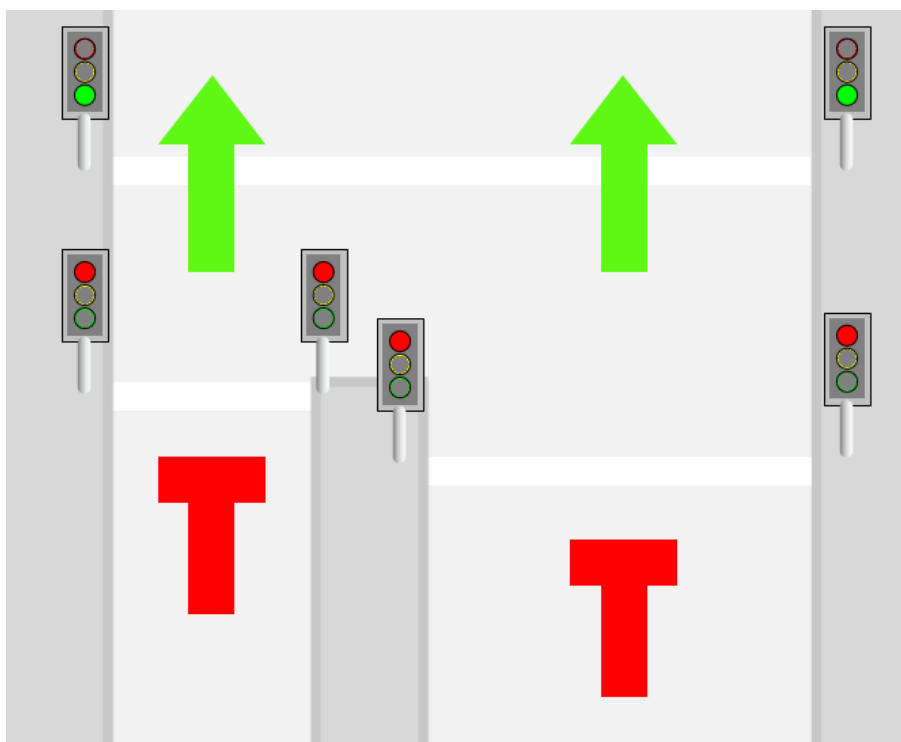
Stage 4 – Traffic clears reservoir (nothing can enter reservoir)

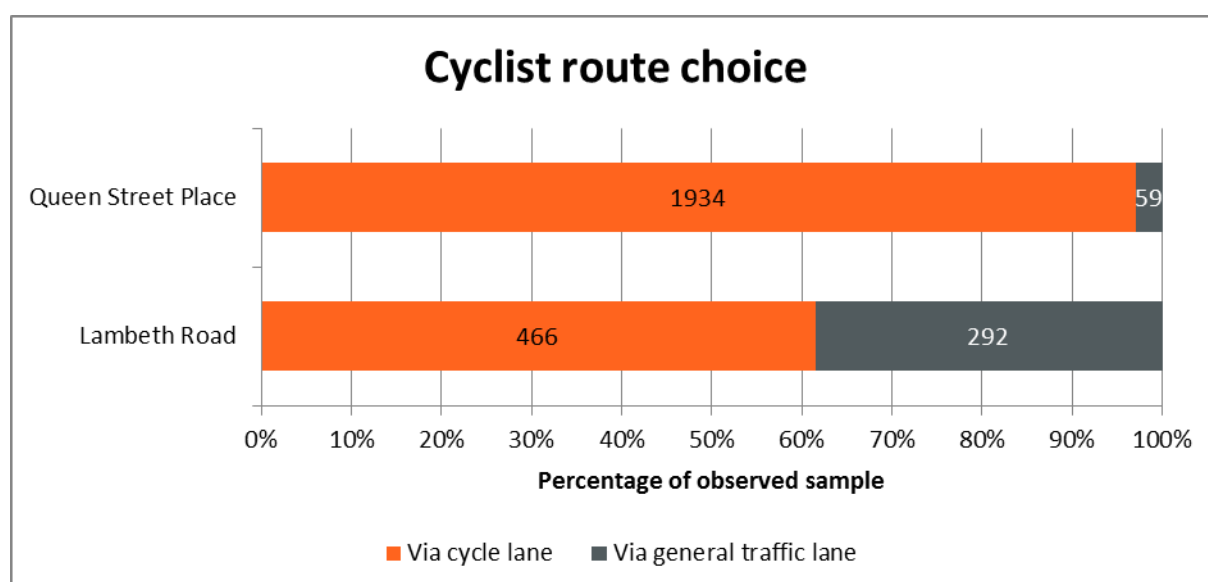
Figure 4 Cyclist route choice

Of the 1,993 cyclists recorded on Queen Street Place site, it was observed that 1,934 (97%) proceeded into the reservoir via the cycle lane (and cycle gate), while the remaining 59 (3%) used the general traffic lane. In comparison, on Lambeth Road 466 (61.5%) of the sample of 758 cyclists were observed to proceed via the cycle lane and gate, while the remaining 292 (38.5%) used the general traffic lane (see Figure 4).

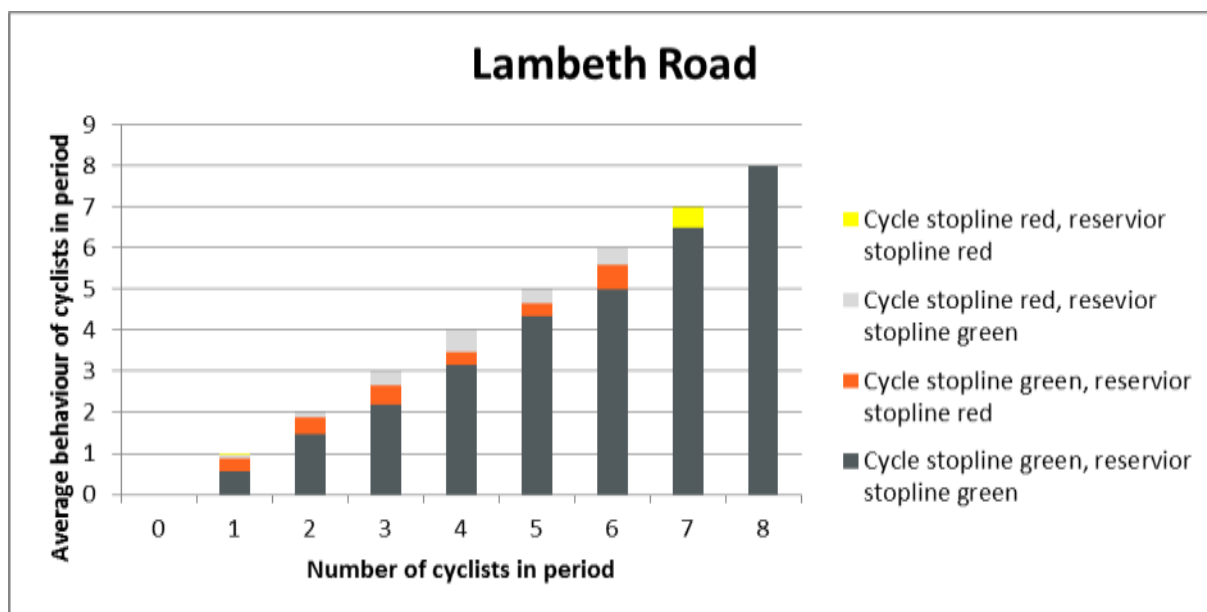
Figure 13 Average behaviour of cyclists at Lambeth Road cycle lane, based upon number of cyclists in any given signal cycle

At Lambeth Road it was found that the number of cyclists passing through a red signal did not proportionally increase with the number of cyclists, and that it remained largely static at around half a cyclist per signal cycle on average either passing the cycle lane signal on red, or the reservoir signal on red (see Figure 13). It may be hypothesised that this is a result of opportunistic behaviour, with limited opportunities to pass the reservoir red for a limited number of cyclists at any given signal cycle.

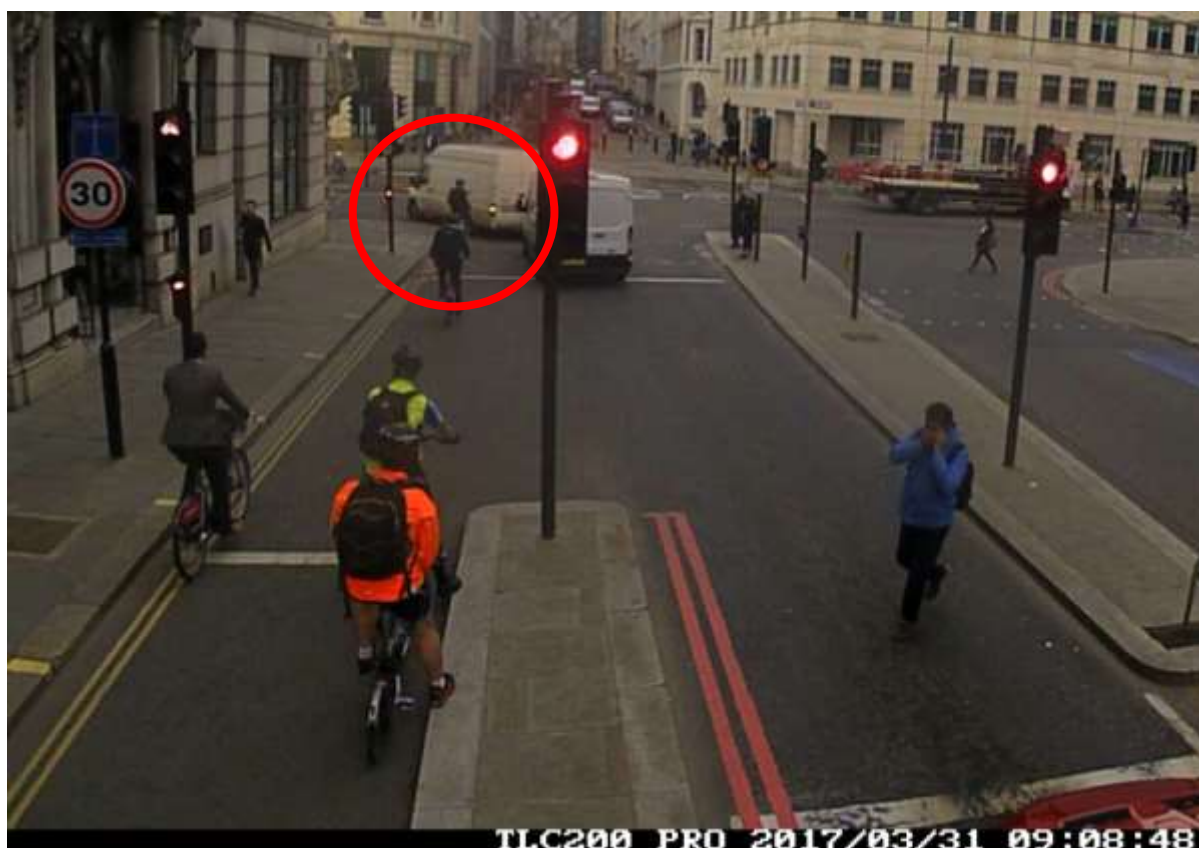
Figure 16 Cyclist crossing cycle stop line on red conflicts with turning vehicle at Queen Street Place

425 of the cyclists (22%) using the cycle gate at Queen Street Place were observed to disregard the initial red signal on the cycle gate and then use the green signal at the reservoir stop line. The Queen Street Place video footage revealed only one instance of this resulting in a conflict (see Figure 16 below). This cyclist is indicated in the red circle in the image, where the cyclist passed the cycle lane signal at red and nearly came in to contact with the white van turning left (which had passed the general traffic signal on green). The cyclist was travelling straight ahead.

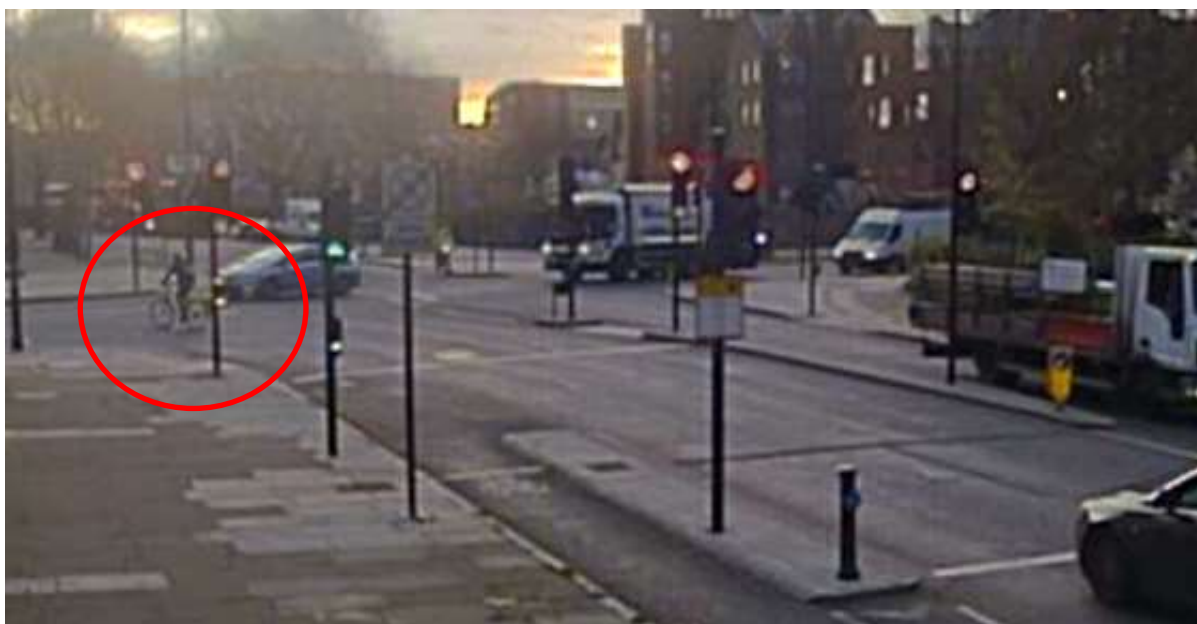
Figure 18 Cyclist in conflict with traffic after passing advanced stop line on red signal

83 (17.8%) cyclists using the cycle gate proceeded via the cycle lane at a green signal then proceeded through the reservoir stop line on a red signal. The Lambeth Road video footage revealed that this resulted in conflict (i.e. involving action to avoid collision) with motor vehicles on three occasions. An example is depicted in Figure 18 below, whereby the cyclist

did not comply with the red signal at the reservoir stopline and came in to conflict with traffic. No actions observed within this study appeared to result in collision between any parties.

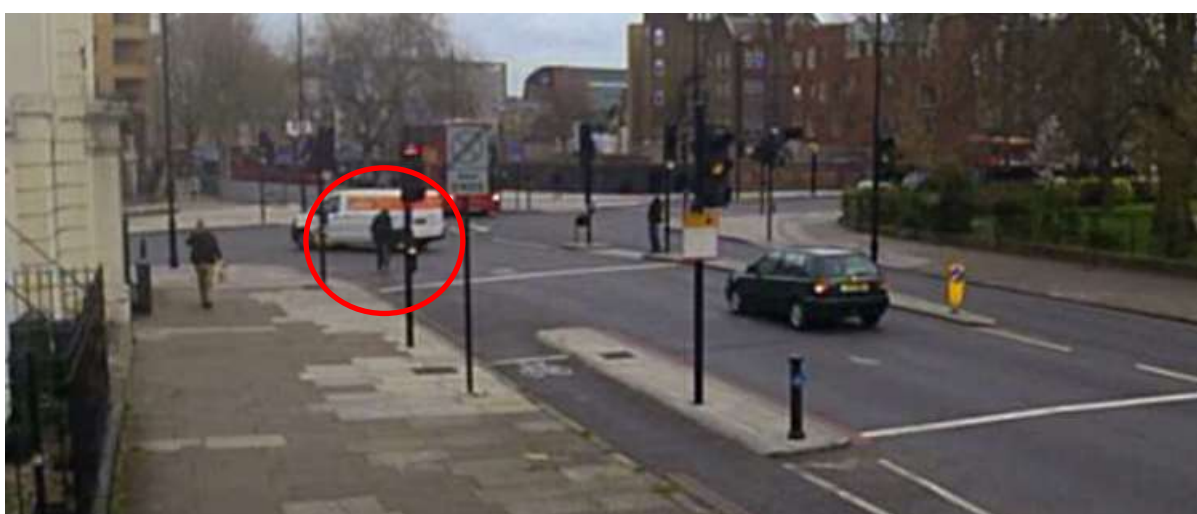
Figure 19 Cyclist conflict with general traffic after passing cycle lane signal at red

Figure 19 shows a cyclist passing the cycle stop line on red and then coming in to conflict with general traffic turning left. 8.8% of the cyclists (41 cyclists) using the cycle gate proceeded at a red signal through the initial red signal and then through the reservoir stop line on a green signal. 38.7% of the cyclists (113 cyclists) using the general traffic lane proceeded at a red signal through the traffic stop line and then at a green signal through the reservoir stop line.

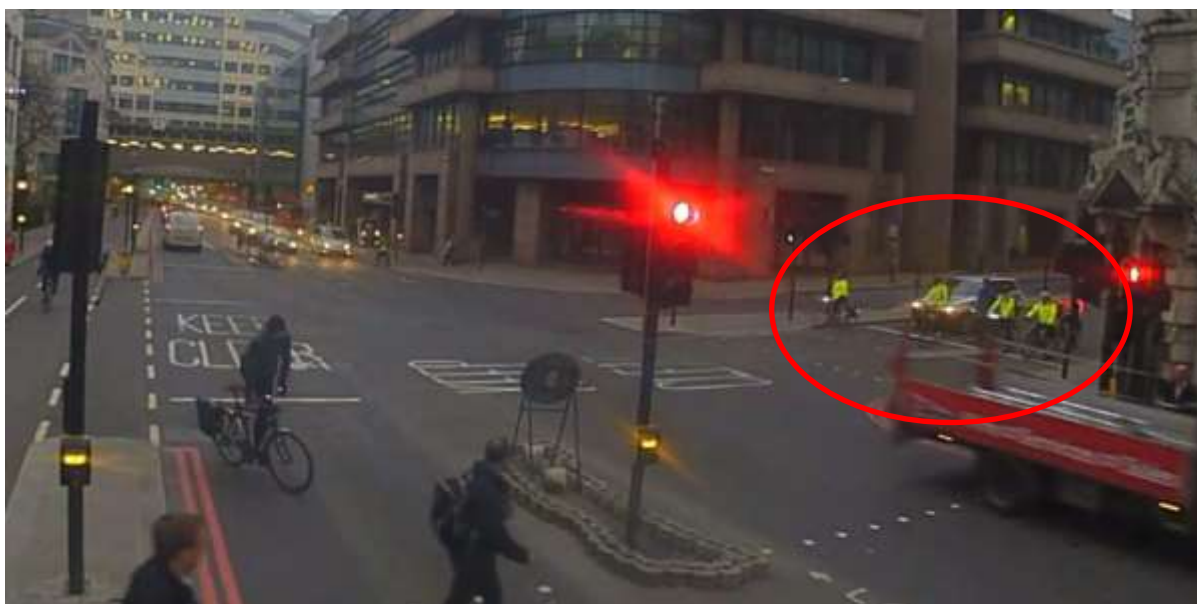
Figure 23 Car stopped in the reservoir space – Queen Street Place

Interaction between cyclists and general traffic waiting in the reservoir space was only observed once as can be seen in Figure 23, where the car did not comply with the general traffic stopline red signal and stopped in the reservoir.
