TRANSPORT AND ROAD RESEARCH LABORATORY
Department of Transport

RESEARCH REPORT 55

SAFETY ASPECTS OF THE SINCLAIR C5 ELECTRICALLY ASSISTED PEDAL TRICYCLE

by I D Neilson and J S Armour

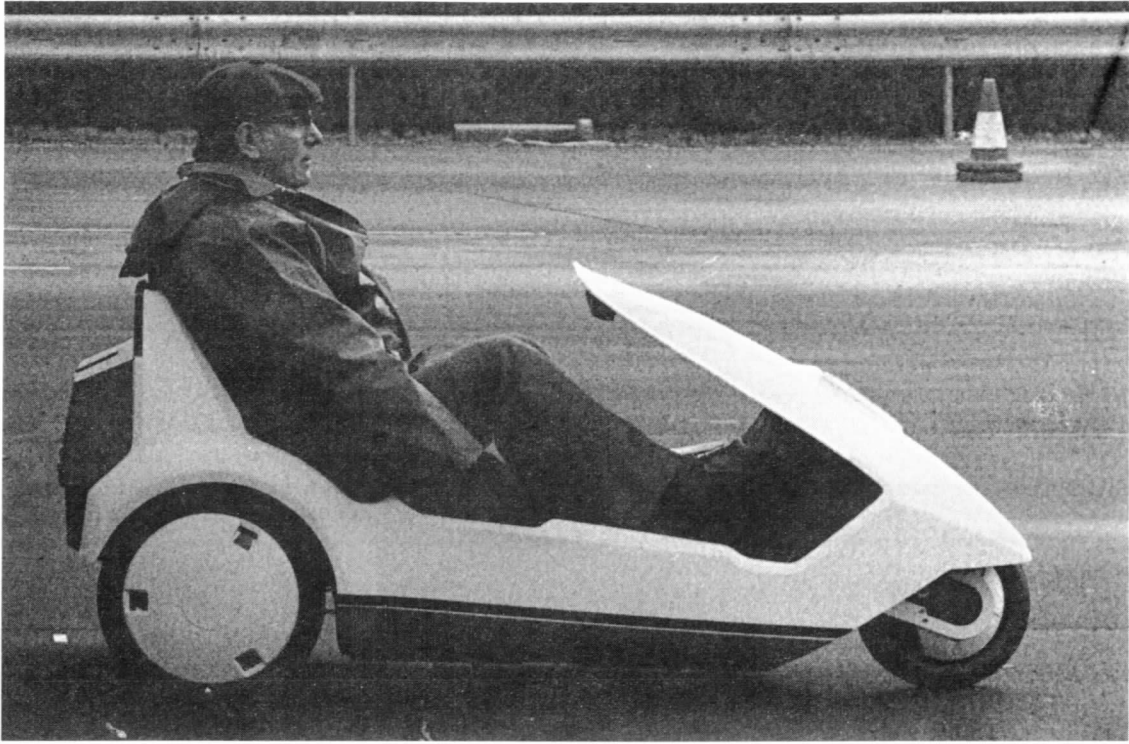
Neg. no. CR132/85/5

Plate 1 Side view of the Sinclair C5

The marketing of the Sinclair C5 electric power assisted tricycle last winter was greeted with interest because it was a novel concept that might appeal to various sectors of the general public. An idea of the configuration and scale of the C5 is given in Plates 1 and 2. Inevitably doubts were raised about its safety and it was arranged that this should be assessed at TRRL. This report presents the outcome of this work.

The C5 is a tricycle with a brake on the single front wheel and a brake on the offside rear wheel which is operated separately as on a bicycle. The drive is on to the other rear wheel. The brakes are hand operated from the handlebars which are located under the rider's thighs. (See Plates 1 and 2). With this layout some reduction in maximum possible braking is accepted because not all wheels are braked. It is also possible that the C5 may yaw somewhat when either power or the rear brake is applied. With only one rear brake, the machine

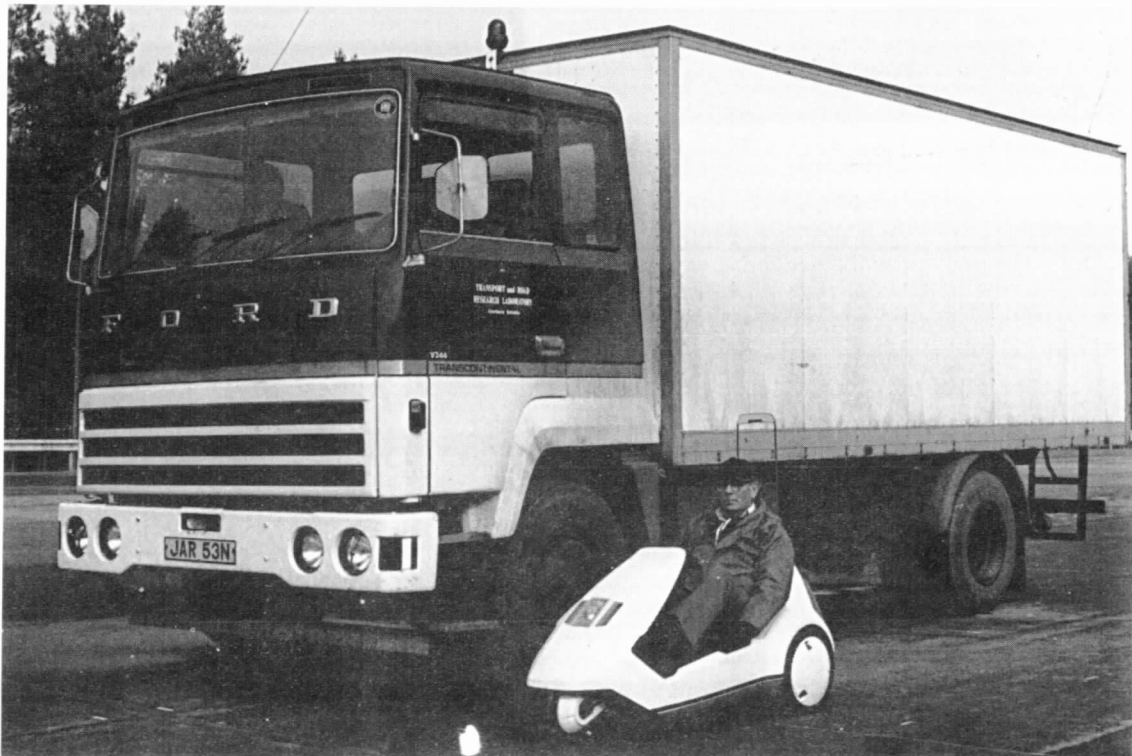
Neg. no. CR132/85/3

Plate 2 Sinclair C5 alongside a Ford Transcontinental
16 tonnes GVW lorry
