# **A review of the durability of soil reinforcements**

**Prepared for Quality Services Civil Engineering,  
Highways Agency**

M J Greene and K C Brady

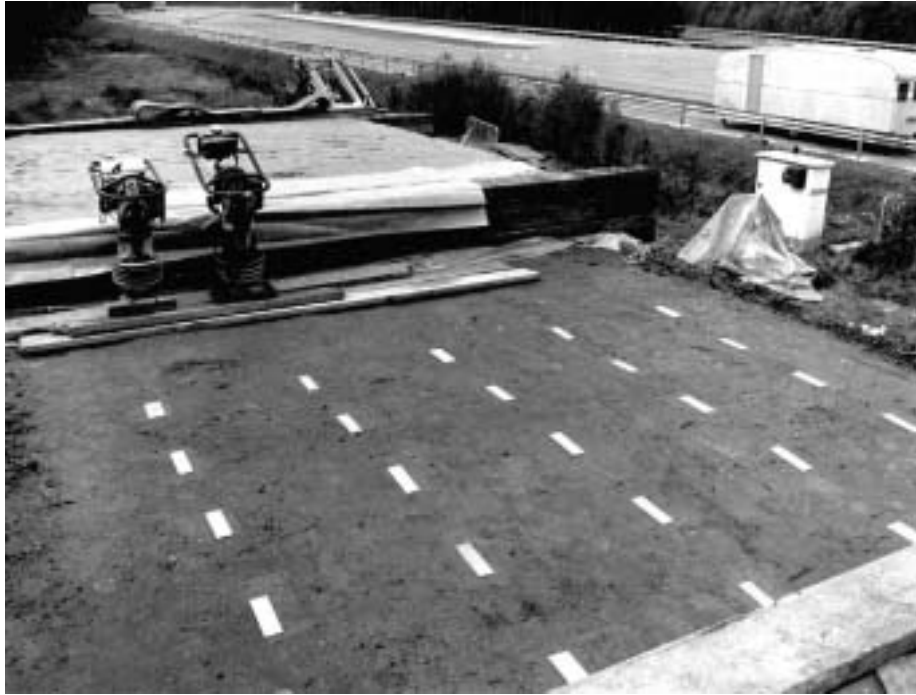
**Figure 3** View of the embankment for the corrosion experiment at the Laboratory showing the arrangement of coupons and the compaction plant used

The soils were compacted in 125 mm layers using a Wacker vibro-tamper weighing 50.8 kg in the pits, and a Wacker vibro-tamper weighing 101.6 kg on the embankment. The number of passes for each layer was in accordance with the then current (5th Edition) Specification for Road and Bridge Works (DOT, 1976). The mean moisture content and the mean dry density of the compacted London Clay were 26.9 per cent and 1467 kg/m<sup>3</sup> respectively: the values for the compacted Bramshill Sand were 9.6 per cent and 1789 kg/m<sup>3</sup>.

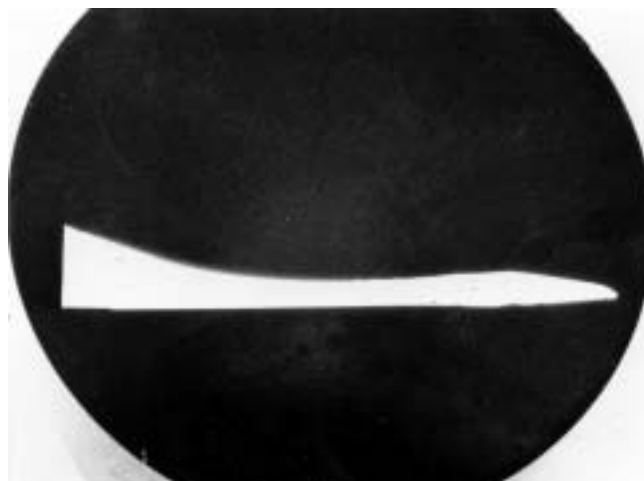
**Figure 7** Profile of a particularly heavily corroded section of an aluminium alloy coupon recovered from the corrosion experiment at the Laboratory in 1990

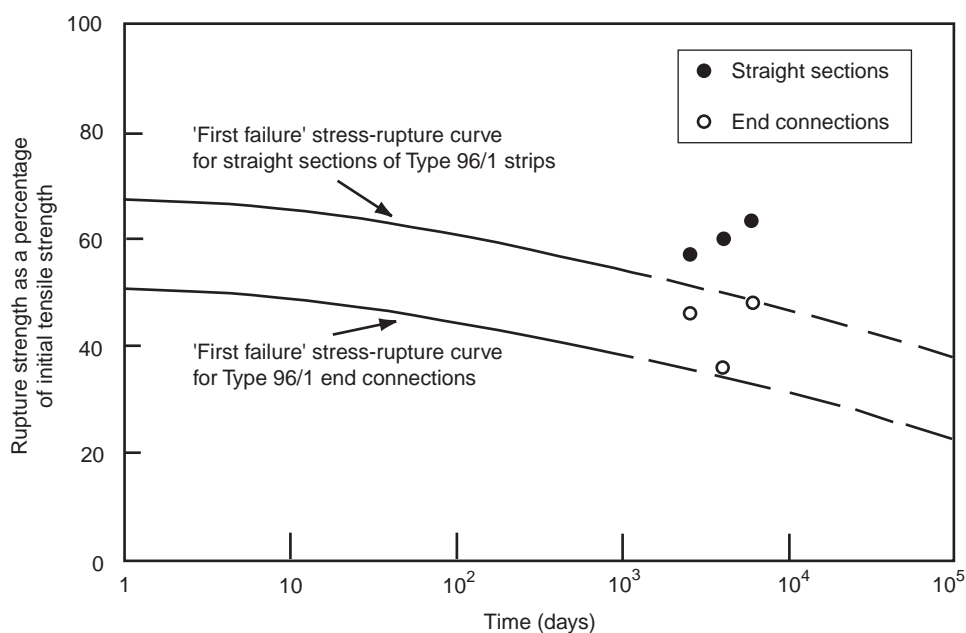
**Figure 13** Results of tensile tests on sections of GRP reinforcements recovered from the experimental reinforced soil structure at the Laboratory

Figure 13 presents graphically the data from the strips extracted from the experimental structure. Also plotted are the lower bound curves obtained from a series of stress-rupture tests undertaken by Pilkington Bros. Full details of this work and other tests on GRP reinforcements have been reported by Greene and Brady (1994).

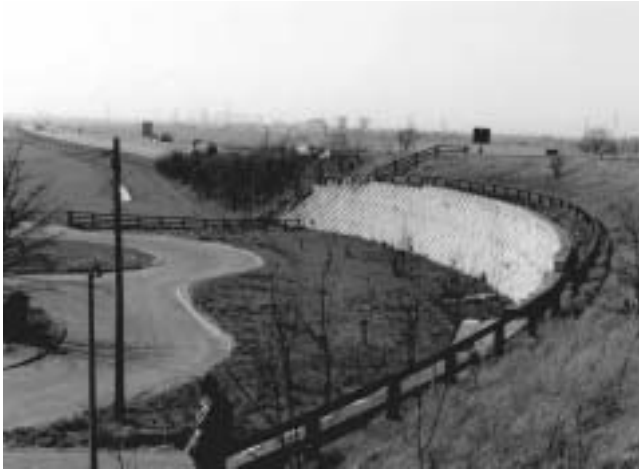
**Figure 14** View of the completed reinforced soil wall at Whitley Bridge

was one of the first reinforced soil structures to be built on the highway network in the UK. The wall was about 100 m long, had a maximum height of 6 m and it supported a slip road to the motorway; a view of the completed structure is shown in Figure 14.

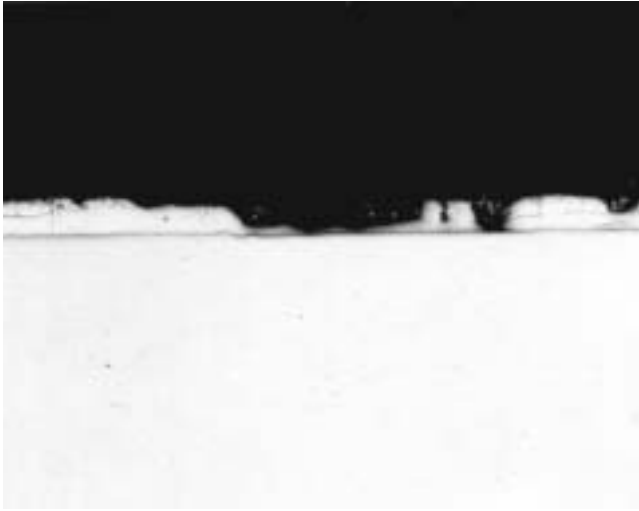
a Micrograph showing partial loss of galvanising (x100)

b Micrograph showing partial loss of galvanising and the presence of corrosion products (x200)

**Figure 22** Micrographs from strip recovered from the top of the wall (layer A) at Whitley Bridge

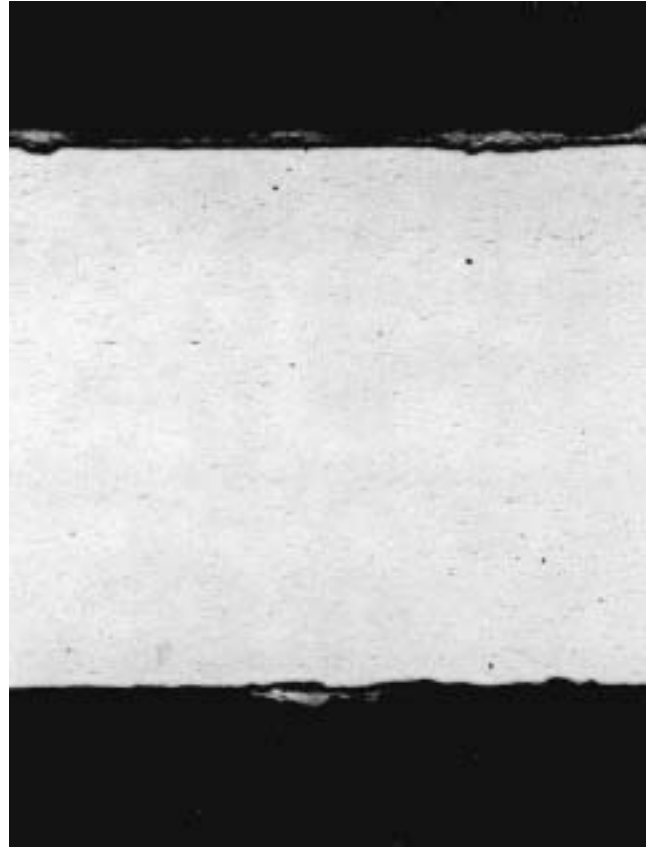
a Micrograph showing loss of galvanising (x20)

b Micrograph showing loss of galvanising and corrosion of underlying steel (x100)

**Figure 23** Micrographs from strip recovered from the bottom of the wall (layer I) at Whitley Bridge

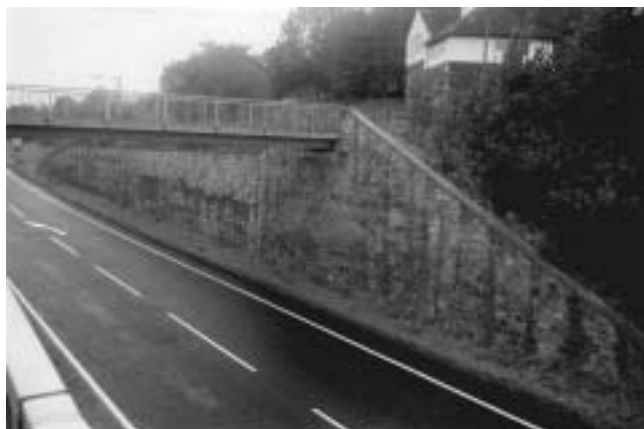
**Figure 25** View of the anchored earth wall at Otley taken in October 1998

The wall is 86 m long, has a maximum height of 6 m and supports an access road and bankseat to a footbridge. A view of the structure, taken in October 1998, is shown in Figure 25.

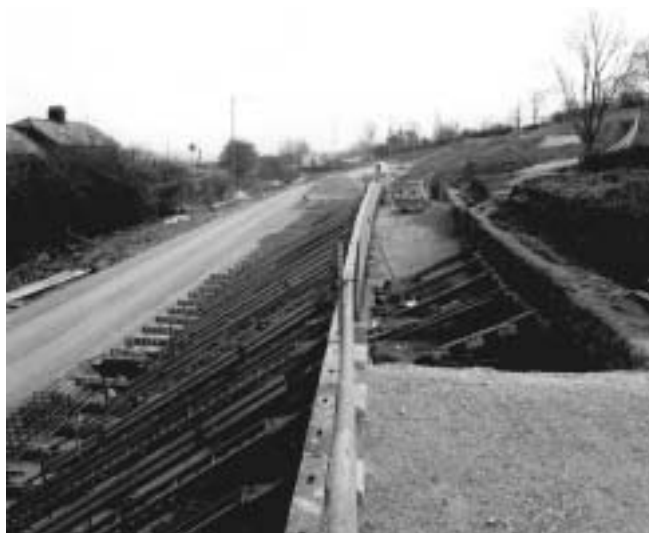
**Figure 27** View of the construction works at the Otley site
