Lime pile remediation of a Gault Clay embankment slope on the M1

**Prepared for Geotechnics and Ground Engineering,
Highways Agency**

D R Carder, K J Barker and M R Easton

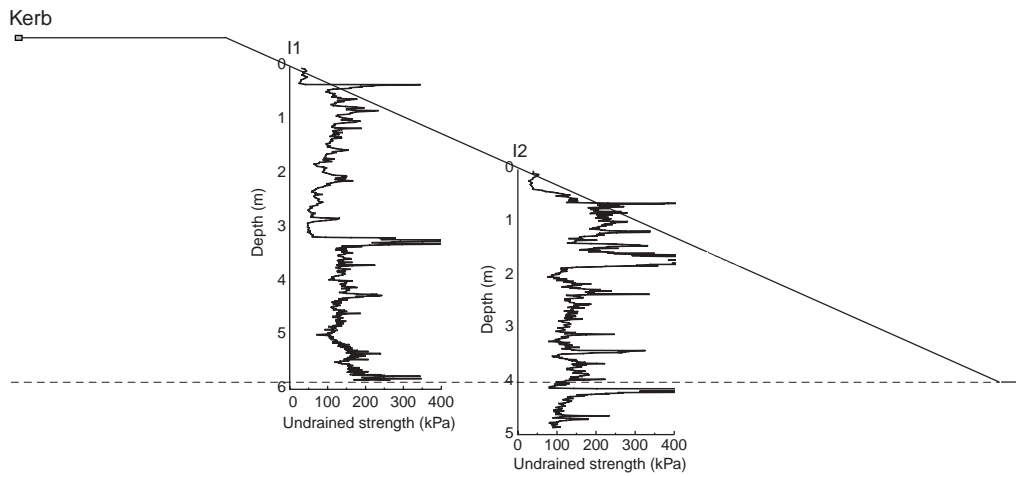
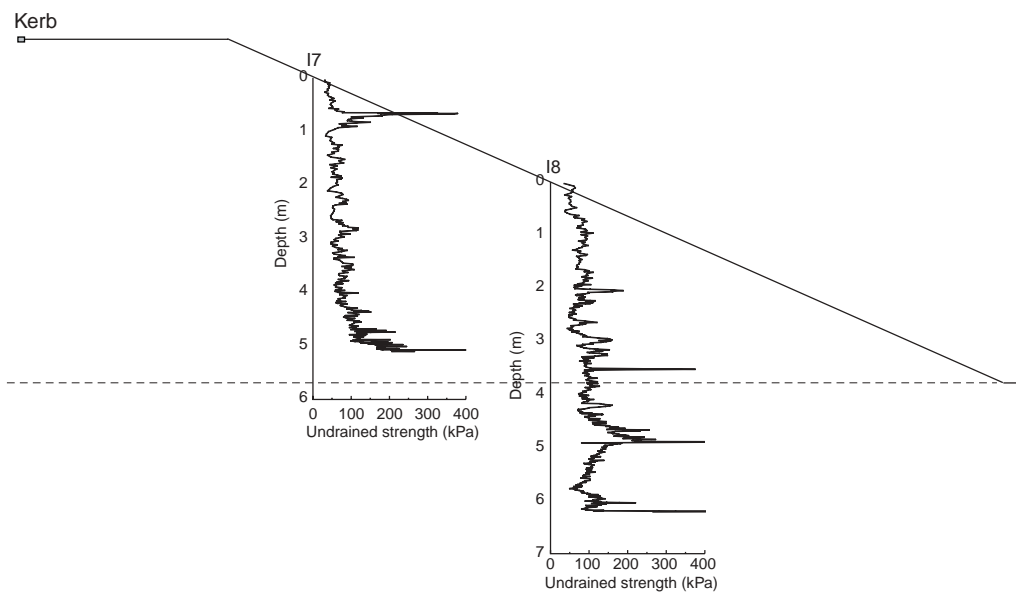
Figure 2 Panda penetrometer strength profiles at each area

(a) Area 1: Unlined lime piles

(b) Area 2: Lined lime piles

(c) Control area

The results in Figures 2b and 2c generally indicated an undrained shear strength of just below 100kPa for the clay within about 3m of the slope surface. The corresponding zone appeared slightly stiffer in Figure 2a where the unlined lime piles were installed. In some tests a higher strength was also recorded at about 0.5m depth at the interface between the topsoil and the clay; this is possibly associated with some drying of the clay surface and was particularly noticeable in tests near to the top of the slope. Some increases in undrained strength to values just above 100kPa were observed below about 3m depth at each test location. In cases where the Panda penetrometer tests continued into the clay foundation, there was no evidence of a layer of higher strength which tended to confirm that a drainage blanket had not been installed below the clay fill at the time of embankment construction.

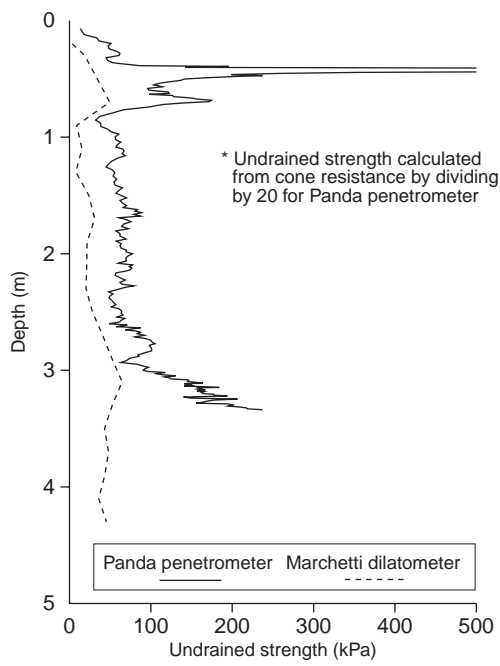
Figure 3 Soil profiling using Panda penetrometer and Marchetti dilatometer (near top of slope in control area)

(a) Undrained shear strength

(b) Dilatometer modulus using Marchetti probe

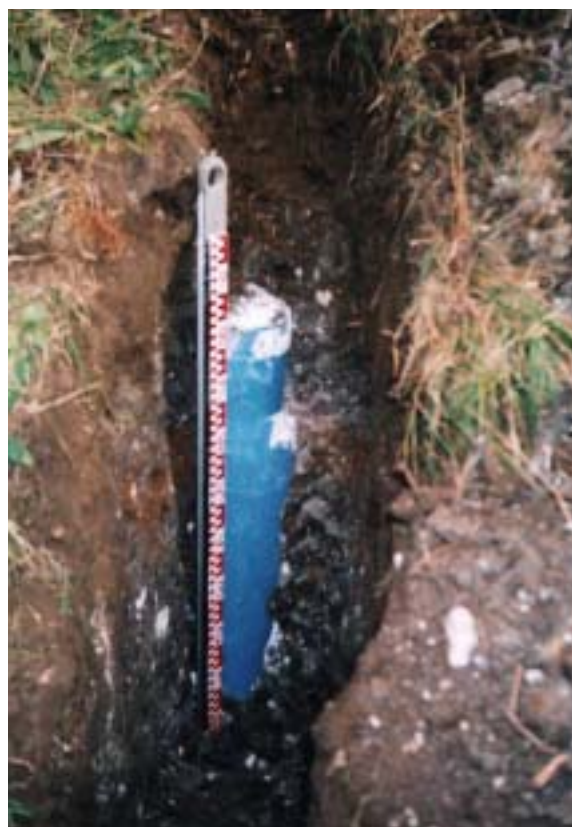
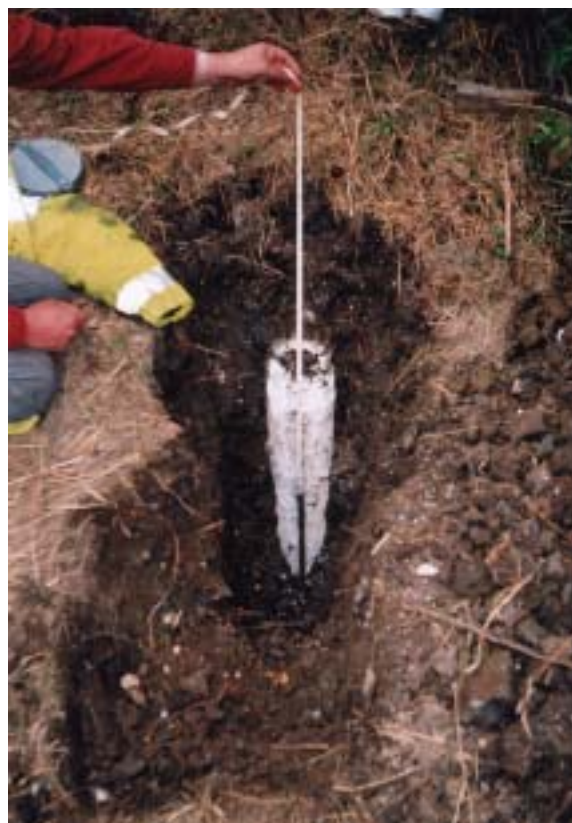
Plate B1 Exhumation of lime piles

(a) Lined lime pile

(b) Unlined lime pile
