Basic oxygen steel slag as surface course aggregate: An investigation of skid resistance

Prepared for Viridis Ltd.

P G Roe

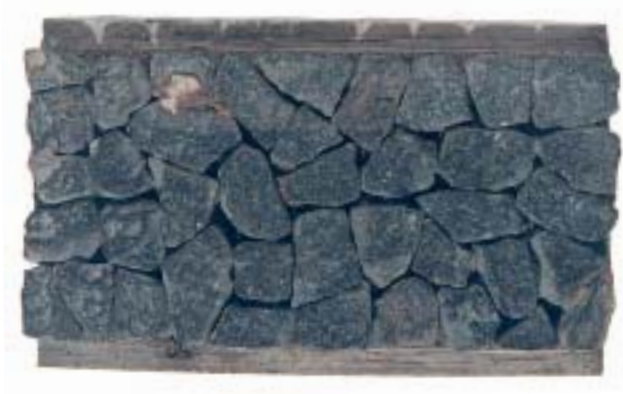
Figure 3.1 PSV specimen – control stone (TRL)

Figure 3.1 shows a normal specimen of control stone and Figure 3.2 shows a BOS sample made from ‘regular’ particles (as used in the TRL ‘standard’ tests). Figure 3.3 shows a specimen with a mixture of regular and irregular BOS particles from the TRL tests. Figure 3.4 shows a specimen from one of the commercial laboratories with ‘regular’ particles, while Figure 3.5 illustrates a sample with a high proportion of ‘irregular’ particles. Lastly, Figure 3.6 shows the regimented arrangement of particles from Laboratory A.

All of these specimens had been made in accordance with the same written standard and complied with the written requirements. However, they differed considerably in the way in which the words were interpreted (especially laboratory A) and, in the process, features were introduced into the specimens that could affect the pendulum measurements. For example, tighter packing of individual stones reduces the number of exposed edges that can catch

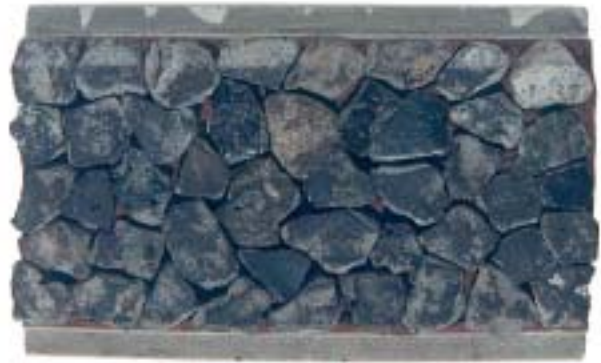
Figure 3.4 PSV specimen – (Laboratory B, reported PSV=53)

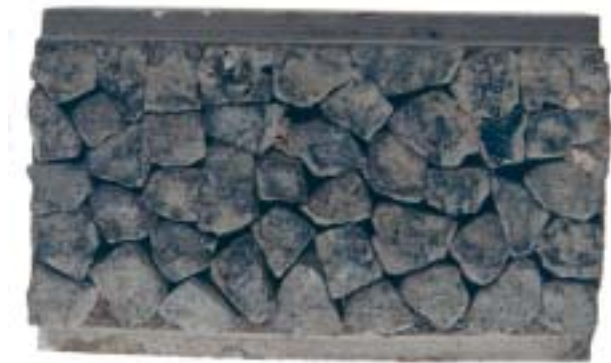
Figure 3.2 PSV specimen – BOS ‘regular’ particles (TRL, reported PSV=50)

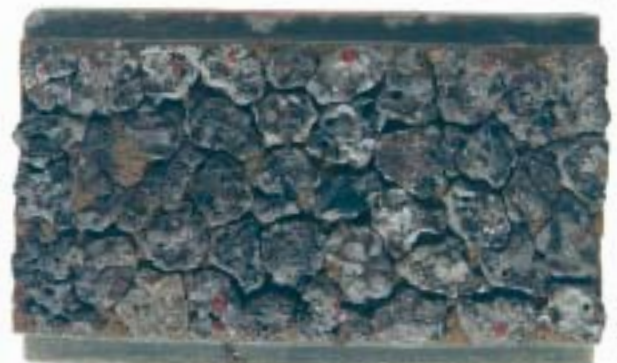
Figure 3.5 PSV specimen – (Laboratory D, reported PSV=58)

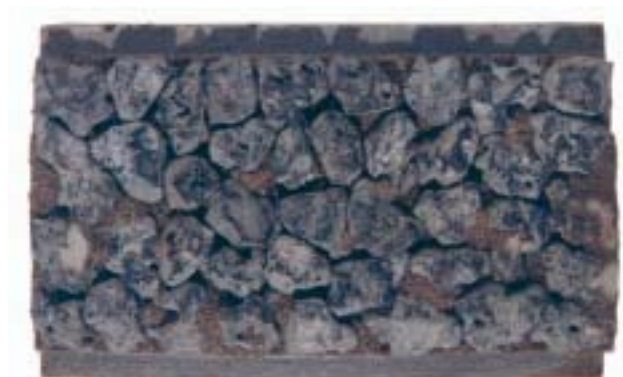
Figure 3.3 PSV specimen – BOS ‘random’ particles (TRL, reported PSV=56)

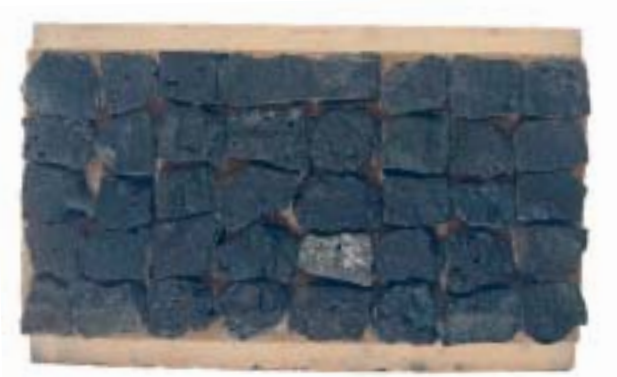
Figure 3.6 PSV specimen – (Laboratory A, reported PSV=65)

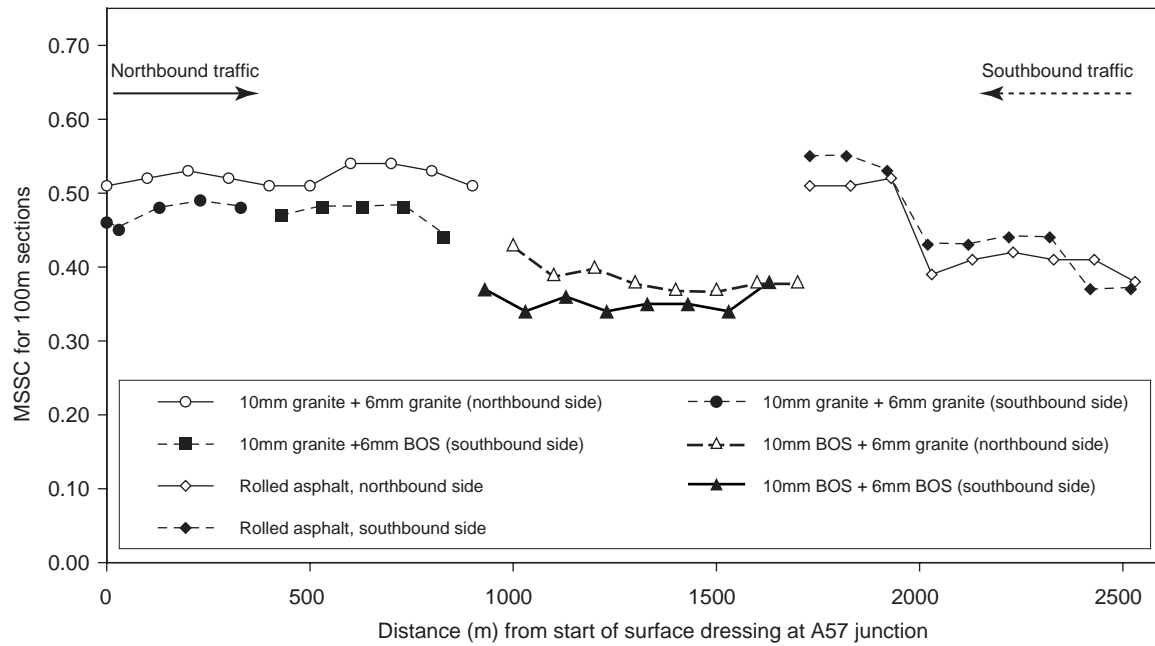
Figure 5.1 Summer 2000 MSSC on Site C

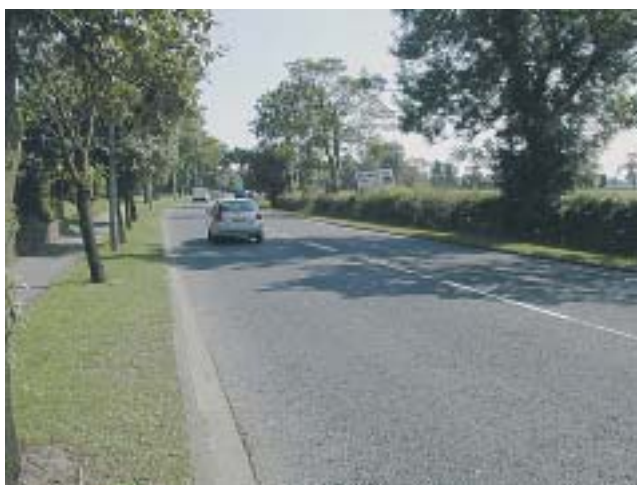
Figure 5.2 Site D looking towards the BOS slag section

Site D (Figure 5.2) is a typical outer-suburban principal road, with occasional side turnings and entrances but no major junctions. It is a gently curving road and is subject to a 40mph speed limit. The route generally carries free-flowing local light traffic, with the occasional bus or delivery vehicle, but little heavy traffic. Figure 5.3 shows the surfacings where the old chipped rolled asphalt (right) and the SMA with BOS slag coarse aggregate meet on the southbound side.

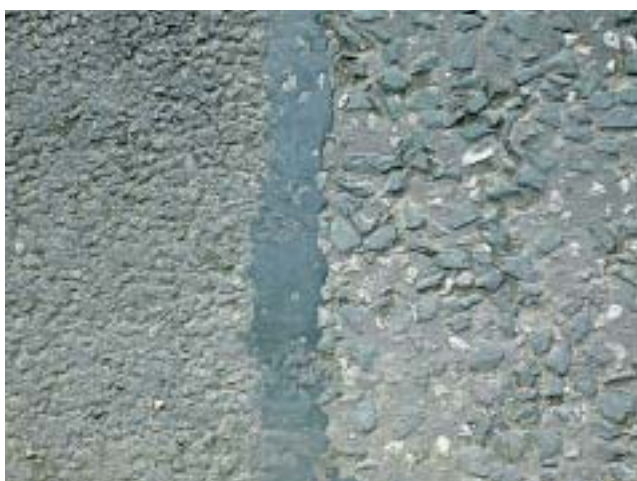
Figure 5.3 The surfacings on site D (BOS slag SMA to the left)

The level of skid resistance along the two parts of the sites was generally uniform and above any likely investigatory level. It is interesting to observe that the BOS slag appeared to have been polished less by the traffic than was the natural aggregate during the summers. In both the November measurements (1999 and 2001) the two types of surfacing gave the same average SC (0.48 and 0.45 respectively). During the summer periods, however, the BOS slag gave slightly higher average MSSC values than the old road surface.

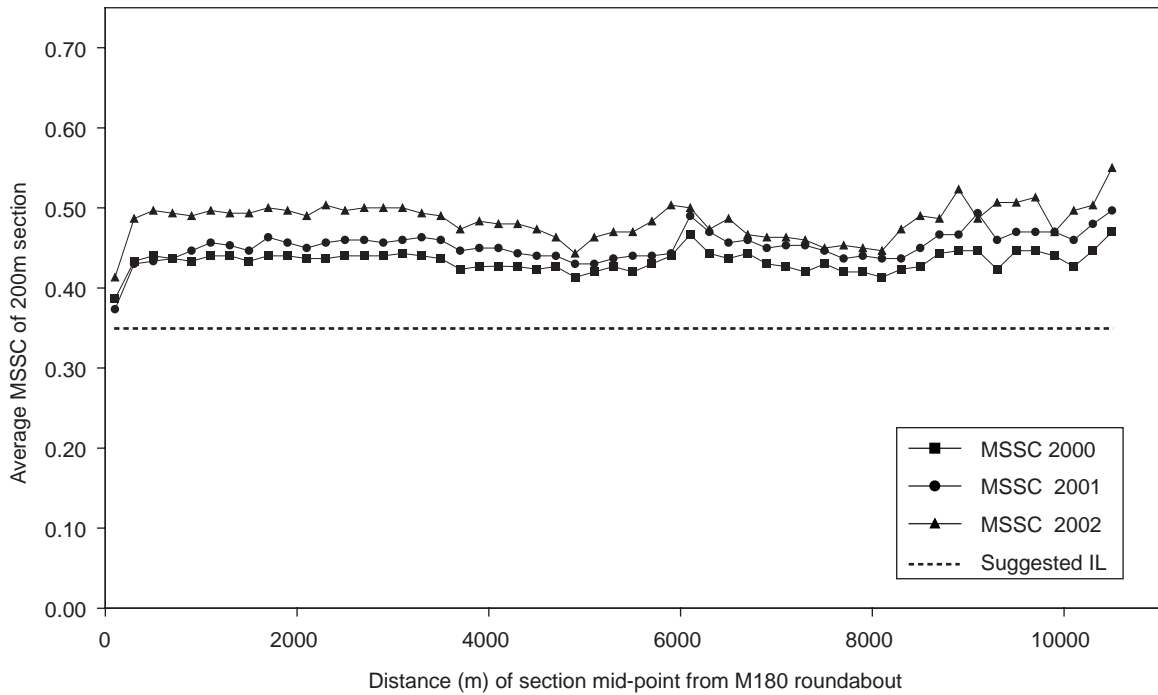
Figure 5.5 Variation in skid resistance along Site E over three summers

However, by the summer of 2000 the level of skid resistance was broadly uniform along the site with long stretches at similar levels. This continued to be so throughout the monitoring period. This is illustrated in Figure 5.5, which shows, for the three seasons, the variation in MSSC along the site. The likely investigatory level for this type of site, 0.35 is also included in Figure 5.5 for comparison. In each season, skid resistance was maintained above the investigatory level, with only minor variations, along the whole site.

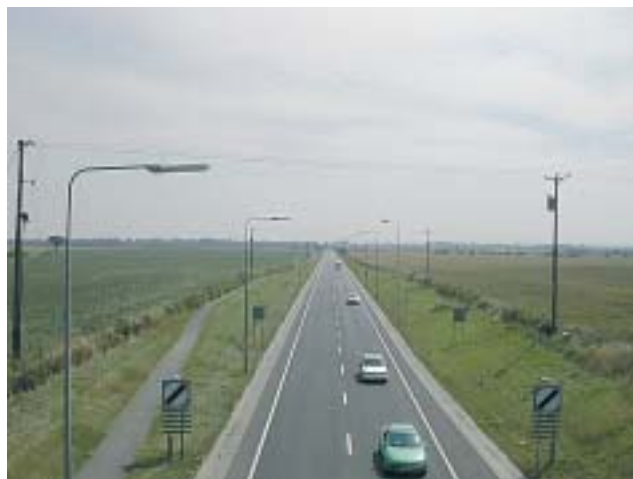
Figure 5.6 Site G: de-restricted section looking south

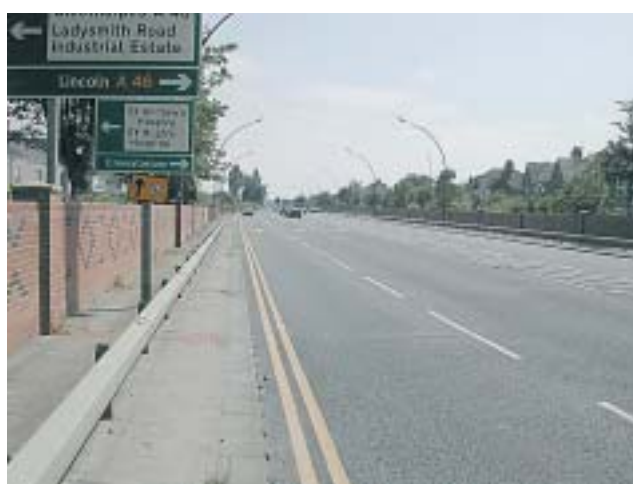
Figure 5.7 Site G: 30mph section, traffic light approach

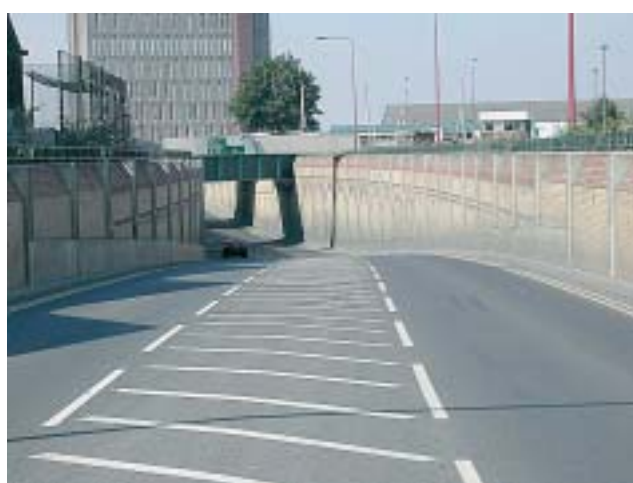
Figure 5.8 Site G: underpass section looking north

- *Chainage 3500-3900:* This is the ‘underpass’ section, laid with BOS slag up to the approach to the traffic lights at the end of Peaks Parkway. There is a sharp drop in SC in the middle of the section. This corresponds to the lowest point of the underpass. The low SC here was not due to a deficiency in the BOS slag surfacing, but to the presence of contaminating materials. The road on this section drained to this point and mud and detritus accumulated in the dip, both contaminating the surface and, possibly, acting as an additional polishing medium. (This effect was even more marked on the southbound side).

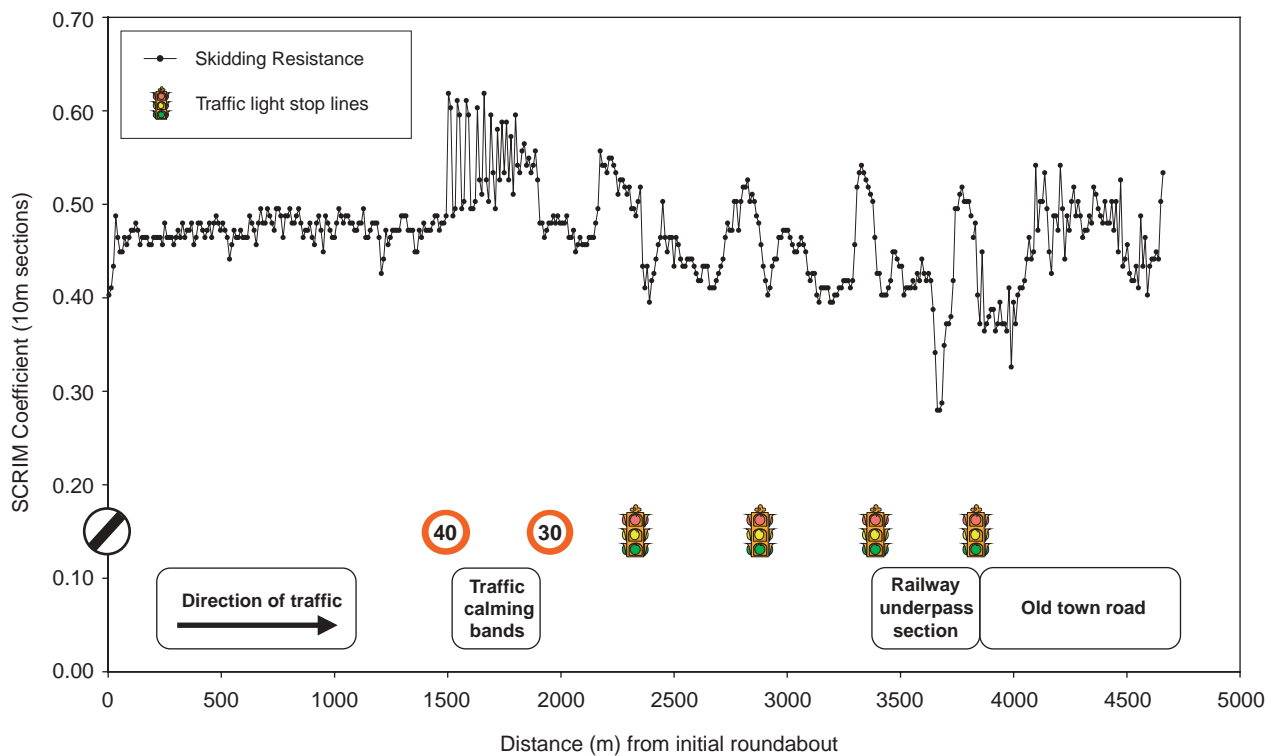
Figure 5.9 Variation of SC along Site G in September 2000

Unlike the other sites, where the skidding resistance was generally uniform along the test lengths, because of the different traffic behaviour, there was far more variation here. This is illustrated in Figure 5.9, which shows the SC for July 2002 for the northbound lane. In this figure, each point represents a single 10m measurement.

Looking at Figure 5.9 from left to right (in the direction of traffic), a number of features can be seen in the SC measurements, described as follows. All these effects were mirrored on the corresponding parts of the southbound lane:

- *Chainage 3900 onwards:* This is the ‘old road’ section and the variable nature of the skidding resistance on this section reflected conditions on the road. This had a mixture of surfacings and substantial patched areas along its length, as well as entrances to retail sites, a bus garage and a further set of traffic lights.

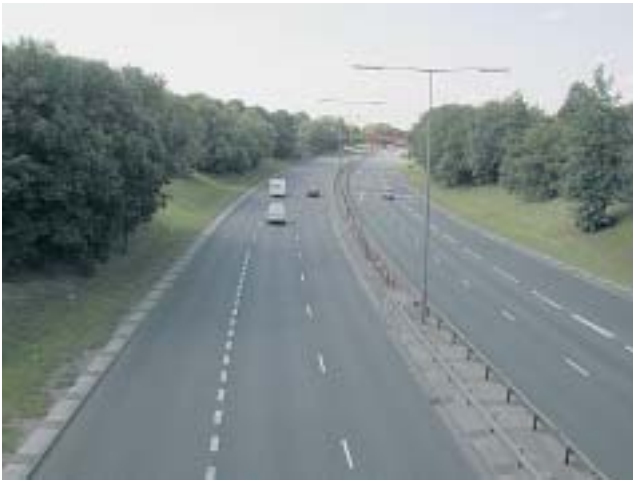
Figure 5.10 Site H (the left carriageway) BOS slag sections

Site H (Figure 5.10) provides a comparison of the performance of two sources of BOS slag and a natural aggregate, all laid at the same time and subject to the same traffic conditions. At the time of the final measurements in

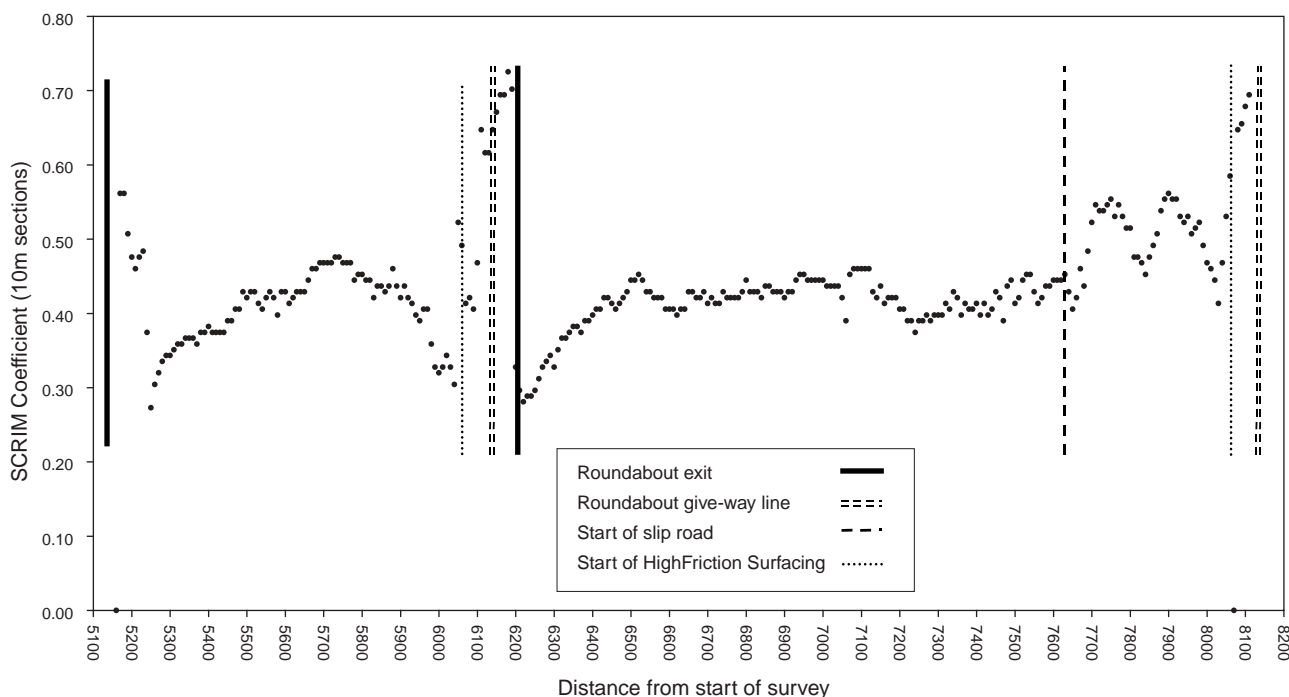
Figure 6.1 Variation in skidding resistance on a ‘principal road’ with acceleration and deceleration areas
