PUBLISHED PROJECT REPORT PPR045

TYRE BALES IN CONSTRUCTION: CASE STUDIES

by M G Winter, J M Reid and P I J Griffiths (TRL Limited)

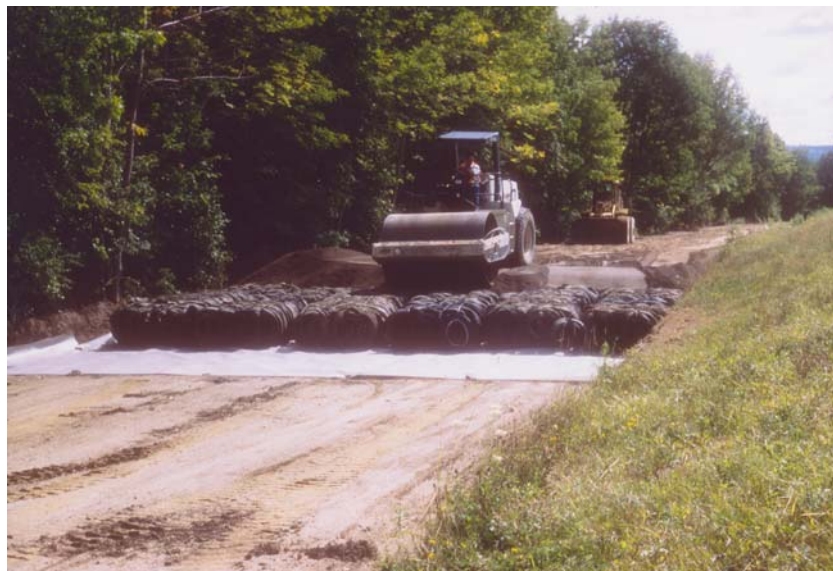
Figure 1.1 – CR647 under construction. (Photograph © Chautauqua County Department of Public Facilities.)

Construction (Figure 1.1) was broadly the same as described below for the Kabob Road but without the blacktop layers or the side drain.

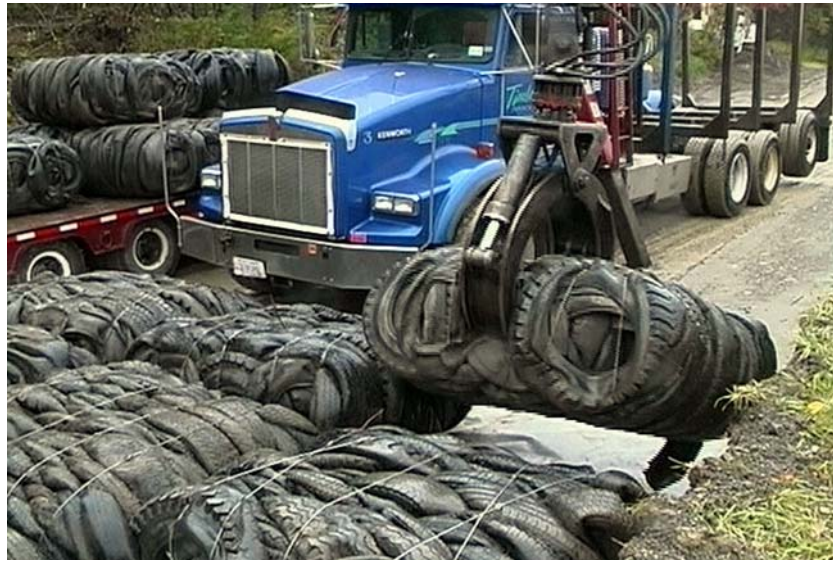
Figure 1.3 – Construction of the tyre bale section of CR342 – placement of the sand layer.
(Photograph © Chautauqua County Department of Public Facilities.)

A total of 360 bales were carefully placed side-by-side (Figure 1.3) in a single layer, six bale wide 'chessboard' pattern on the geosynthetic using a log-grab, commonly used in the forestry industry. The bales were placed such that the retaining wires were parallel to the direction of the road and were thus best placed to carry the applied loads. A layer of coarse sand was placed on top of the bales (Figure 1.4) and a vibratory roller used to fill and compact the sand into the voids between the bales¹ (Figure 1.1). The sand layer was carefully

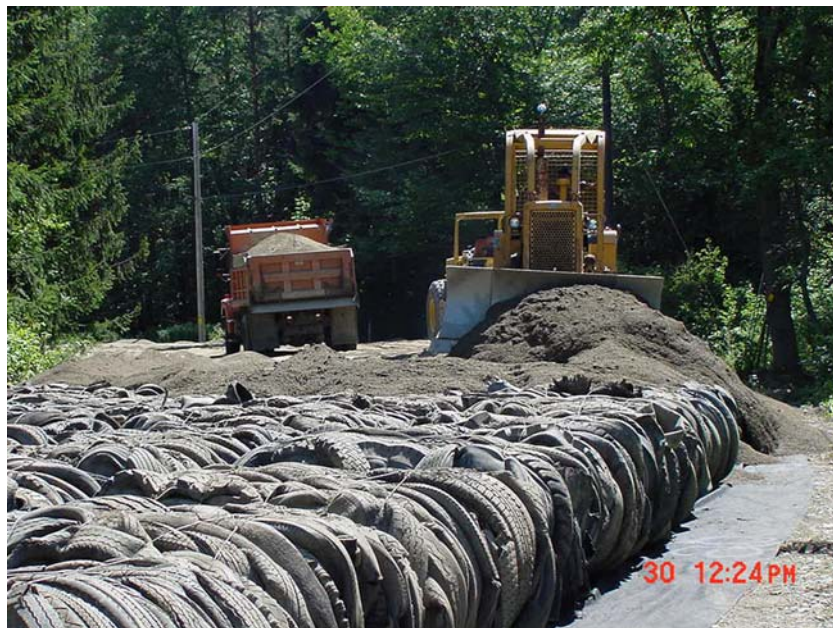
Figure 1.4 – Construction of the tyre bale section of CR342 – placement of the sand layer.
(Photograph © Chautauqua County Department of Public Facilities.)

graded prior to rolling to give a layer thickness of approximately 3' (0.076m). A fire truck and tanker were used to pump thousands of gallons of water onto the layer of sand to wash it into any areas missed by the vibratory roller. These areas were re-filled with sand and rolled once more.

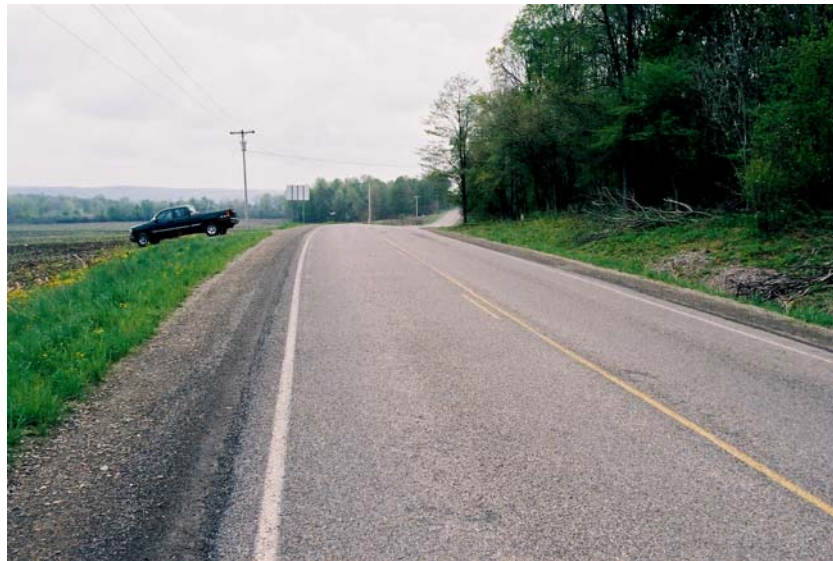
Construction was completed in summer 2000 and Chautauqua County officials are confident that the section of CR342 reconstructed using tyre bales under blacktop will perform as well or better than the more traditional methods of construction used adjacent to that section (Figure 1.5).

Figure 1.5 – CR342 in May 2004.

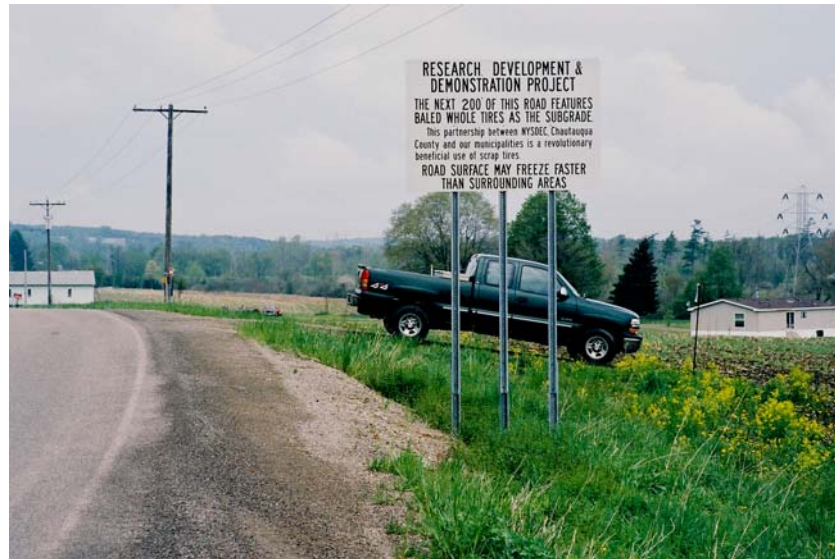
It is worthwhile to note that due to the thermal insulating properties of the tyre bales freeze-thaw action has ceased to be a problem at this site. This is because the thermal insulating properties of the tyre bales slow the movement of heat from the lower layers of the road construction. While this means that the frost does not penetrate as deeply it may also mean that this section may freeze more quickly than adjacent areas.

A sign has been placed at the start of the section to warn drivers of this possibility (Figure 1.6). However, no manifestation of this phenomenon has been observed and these portions of the signs, which are also placed on all of the other tyre baled roads, are likely to be removed in the near future.

Figure 1.6 – Tyre bale section of CR342. The warning signs regarding the potential for early freezing are likely to be removed in the near future.

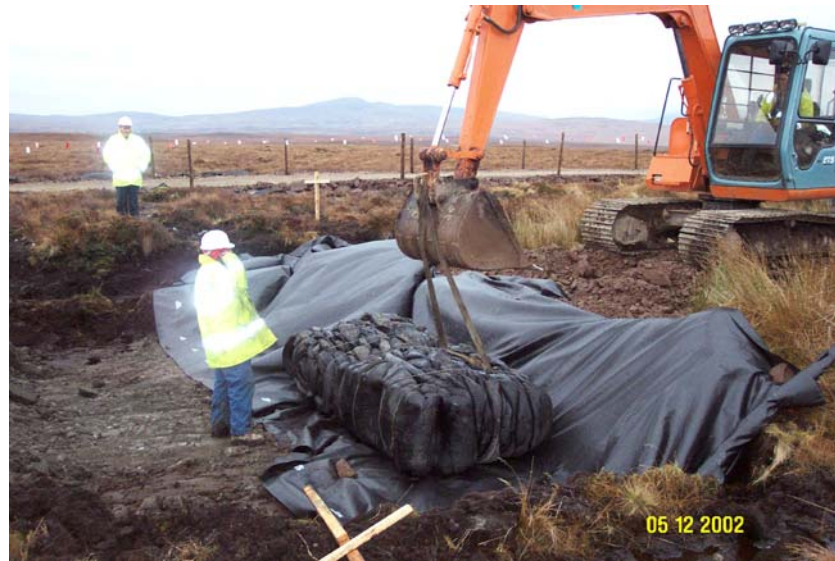
Figure 2.1 – Placing the tyre bales on the B871. (Photograph © Highland Council.)

Construction of the tyre bale embankment took place during a two week period in December 2002. The construction sequence was important to the successful installation of the tyre bales and involved excavation to 1500mm below existing road level, placing the geosynthetic and the first layer of bales (Figure 2.1). At this stage the gaps between the bales and the accessible voids in the bales were filled with lightweight expanded clay aggregate (Figure 2.2). The second layer of bales and lightweight fill was then placed before the geosynthetic was wrapped around the entire assembly and a 250mm layer of fine rockfill was placed to create a working platform. A nominal layer of welded reinforcing mesh (A252: 8mm bars at 200mm centre-to-centre spacing) was included in this layer to provide additional stiffness, following common practice in Finland. These operations were carried out in 5m long bays, such that each complete bay created a secure working platform from which the next could be constructed.

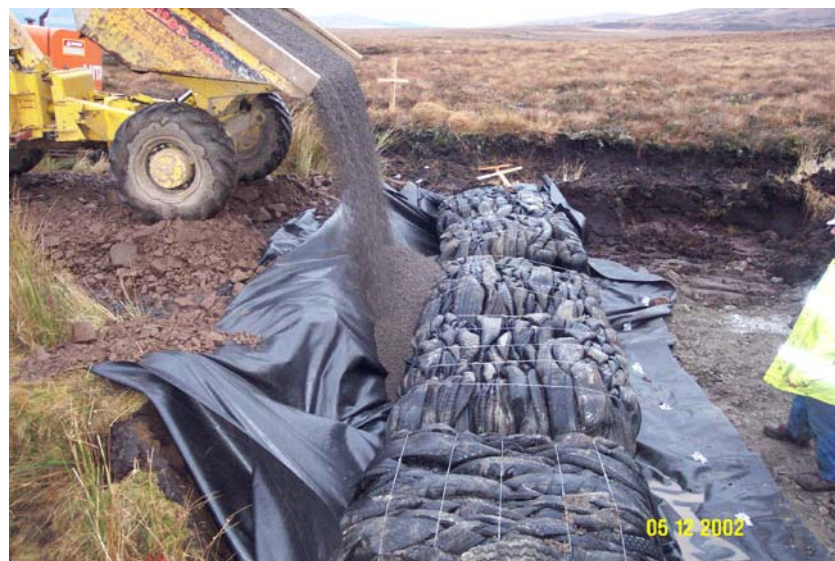
Figure 2.2 – Placing the tyre bale infill on the B871. (Photograph © Highland Council.)

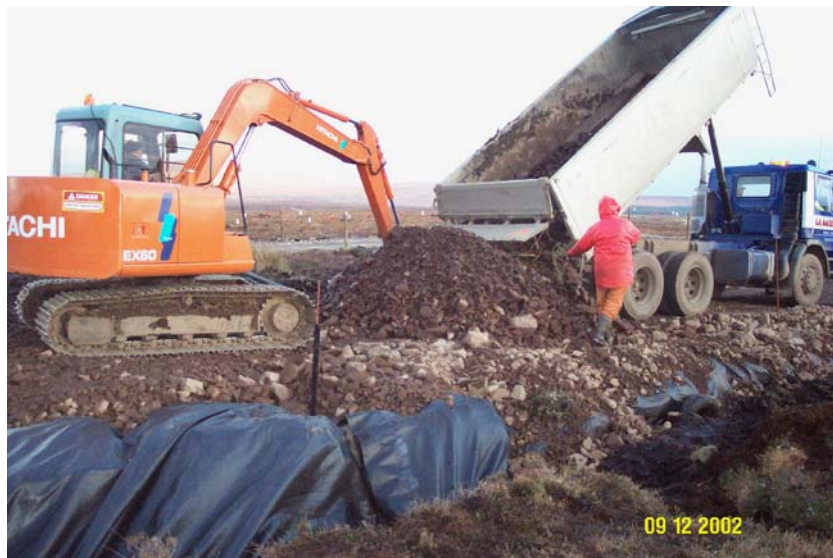
Figure 2.4 – Road construction on top of the tyre bales on the B871. (Photograph © Highland Council.)

A 100mm layer of primary Type 1 sub-base was compacted on top of the fine rockfill layer to provide a running surface to the road that was then opened to traffic (Figures 2.4 and 2.5). After three months some loosening of the Type 1 sub-base surface was observed and a 50mm layer of fine sand and gravel was added using a paving machine to provide better interlock at the surface. This enabled the

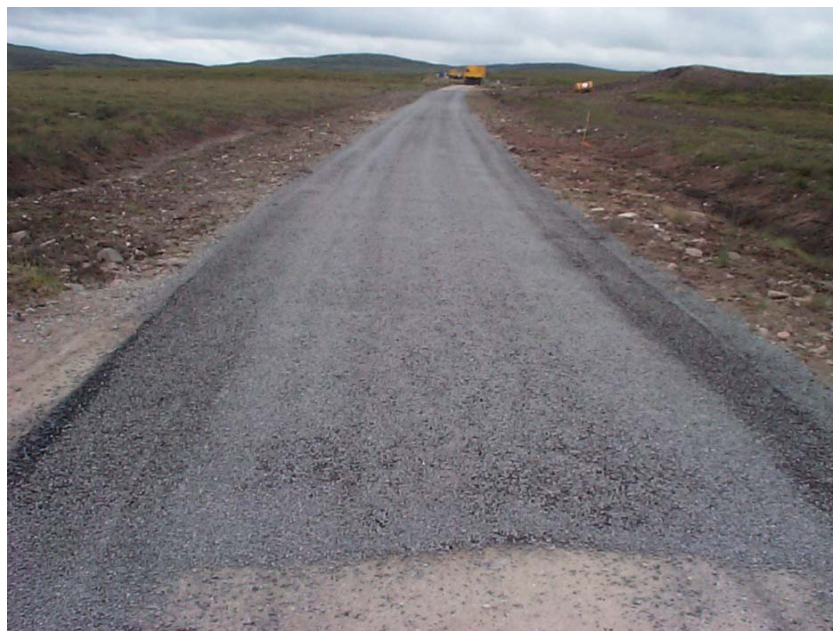
Figure 2.5 – The completed tyre bale road construction on the B871. (Photograph © Highland Council.)

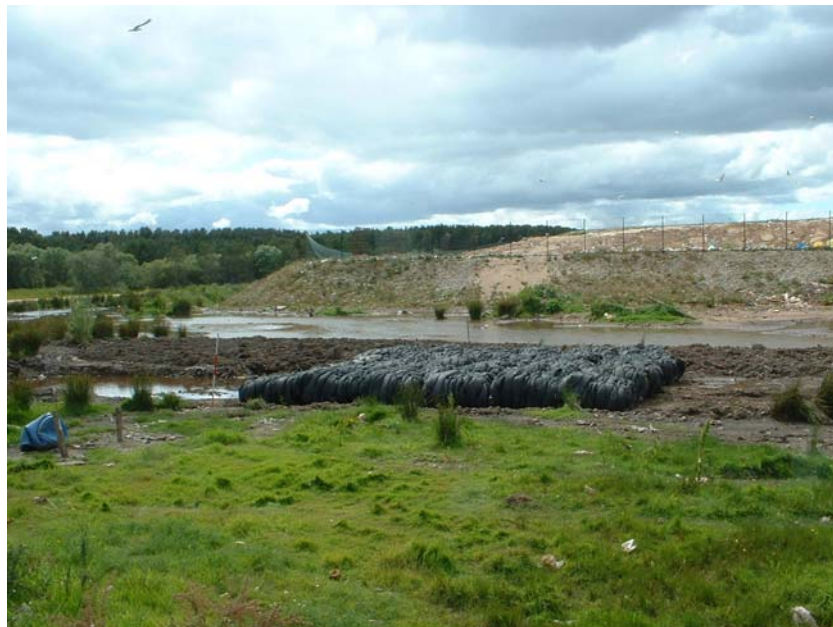
Figure 4.1 – Construction of the landfill access road. (Photograph © Northern Tyre Recycling.)

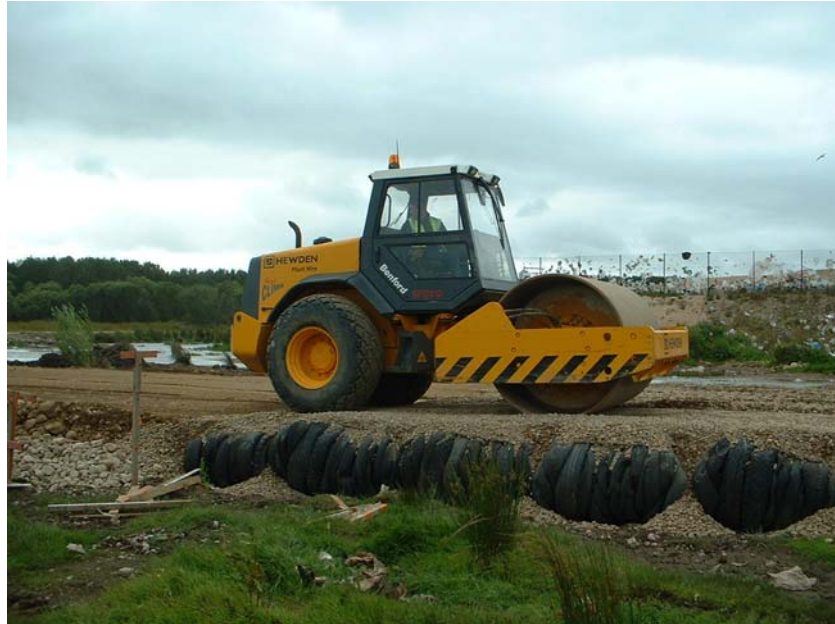
Figure 4.2 – Construction of the landfill access road. (Photograph © Northern Tyre Recycling.)

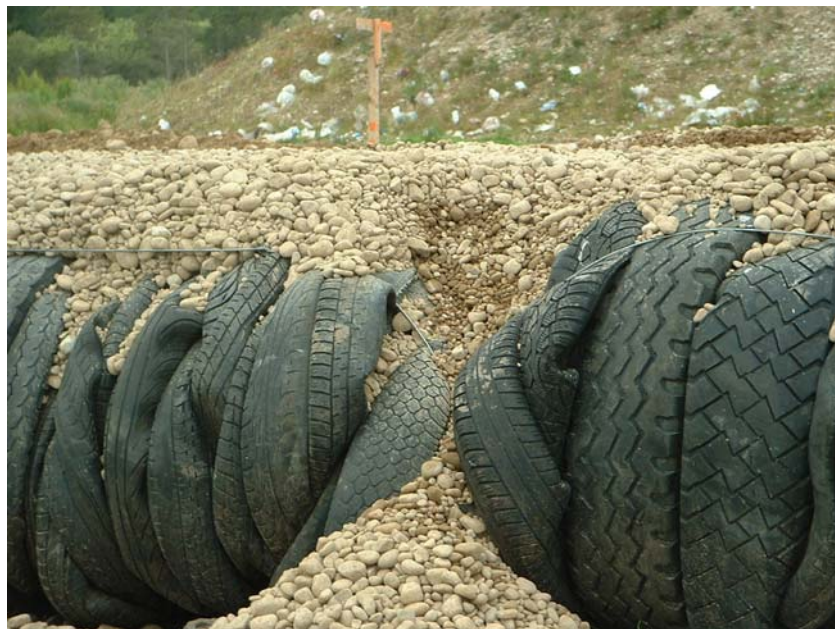
Figure 4.3 – Detail of the constructed landfill access road. (Photograph © Northern Tyre Recycling.)

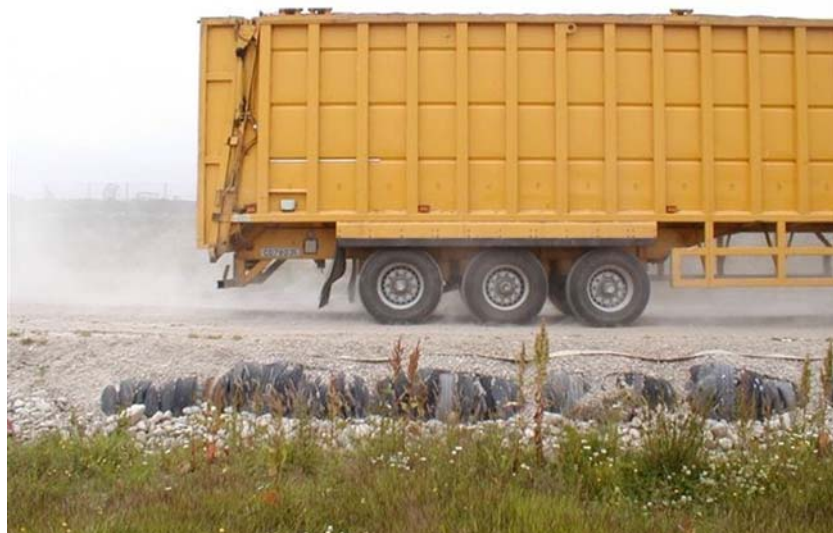
The tyre blocks have proved fit for use in this situation as they are free draining and can therefore cope with the frequent flooding that the landfill site experiences. The road was carefully observed for more than a year with no signs of potholing, cracking and settlement. No evidence of failure has been observed and the areas of road constructed with tyre bales are performing equally with those constructed using cobbles.

Figure 4.4 – The completed landfill access road. (Photograph © Northern Tyre Recycling.)

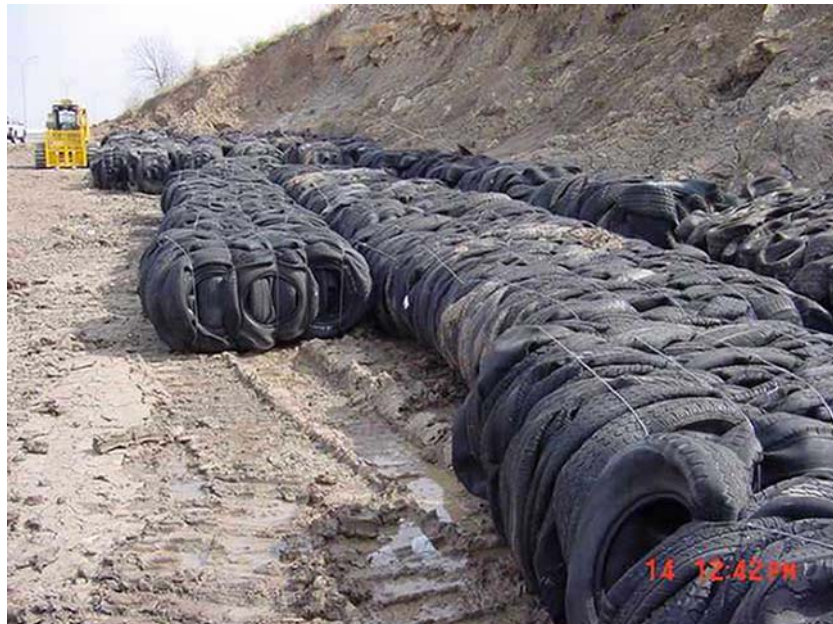
Figure 5.2 – Placing tyre bale layer one in the excavated IH30 slope failure. (Photograph © Texas Department of Transportation.)

Tyre bales were laid in the base of the excavation (Figure 5.2) and pushed together in order to ensure contact between adjacent bales and to fill the entire area of the excavation. This first layer of bales was covered with 8" (0.203m) to 12" (0.305m) of spoil from the excavation and a second layer of bales placed (Figure 5.3). This approach was adopted in order to alleviate fears regarding the potential vulnerability of a large volume of tyre bales to spontaneous combustion. However, further examination of the available literature (e.g., Sonti *et al.*, 2000) points to this risk being minimal due to the reduction in available oxygen and the decrease in surface area caused by the tyre baling process. Additionally, potential shear failure planes could be introduced by the use of this approach, which is highly unlikely to be repeated in either the USA or elsewhere. The potential geotechnical implications of this approach would almost certainly have been recognised during the certification/checking process that is mandatory for geotechnical works on trunk road and motorway schemes in the UK and is unlikely to have been adopted.

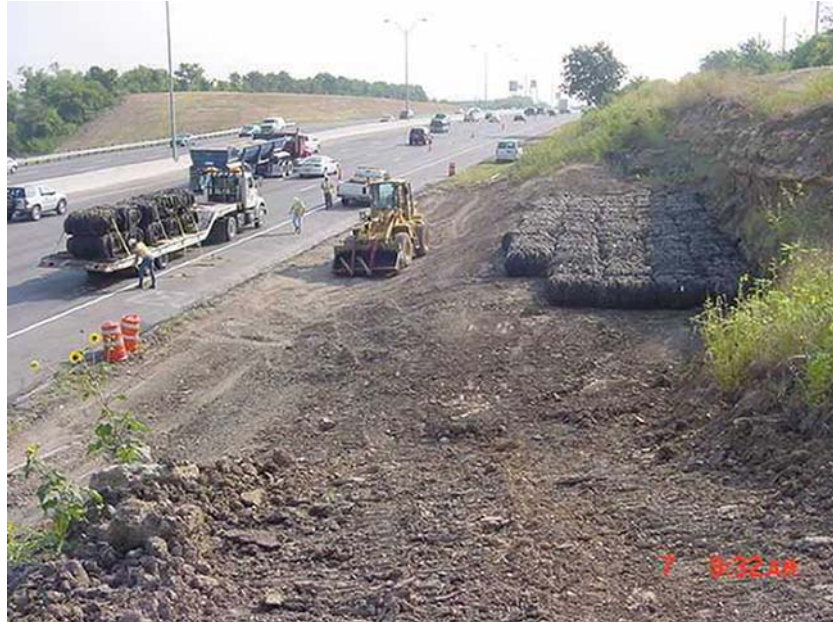
Figure 5.3 – Placing tyre bale layer two in the excavated IH30 slope failure, note the cover to layer one. (Photograph © Texas Department of Transportation.)

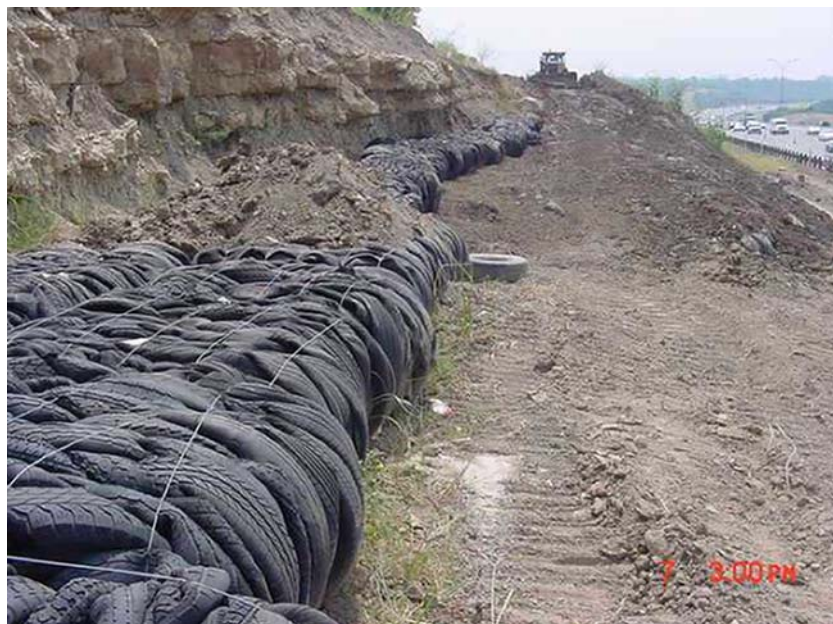
A third layer of tyre bales was placed in a similar fashion (Figures 5.4 and 5.5). However, after the placement of just one row of bales (Figure 5.4) the economically viable supply of tyres for the bales dried up due to external factors, leaving layer three only partially complete and omitting a further three potential subsequent layers.

Figure 5.4 – Placing tyre bale layer three in the excavated IH30 slope failure, note the cover to layers one and two. (Photograph © Texas Department of Transportation.)

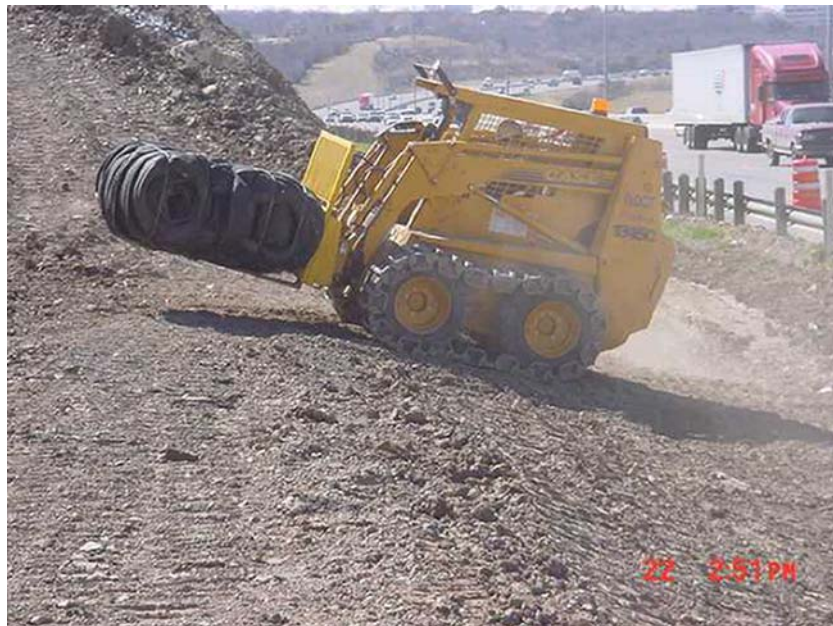
**Figure 5.5 – Moving tyre bales up the partially constructed slope repair to layer three.
(Photograph © Texas Department of Transportation.)**

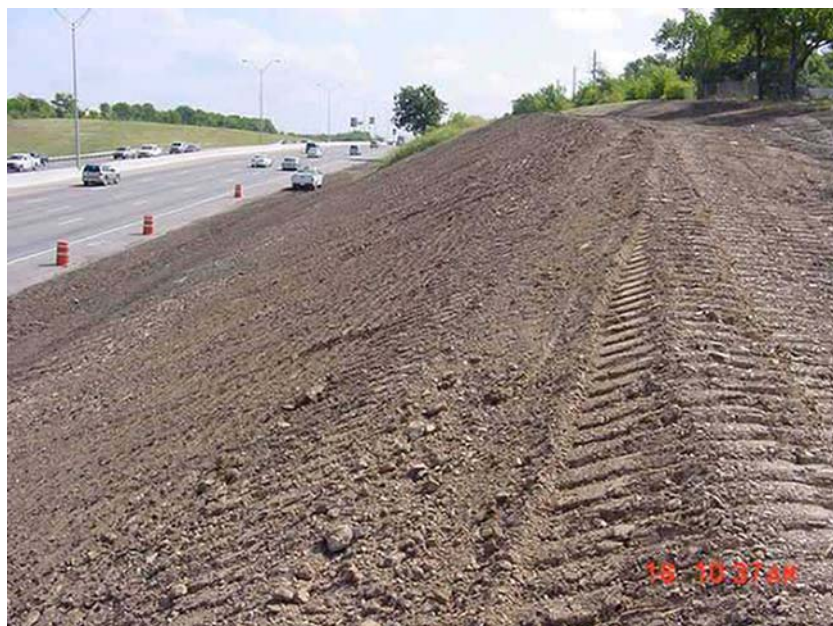
Figure 5.6 – The completed repair. (Photograph © Texas Department of Transportation.)

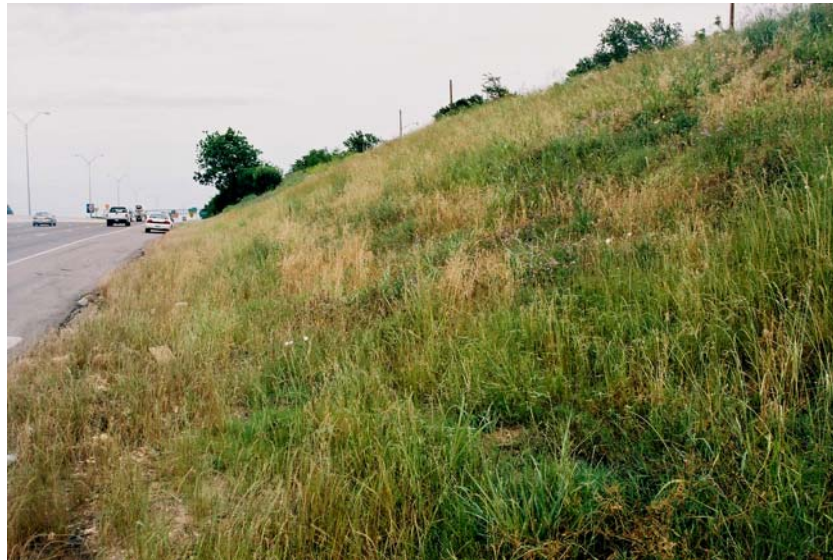
Figure 5.7 – General view of the slope in May 2004.

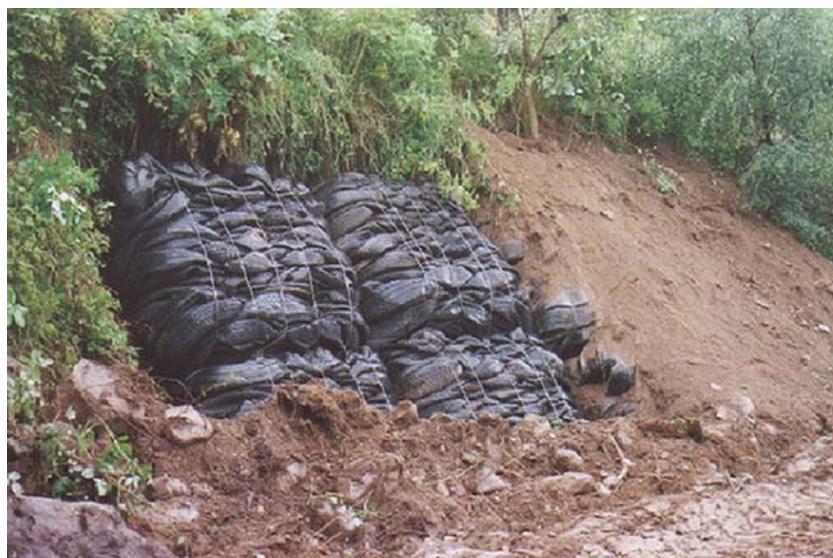
Figure 7.2 – Construction of the slope repair. (Photograph © Northern Tyre Recycling.)

A construction solution involving the use of tyre bales to capture and drain the water away from the slope was devised (Figures 7.2 and 7.3).

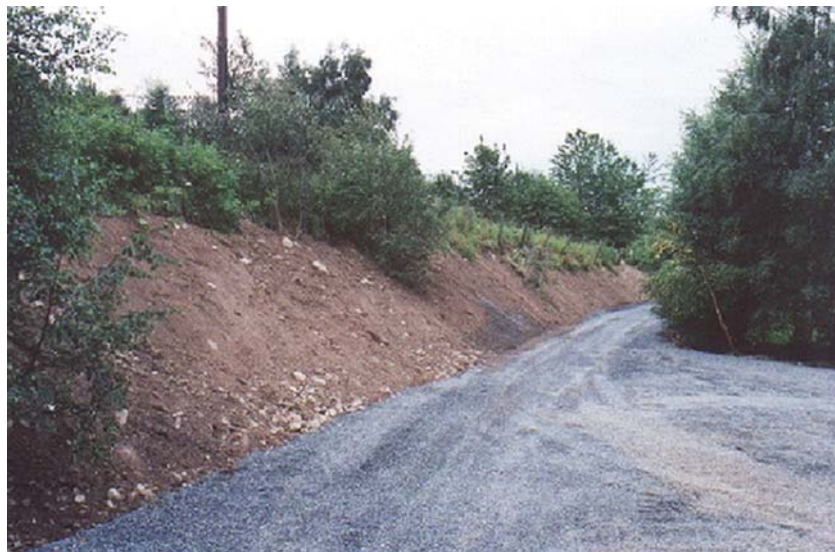
Figure 7.4 – The completed slope immediately after construction. (Photograph © Northern Tyre Recycling.)

The slope face was excavated and tyre bales were placed in the void created. This allowed the water coming from both above and behind the slope to be captured in the bales voids and drained to tyre bales forming a drain between the base of the slope and the driveway. The drain was carefully profiled so as to allow flow out to the mains drainage. The completed slope is shown in Figure 7.4.
