**PUBLISHED PROJECT REPORT PPR2051**

Motorcyclists and Barriers on the National  
Highways Road Network

C Erginbas, J Hammond, C Collis

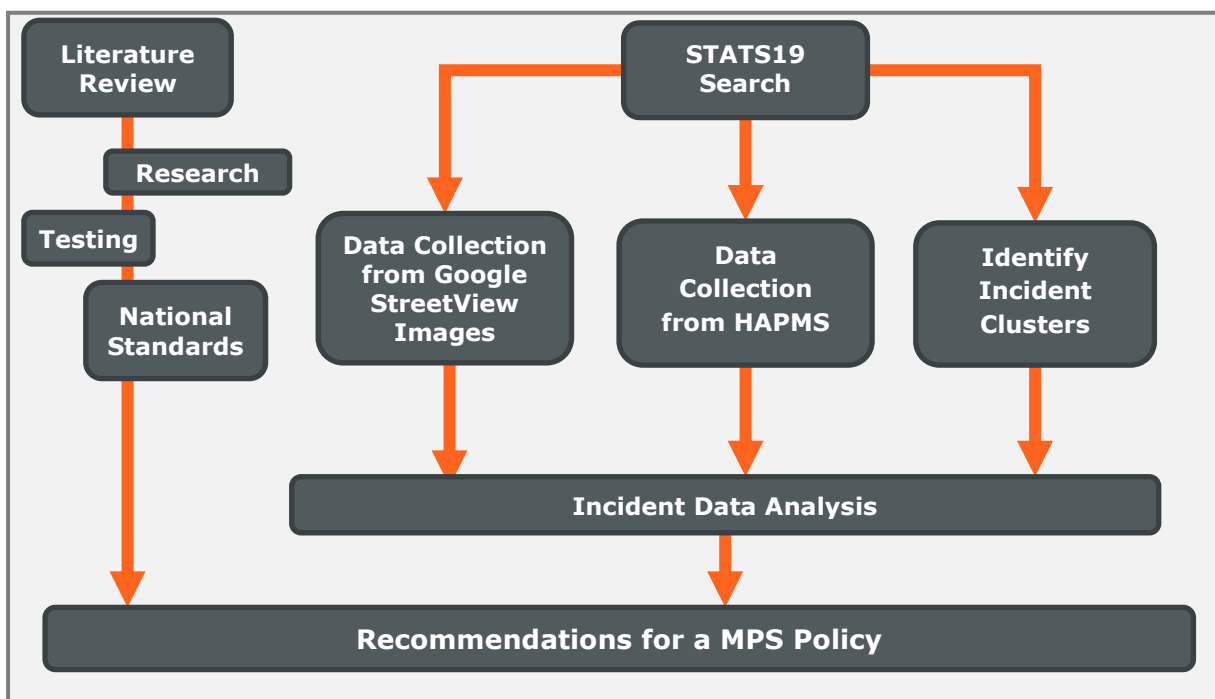
Figure 1: Methodology

The flowchart shown in Figure 1 summarises the methodology adopted in this research to develop the recommendations for a MPS policy.

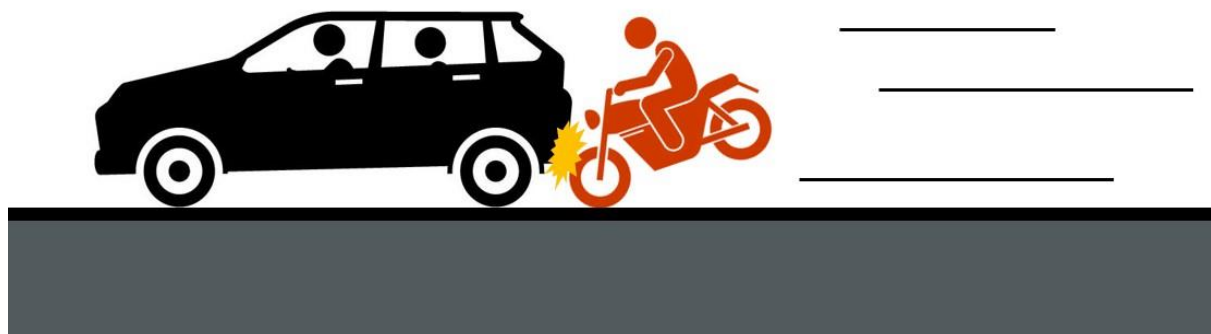
One such type of incident is the rear-end shunt, where a motorcyclist cannot stop in time and hits the vehicle ahead of it, as shown in Figure 2.

**Figure 2: Example of a rear-end shunt**

This sort of incident can be observed on the approach to roundabouts. A rear-end shunt is usually a multiple vehicle scenario that does not necessarily involve a barrier impact. However, one other type of scenario, in which a motorcyclist tries to avoid a rear-end shunt, brakes suddenly, locks the front brake and loses control, is more likely to involve a barrier impact. In this scenario, the errant motorcyclist may slide on the ground after falling from the bike and may reach and hit a barrier. From a National Highways perspective, this sort of incident may

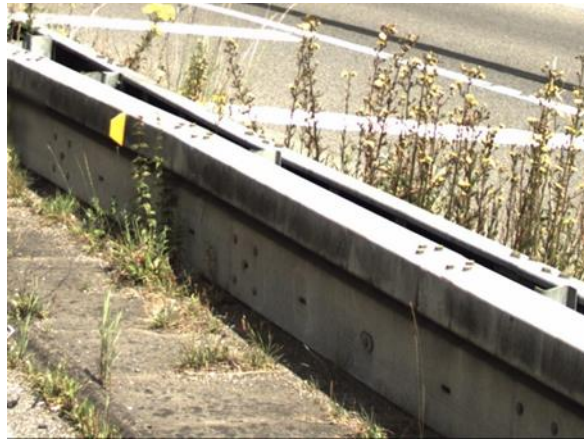
This is the most common MPS type currently being manufactured and promoted within Europe. In this type of MPS (shown in Figure 8), a secondary rail is fitted underneath the main longitudinal of the barrier system. This type of system provides continuous protection from posts for errant motorcyclists impacting the barrier while sliding along the ground, having fallen from their motorcycles. However, these systems do not provide any protection for riders impacting the barriers while they are still on their motorcycles.

**Figure 8: BikeGuard from Highway Care Ltd.**

The main advantage of these systems is that they can be fitted easily under the existing barrier installations, without the need of replacing them. However, as it was previously mentioned, addition of a secondary rail can have adverse effects on the performance of a barrier during an impact with a car. Another disadvantage of these systems is that they can make snow clearing operations harder.

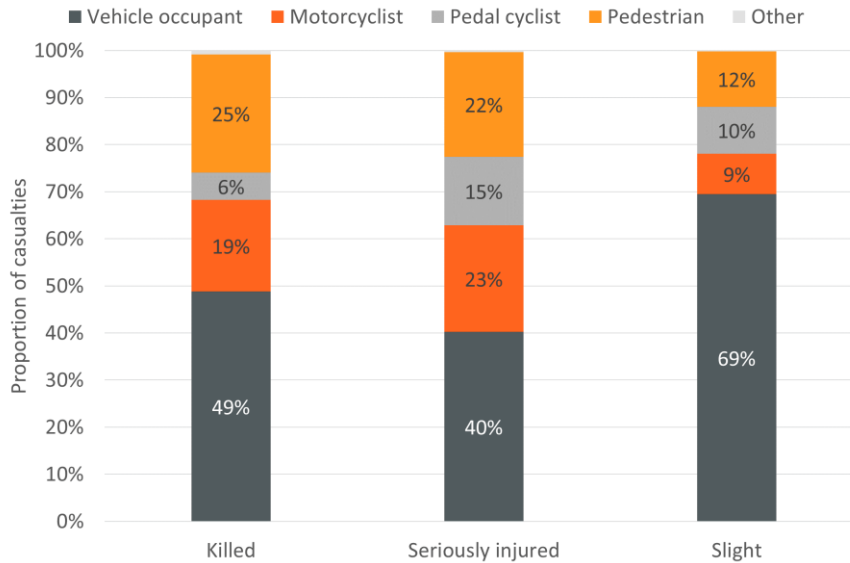
To further understand how casualties are split across different road user groups, data from 2014-2018 was examined in more detail. Figure 12 shows the proportion from each road user group of killed, seriously injured and slightly injured casualties.

**Figure 12: Proportion of casualties by road user type and severity, SRN 2014-18**

Figure 12 shows that vehicle occupants account for the largest proportion of slightly injured casualties (69%). However, the vulnerable road user groups, and especially motorcyclists and pedal cyclists account for larger proportions of the killed and seriously injured casualties.

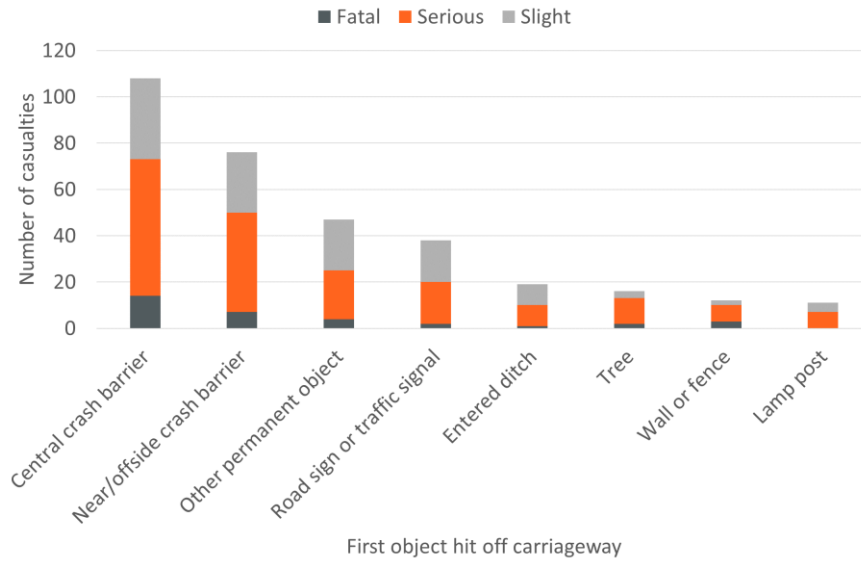
For casualties where the motorcyclist left the carriageway and collided with a roadside object, Figure 18 shows the number of casualties by the type of object the motorcycle hit first.

**Figure 18: Number of motorcyclist casualties by first object hit off carriageway and severity, SRN 2014-18**

As can be seen from the figure, central barriers and nearside/offside barriers were the object types which accounted for the highest and second highest number of motorcyclist casualties. “Other permanent object” which can include many different types of objects was third, followed by “Road sign or traffic signal”.

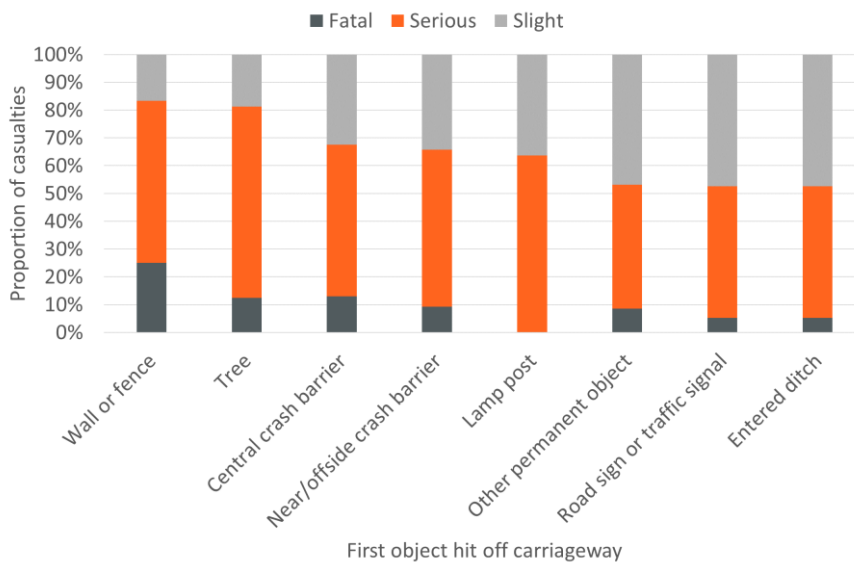
Figure 19 adjusts the previous figure by the percentage of fatal, serious and slight injury casualties resulting from impact with each type of hazard. This way the consequences of hitting each type of roadside hazard can be evaluated, regardless of the total number of incidents.

**Figure 19: Proportion of motorcyclist casualties by first object hit off carriageway and severity, SRN 2014-18**

As shown in the figure, hitting a wall or fence caused the highest ratio of serious or fatal injuries for motorcyclists, with 83% of this sort of impact resulting in either a serious injury or fatality (10 out of 12 casualties). This was closely followed by trees (81% KSI) and then central and nearside or offside crash barriers (68% and 66% KSI respectively).

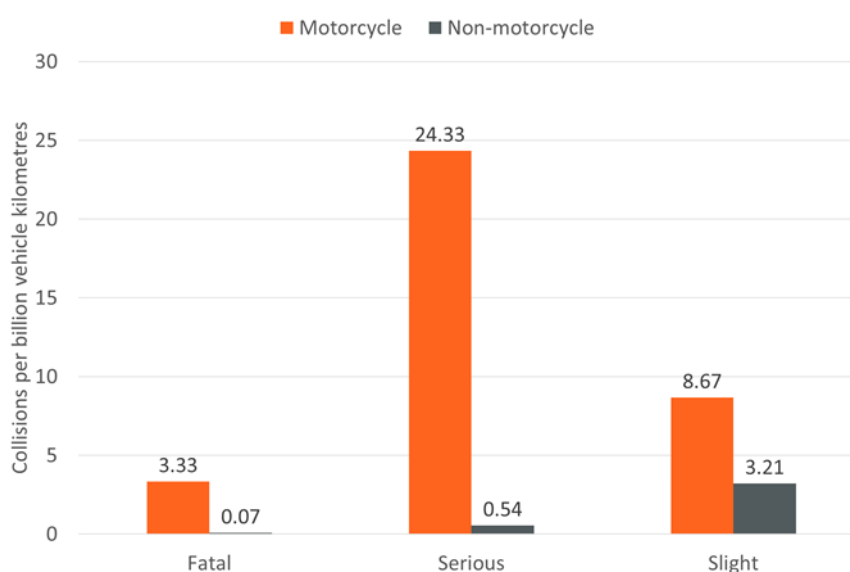
**Figure 21: Single vehicle barrier incidents per billion vehicle kilometres for motorcycles and non-motorcycles, SRN 2014-18**

At first glance, motorcycles, with only 109 (4%) of the 2,913 single vehicle barrier incidents, may not look like a big problem compared to non-motorcycles. However, it is important to account for exposure so Figure 21 shows the number of collisions per billion vehicle kilometres travelled for motorcycles and non-motorcycles, split by severity.

As can be seen in Figure 21, adjusting the numbers with distance travelled per year reveals that motorcycles are heavily over-represented. More specifically, motorcycles (with 2.33 fatal collisions per billion vehicle kilometres) are roughly 33 times more likely to become involved in a fatal single vehicle barrier incident than non-motorcycles (with 0.07 fatal collisions per billion vehicle kilometres).

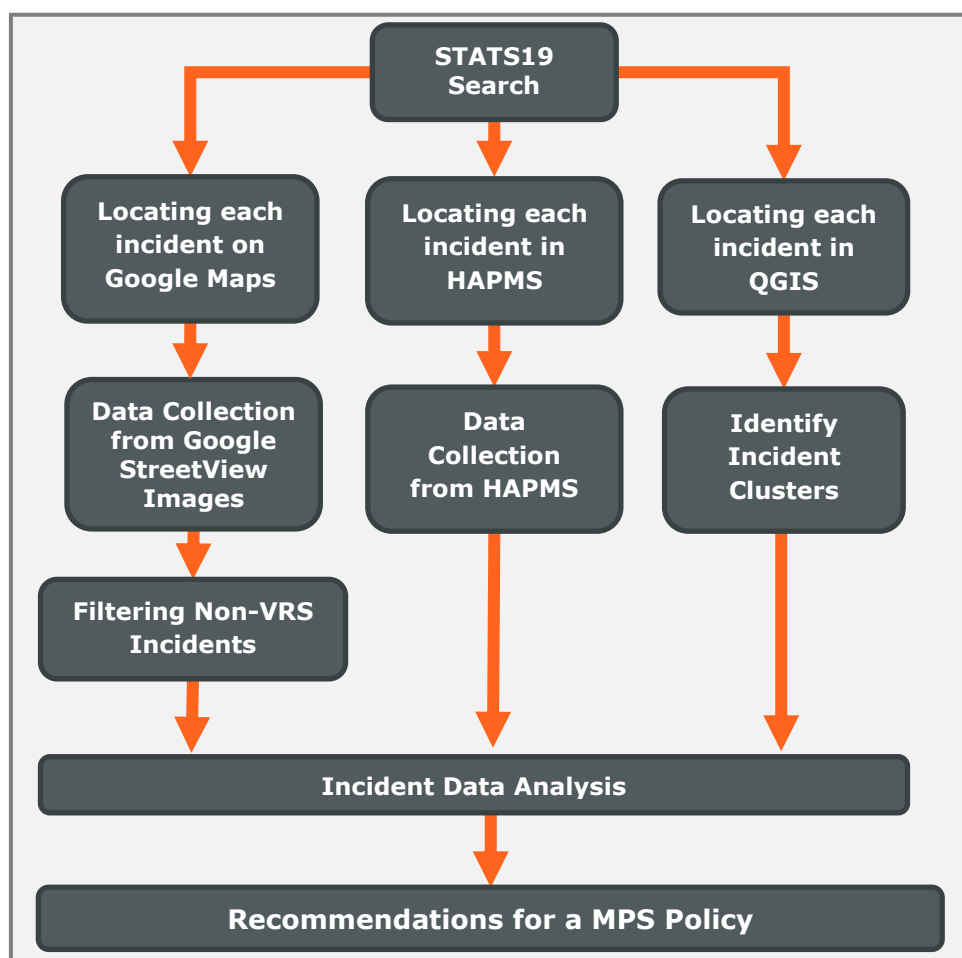
Figure 23: Methodology for data analysis

Figure 23 presents the methodology adopted for the data analysis and the following sections describe the different steps in more detail.

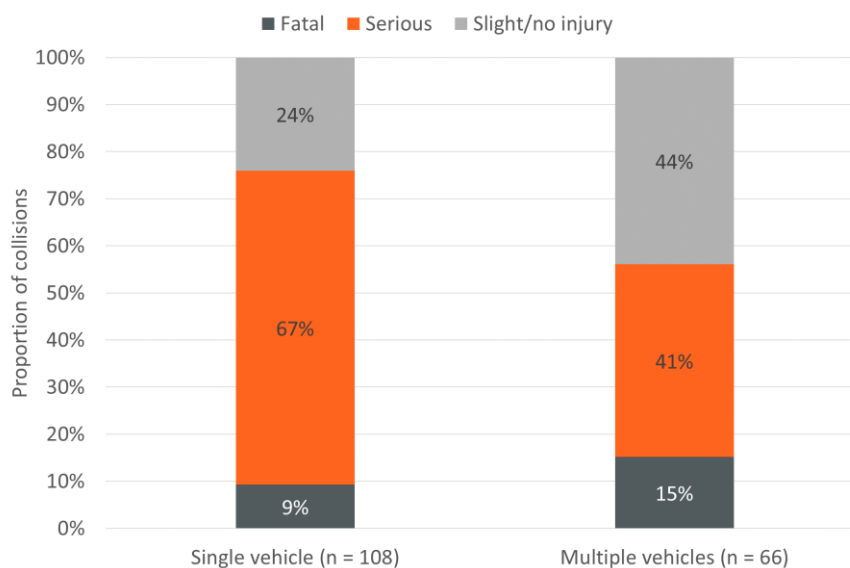
**Figure 25: Proportion of motorcycle-to-barrier incidents, by the number of vehicles involved and severity of most severely injured motorcyclist, SRN 2014-18**

Figure 25 shows a breakdown of these incidents by the severity of the most severely injured motorcyclist and the number of the vehicles involved. The number of vehicles is considered as a key parameter for this research, as this identifies different impact scenarios and influencing factors. Single vehicle collisions accounted for 62% of motorcycle-to-barrier incidents (108 collisions) whereas collisions involving multiple vehicles accounted for 38% (66 collisions).

The graph above shows that, whilst there is lower percentage of killed or seriously injured motorcyclists in multiple vehicle incidents, the percentage of fatalities alone is greater than for single vehicle incidents. This may be due to the different nature of each type of incident.

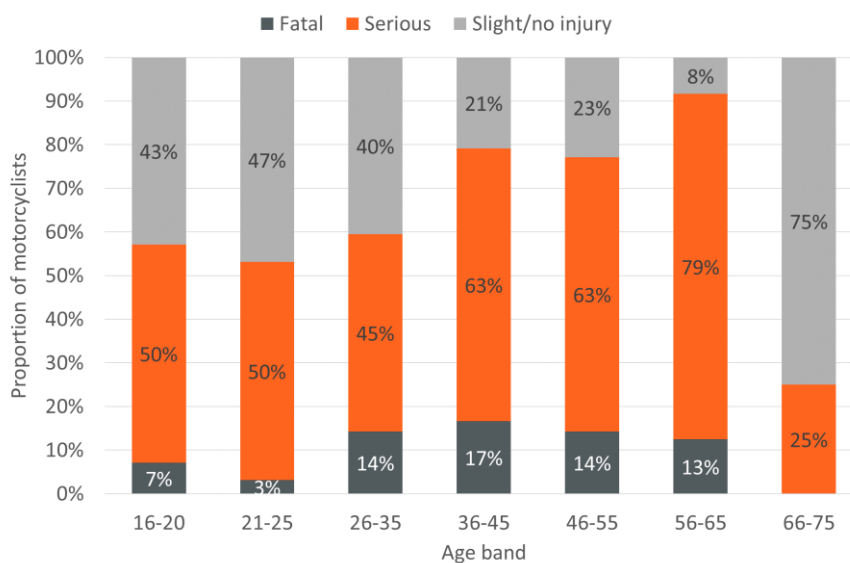
**Figure 28: Proportion of motorcyclists in each age band by severity of most severely injured motorcyclist in collision, SRN 2014-18<sup>7</sup>**

Figure 28 shows the severity of the incident outcome for each age group (note that the number of motorcyclists in the 66-75 age group is very small and so the proportions for this category should be interpreted with caution).

The percentage of riders suffering fatal or serious injury is larger for older age groups (between 36 and 65) than younger age groups. One of the reasons for this may be that older riders can be more susceptible to sustaining injury in the event of an incident.

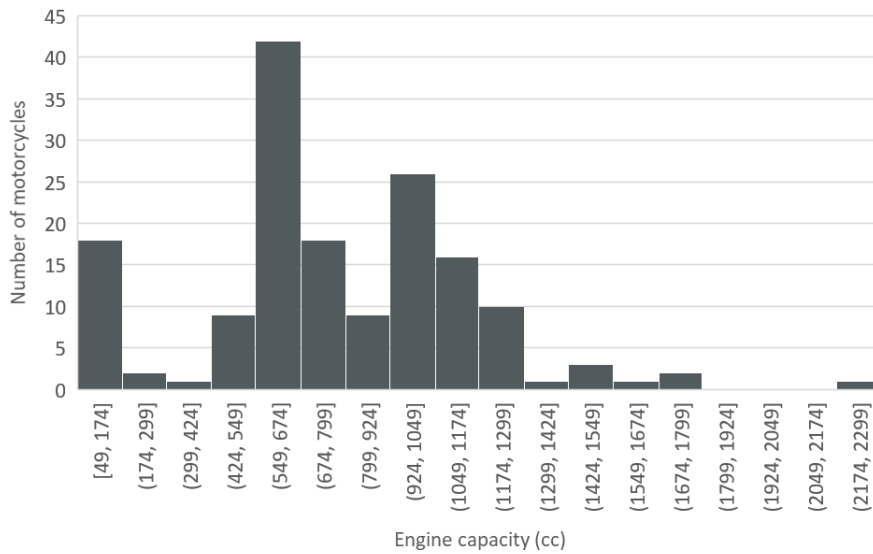
**Figure 35: Engine size distribution for motorcycles involved in barrier incidents, SRN 2014-18**

For 159 of the 175 motorcycles involved in motorcycle-to-barrier incidents, the actual engine capacity of the motorcycle involved in the incident was also recorded within the STATS19 data collection process. The distribution of these is presented in Figure 35.

The mean engine size for motorcycles involved in barrier incidents was 774cc. It can also be seen that the most motorcycles involved in incidents had an engine capacity between around 500cc and 1000cc.

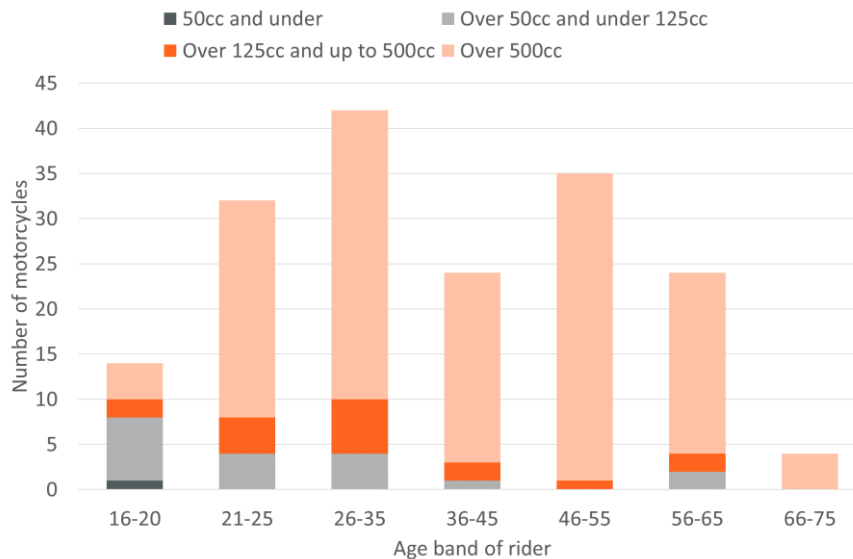
**Figure 36: Number of motorcyclists in motorcycle-to-barrier incidents by type and age band of rider, SRN 2014-18**

Figure 36 presents the number of motorcycles involved in motorcycle-to-barrier incidents by the age band of the rider and the motorcycle engine size.

Examination of Figure 36 suggests that older riders are more likely to be involved in incidents whilst riding more powerful motorcycles. This is to be expected because more powerful motorcycles are likely to be more expensive and therefore less likely to be ridden by younger people who may not be able to afford them.

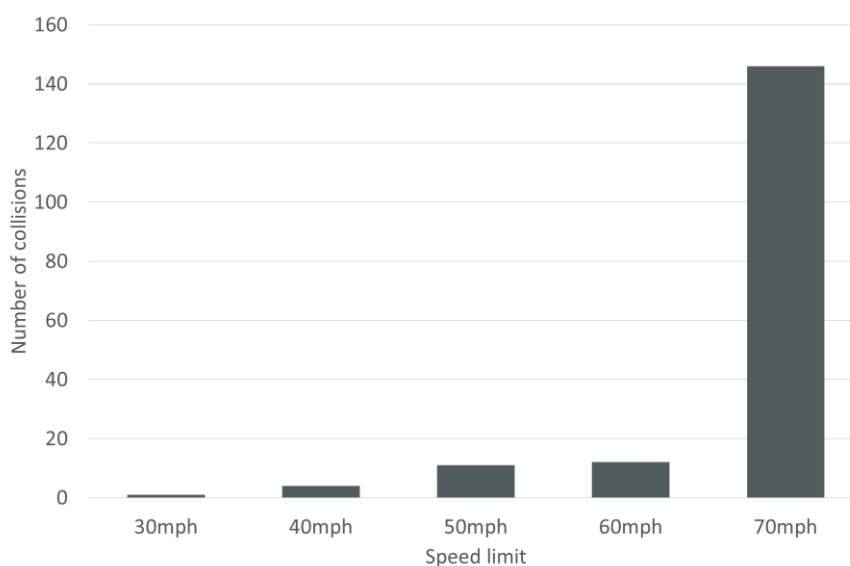
Figure 38 shows the number of motorcycle-to-barrier incidents by the speed limit of the road where they occurred.

**Figure 38: Number of motorcycle-to-barrier incidents by speed limit, SRN 2014-18**

Examination of the speed limit in Figure 38 shows that the majority of motorcycle-to-barrier incidents (84%) occurred on network sections with a speed limit of 70mph. The high-speed nature of these incidents may render a possible MPS installation less effective, as the systems available on the market today are tested to a maximum impact speed of 43.5mph (70km/h).

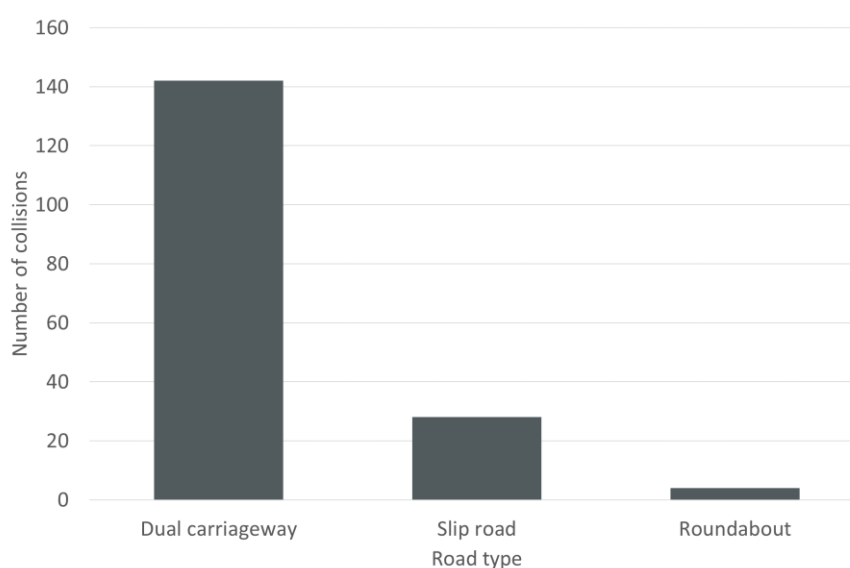
Figure 39 shows the road type recorded within STATS19 for the 174 motorcycle-to-barrier incidents. Of the 174 incidents, 142 (82%) occurred on dual carriageways, 28 (16%) on slip roads and 4 (2%) on roundabouts.

**Figure 39: Number of motorcycle-to-barrier incidents by STATS19 road type classification, SRN 2014-18**

However, investigation of all these incident locations using Google Street View images revealed that some of the incident locations which are coded as dual carriageway actually happened on loops, slip and connector roads that are located at the end of, or before, a dual carriageway. Furthermore, some of these dual carriageways are two-way slip roads, which are designed as recommended within TD22/06 “Layout of Grade Separated Junctions” section 5.27. The authors believe this type of classification makes it difficult to identify the most frequent motorcycle-to-barrier incident location types. For this reason, a new type of classification was introduced for the purposes of this study.

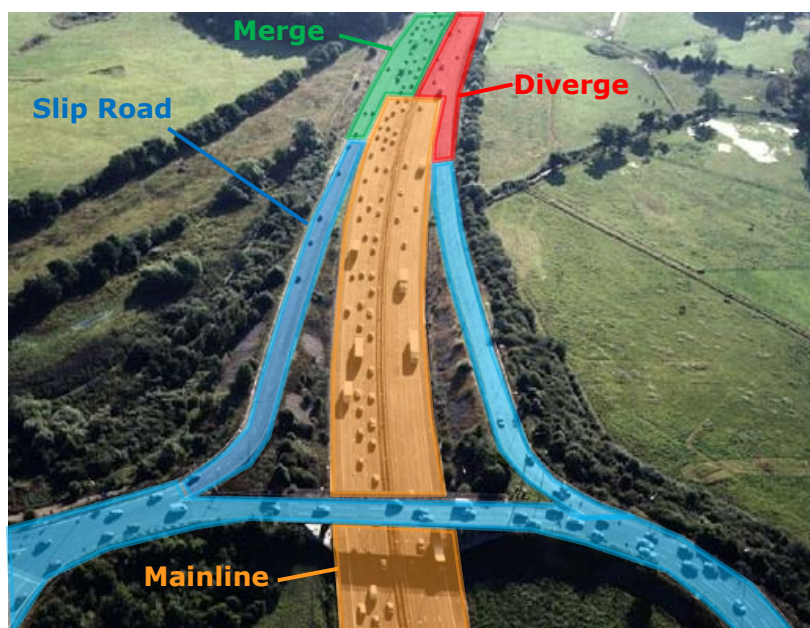
- **Mainline section of a grade-separated junction:** the section of main road, stretching through the grade-separated junction area, from the beginning of the diverge zone to the end of the merge zone.

A diagram of a grade-separated junction showing the different parts used in the classification above is shown in Figure 40.

**Figure 40: Slip and main road sections on a grade-separated junction**

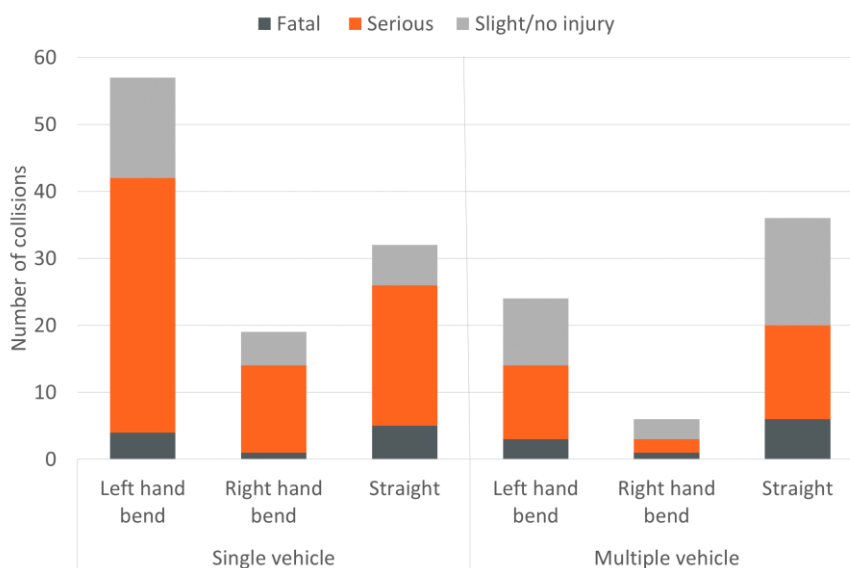
Figure 45 shows the number of motorcycle-to-barrier incidents by the direction of the bend where the incident took place, for single and multiple vehicle incidents.

**Figure 45: Number of motorcycle-to-barrier incidents by number of vehicles involved, direction of bend and severity of most severely injured motorcyclist, SRN 2014-18**

The figure shows that the majority of single vehicle incidents occurred on bends, with left-hand bends having substantially more incidents than right-hand ones. One of the reasons for this may be the existence of hard shoulder on leftmost side of the road. This gives more clear space to motorcyclists who run out of the road on right-hand bends, to get back into control and return to the road. On the contrary, errant motorists usually have less space on the right-hand side of the road to get back in control of their vehicle and hence an impact with a barrier becomes more likely. In addition, the UK drives on the left and therefore most loops and slip roads within grade-separated junctions, which have been shown to have high incident numbers (see Figure 41), are left-hand bends.

Just over half of multiple vehicle incidents occurred on straight sections of road. Due to their nature, multiple vehicle incidents on high-speed roads are difficult to predict; the case is even more challenging for featureless straight sections of roads.

As shown in the figure, motorcyclists generally strike the offside barriers on left-hand bends, and nearside barriers on right-hand bends. This is mainly due to the underlying nature of motorcycle riders running wide on bends. In a similar way to the results from Figure 45, the reason for more offside barriers being struck than the nearside ones could partly be explained by the existence of extra recovery space on the nearside due to the existence of the hard shoulder.

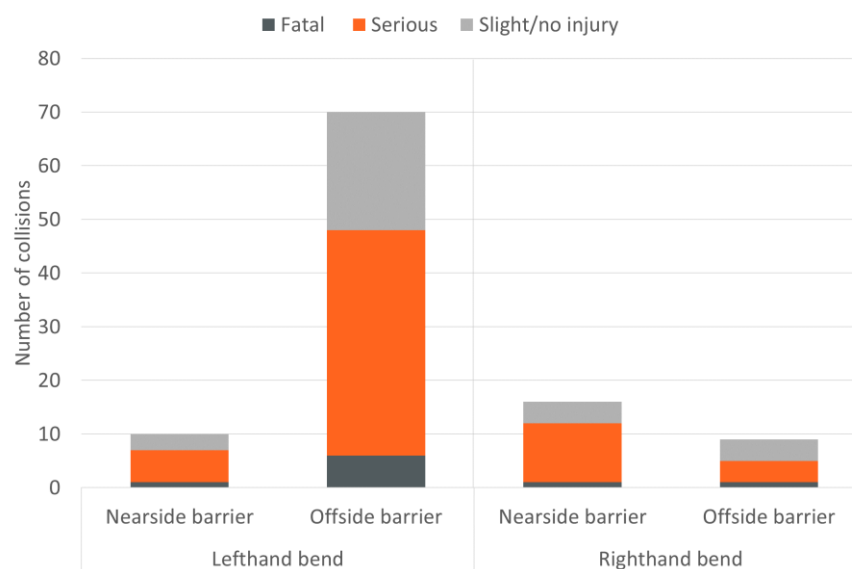
Figure 46 shows the number of single vehicle incidents recorded on bends only (106 incidents), by bend direction and location of the struck barrier.

**Figure 46: Number of motorcycle-to-barrier incidents on bends by direction of bend, location of struck barrier and severity of most severely injured motorcyclist, SRN 2014-18<sup>8</sup>**

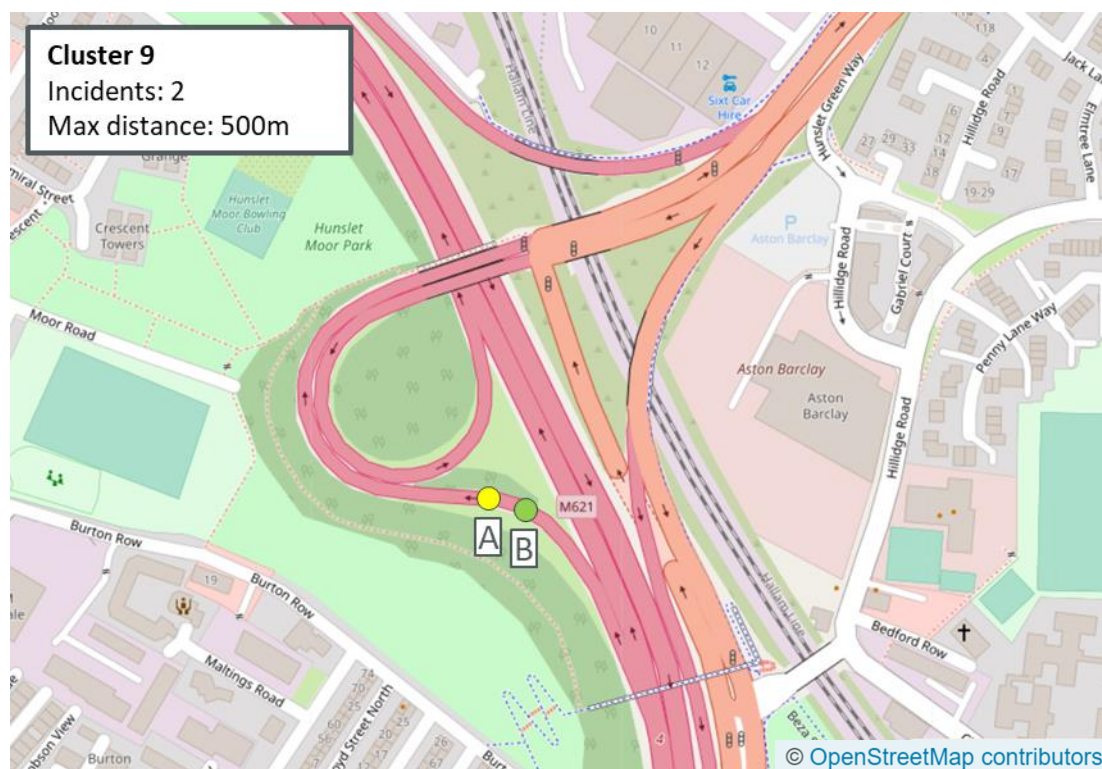
Incident B was similar to Incident A. It involved a motorcycle going ahead round a left-hand bend which then left the carriageway on the offside before hitting an OBB barrier and rebounding. However, in Incident B there was no object hit in the carriageway and the motorcycle was less powerful (124cc). Also, the motorcyclist in Incident B was only slightly injured.

There was no MPS present at either incident location in this cluster.

Figure 60: Cluster 9, M621 Junction 4 (OpenStreetMap)
