**A Review of HGV Crossover Accidents, and the Relative
Costs of Steel and Concrete Barriers
(Phase II Report)**

PPR 280

PUBLISHED PROJECT REPORT

TRL Limited

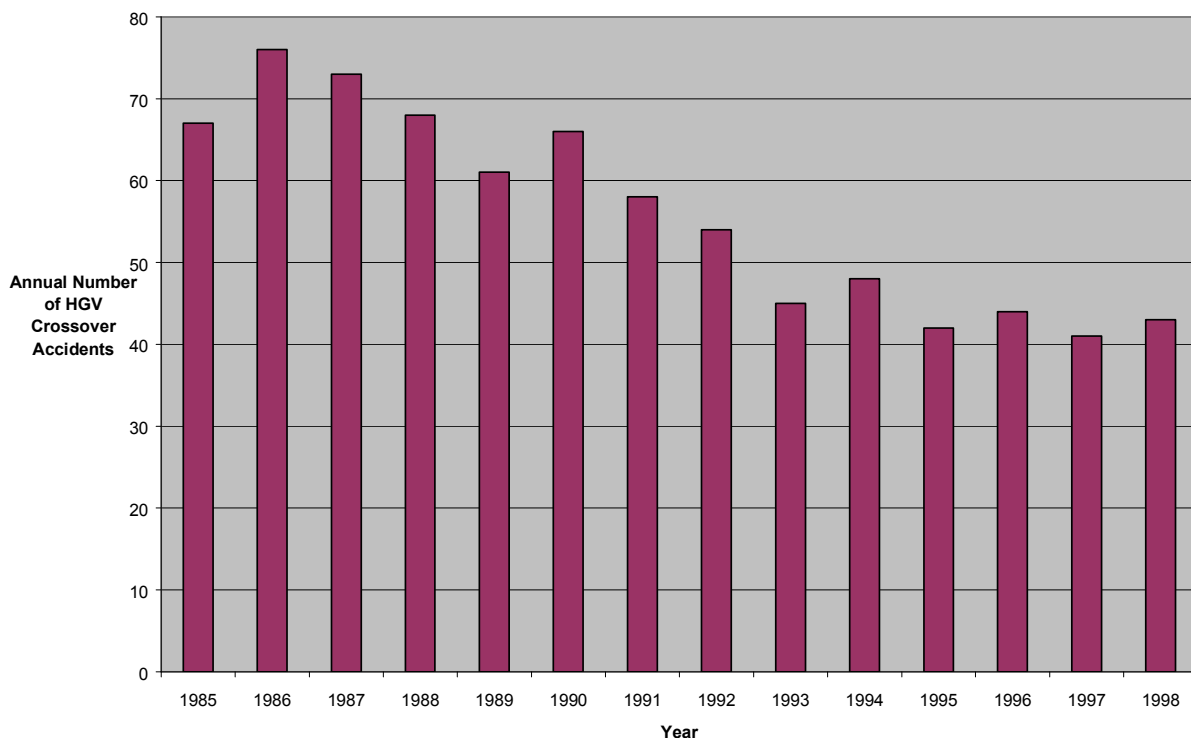
Figure 1: Annual Number of HGV Crossover Accidents on Motorways, A(M) and A roads in Great Britain (Of All Severity)
(see Appendix C, Table C1)

Figure 1 shows the annual number of HGV crossover accidents occurring on major roads in Great Britain between 1985 and 1998.

It shows that the number of HGV crossover accidents per year initially increased quite sharply from 67 in 1985, to 76 in 1986. However, since 1986 the number of accidents has tended to decrease gradually each year. This may be for a variety of reasons, for example an increase in the amount of safety fence or barrier installed on the central reserve. This decrease is not however, due to a reduction in the number of HGVs using these roads, as this value was seen to rise by 47% (from 217 to 320 million vehicle kilometres) between 1985 and 1998 (see Appendix B, Table B3).

After the decrease in the number of HGV crossover accidents between 1986 and 1993, the number of accidents has then fluctuated between approximately 40 and 50 accidents per year between 1993 and 1998.

As previously stated, Figure 1 (above) shows the *total* number of HGV crossover accidents occurring in each year on major roads in Great Britain. This total number of accidents is *broken down* into three distinct categories of accident: *fatal*, *serious* and *slight*. These categories define the severity of the accident, and are related to the severity of the most seriously injured casualty in the accident (as defined in Section 2.1.1).

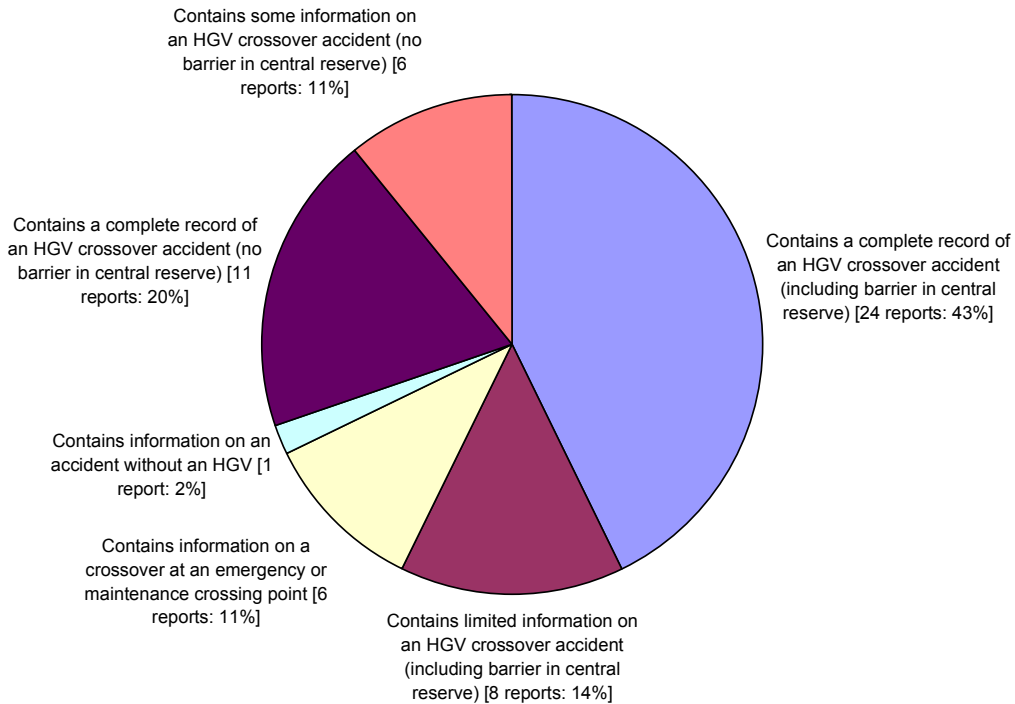
Figure 4: Summary of Information Contained in Fatal Files Held at TRL Limited

Figure 4 gives a brief summary of the information available in the police fatal files held at TRL Limited and examined for this commission.
